# IRAQ - Hasansham M2 Camp

## Tent Condition - Updated 26 January 2017

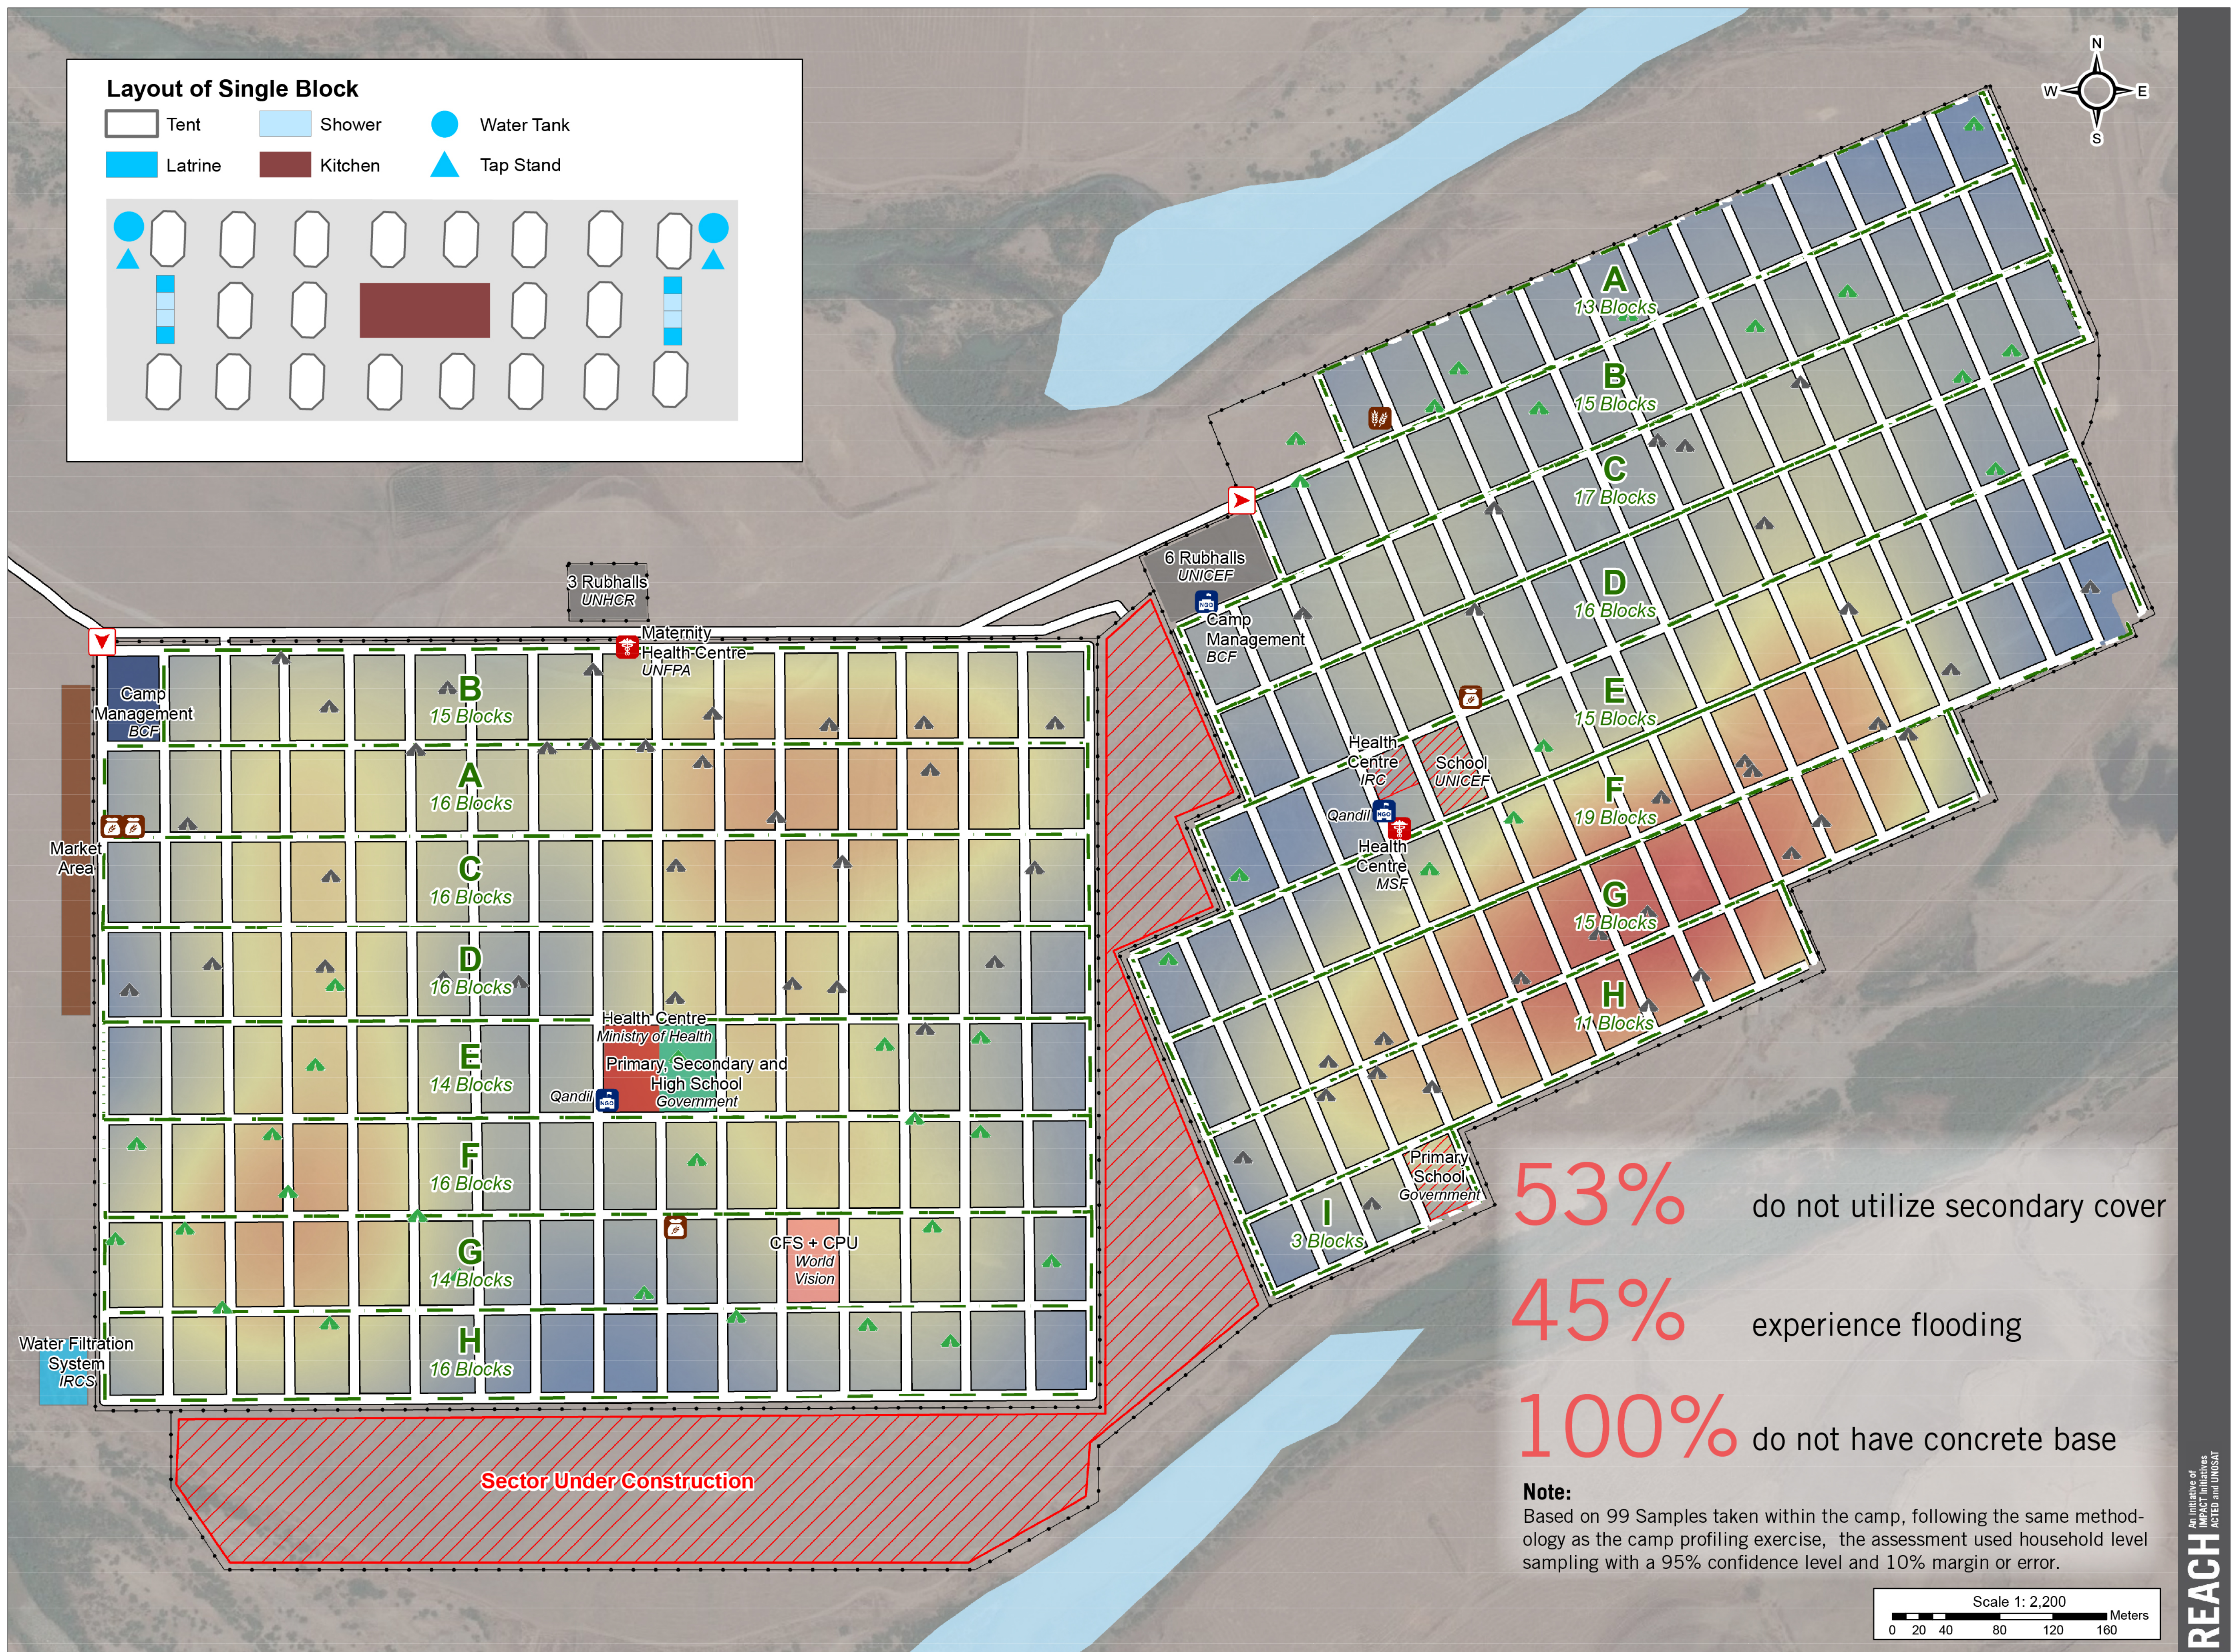
### Density of Sample Tents Experiencing Flooding

**53%** do not utilize secondary cover  
**45%** experience flooding  
**100%** do not have concrete base
