MOZAMBIQUE - Beira City

Mungassa - Structural Damage by Construction Typology - As of 26 March

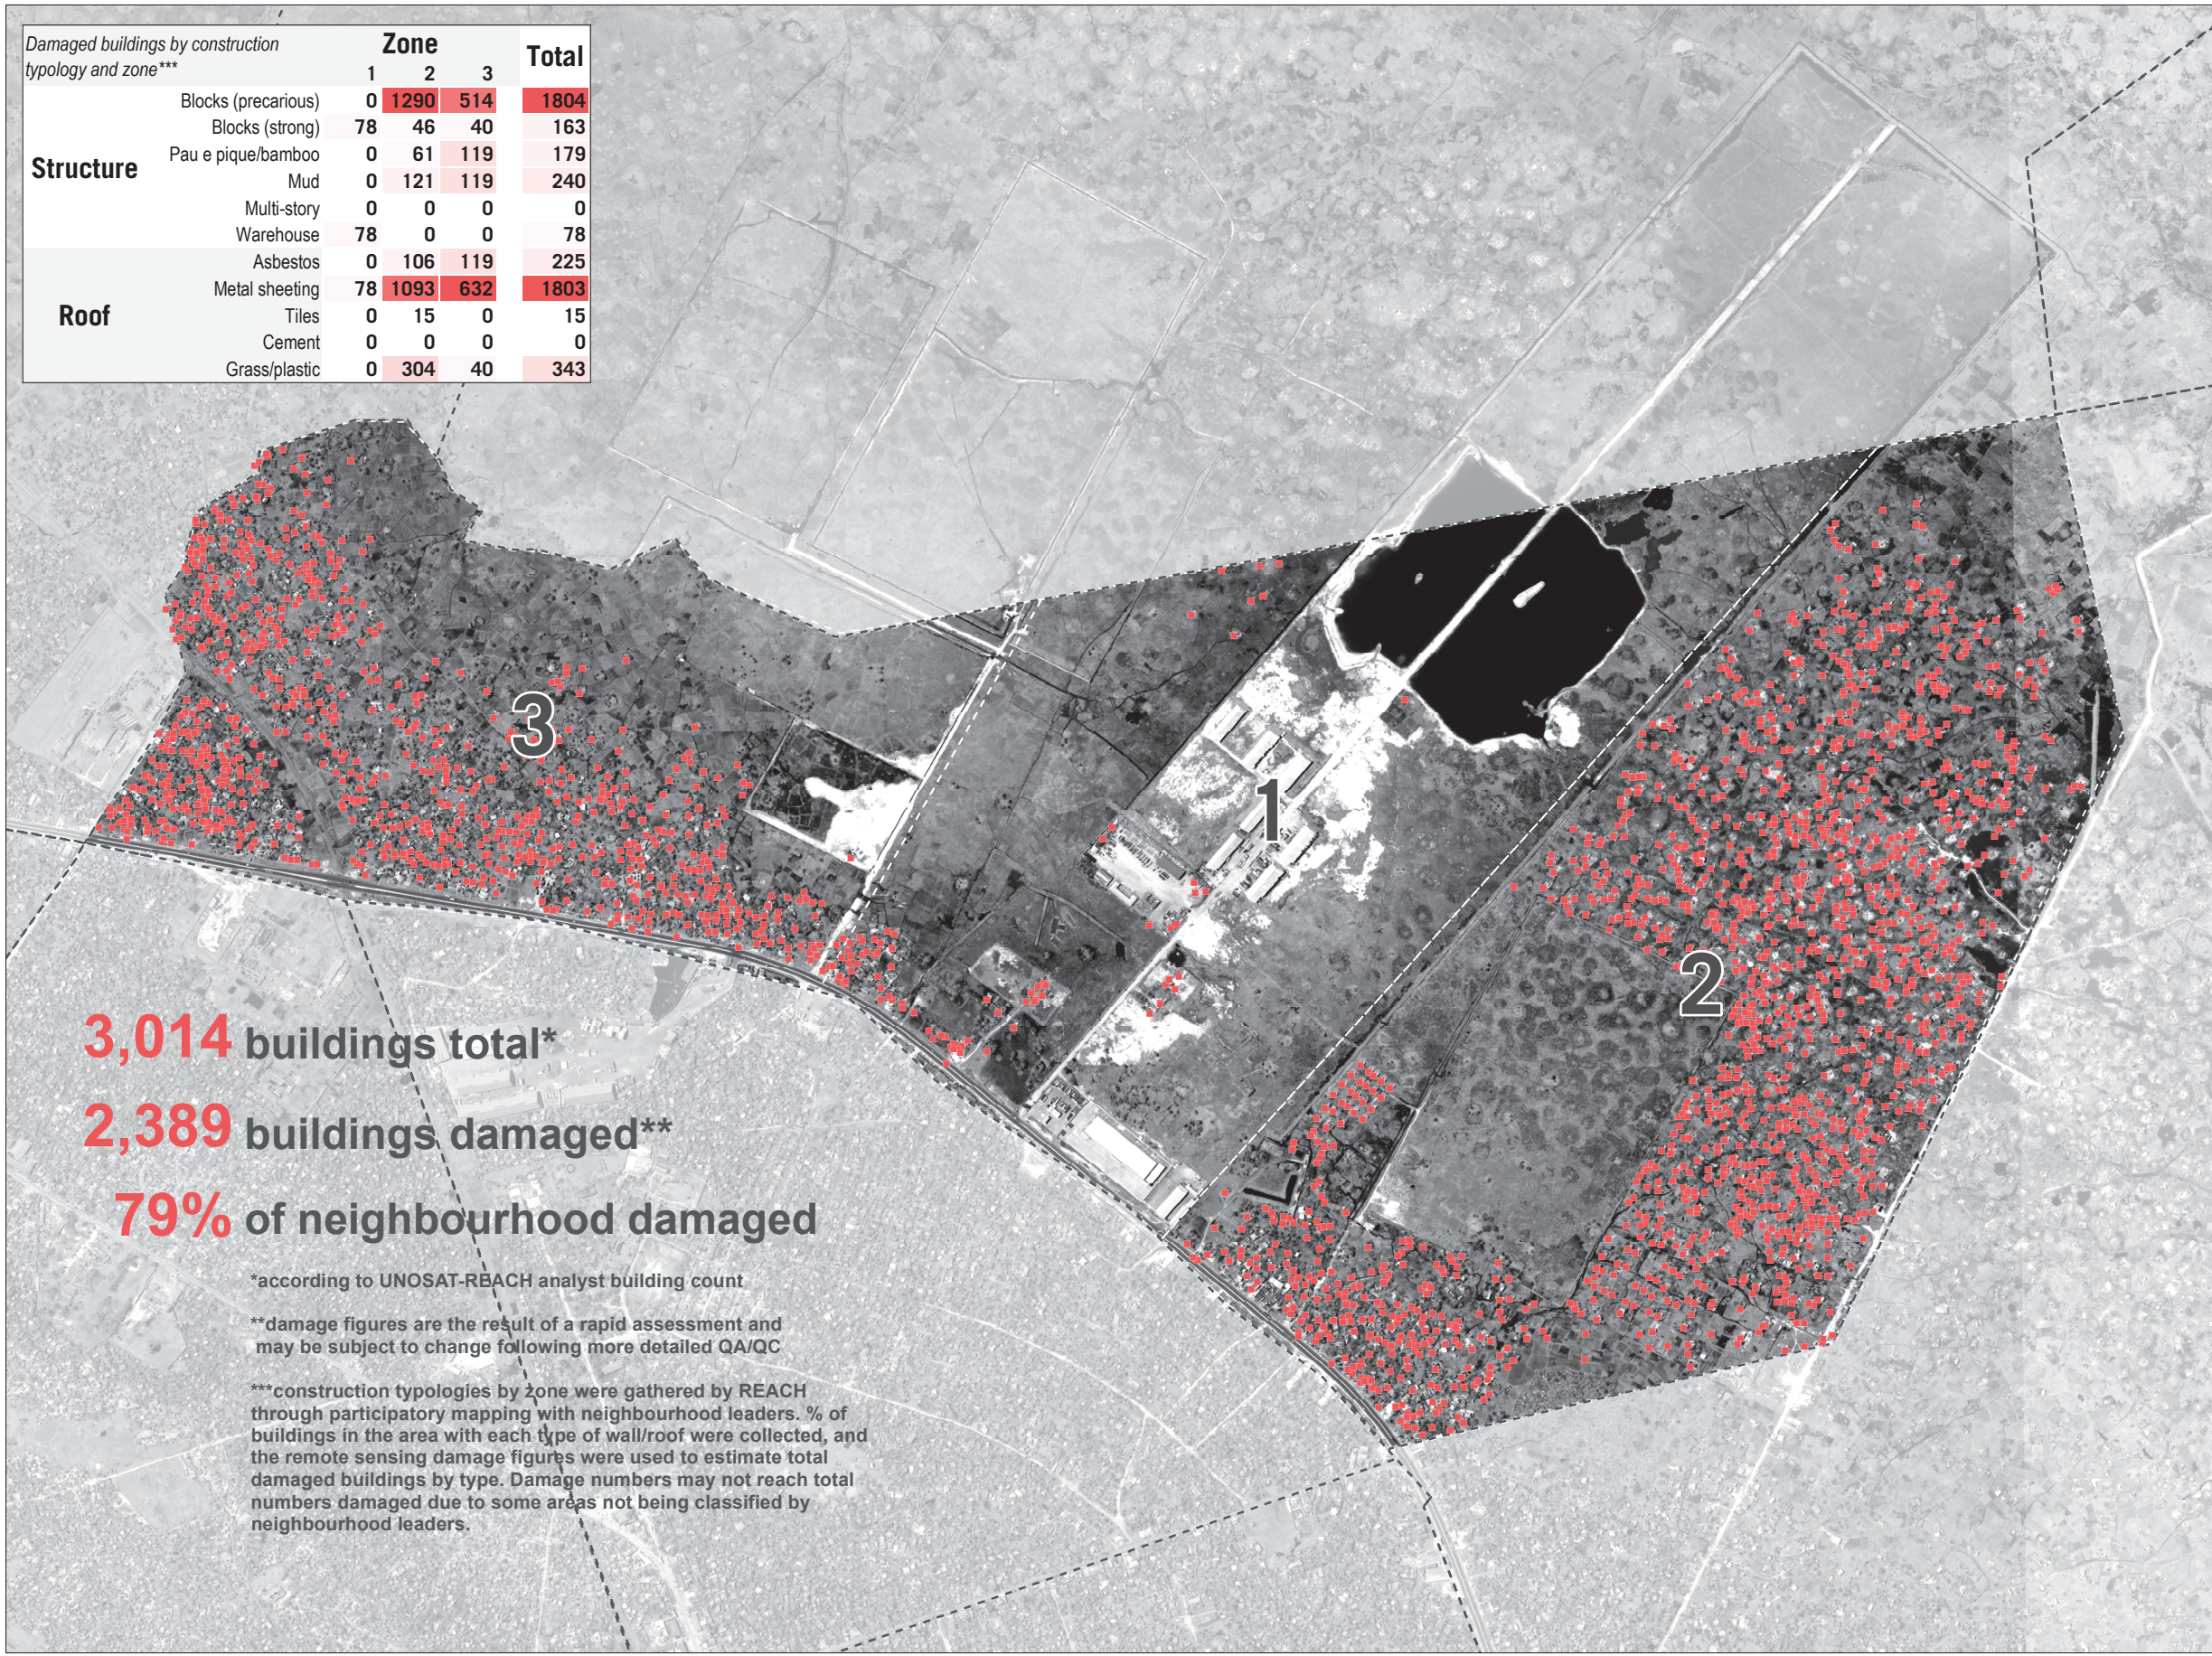
Structure	Zone			Total
	1	2	3	
Blocks (precarious)	0	1290	514	1804
Blocks (strong)	78	46	40	163
Pau e pique/bamboo	0	61	119	179
Mud	0	121	119	240
Multi-story	0	0	0	0
Warehouse	78	0	0	78
Asbestos	0	106	119	225
Metal sheeting	78	1093	632	1803
Tiles	0	15	0	15
Cement	0	0	0	0
Grass/plastic	0	304	40	343

3,014 buildings total*
2,389 buildings damaged**
79% of neighbourhood damaged
