Based on 106 Samples taken within the camp, the assessment used household level sampling with a 95% confidence level and 10% margin or error.

### Density of Sample Tents Experiencing Flooding

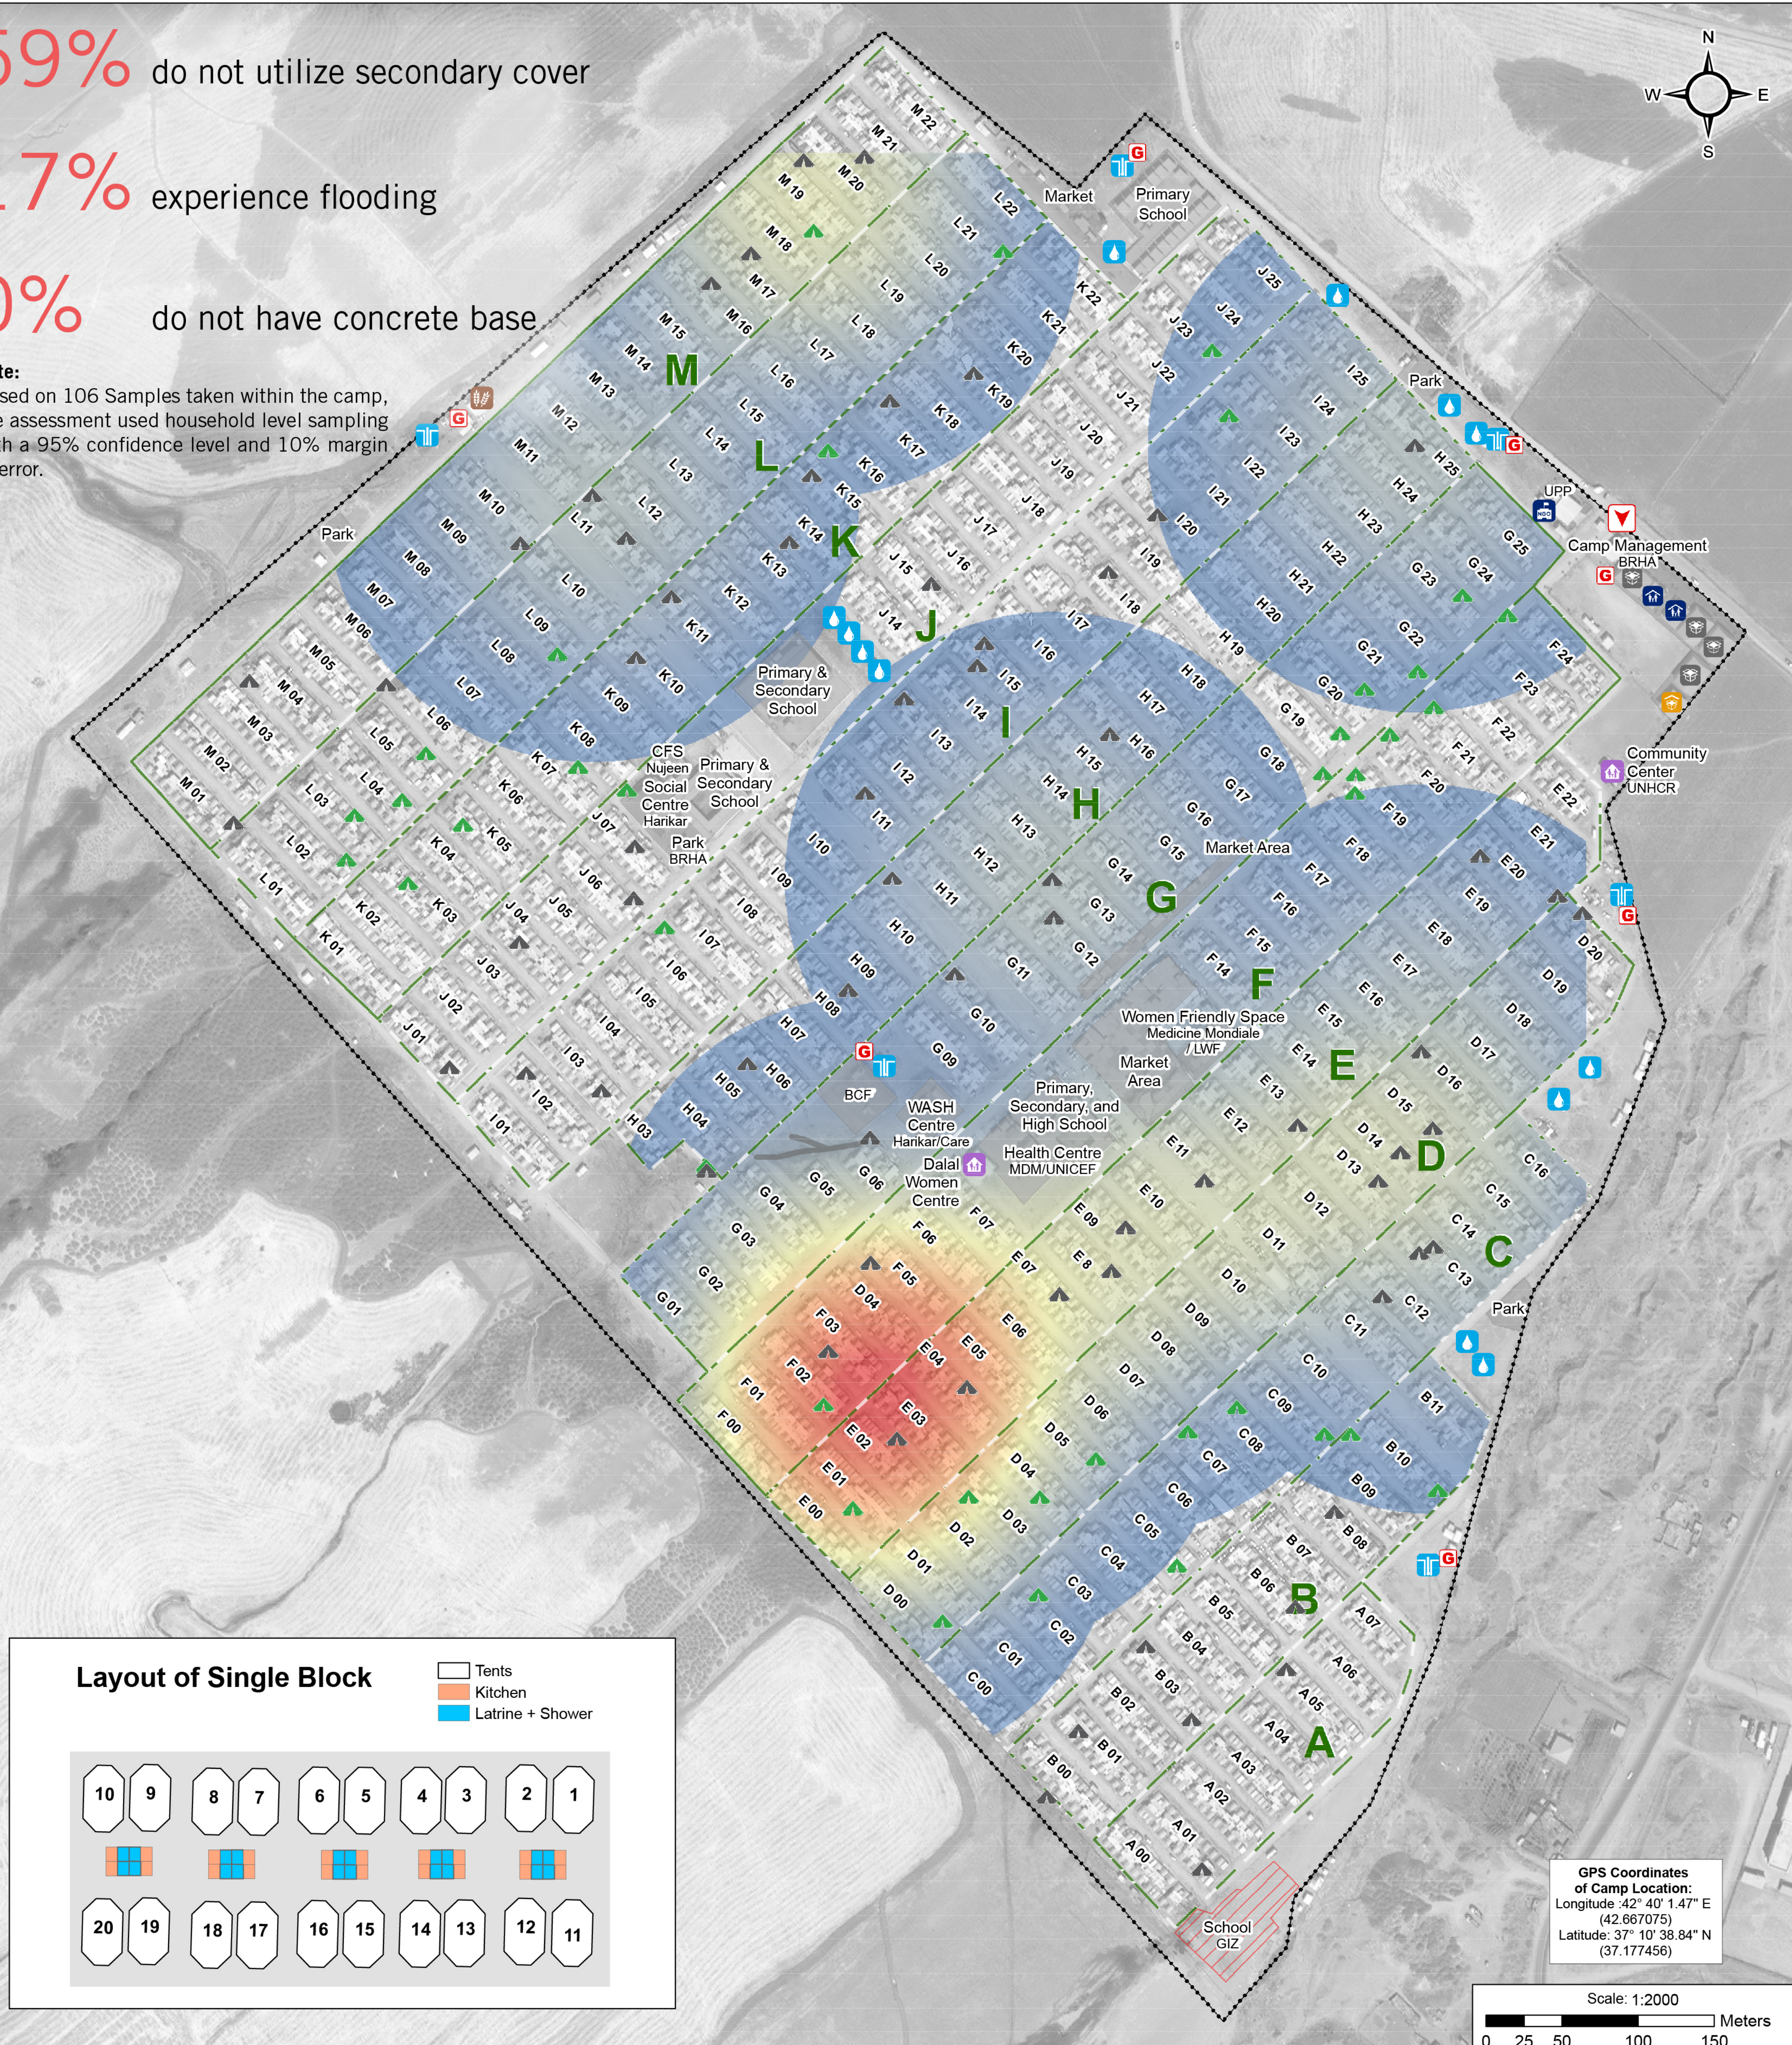
59% do not utilize secondary cover

17% experience flooding

0% do not have concrete base
