MOZAMBIQUE - Beira City

Nhaconjo - Structural Damage by Construction Typology - As of 26 March

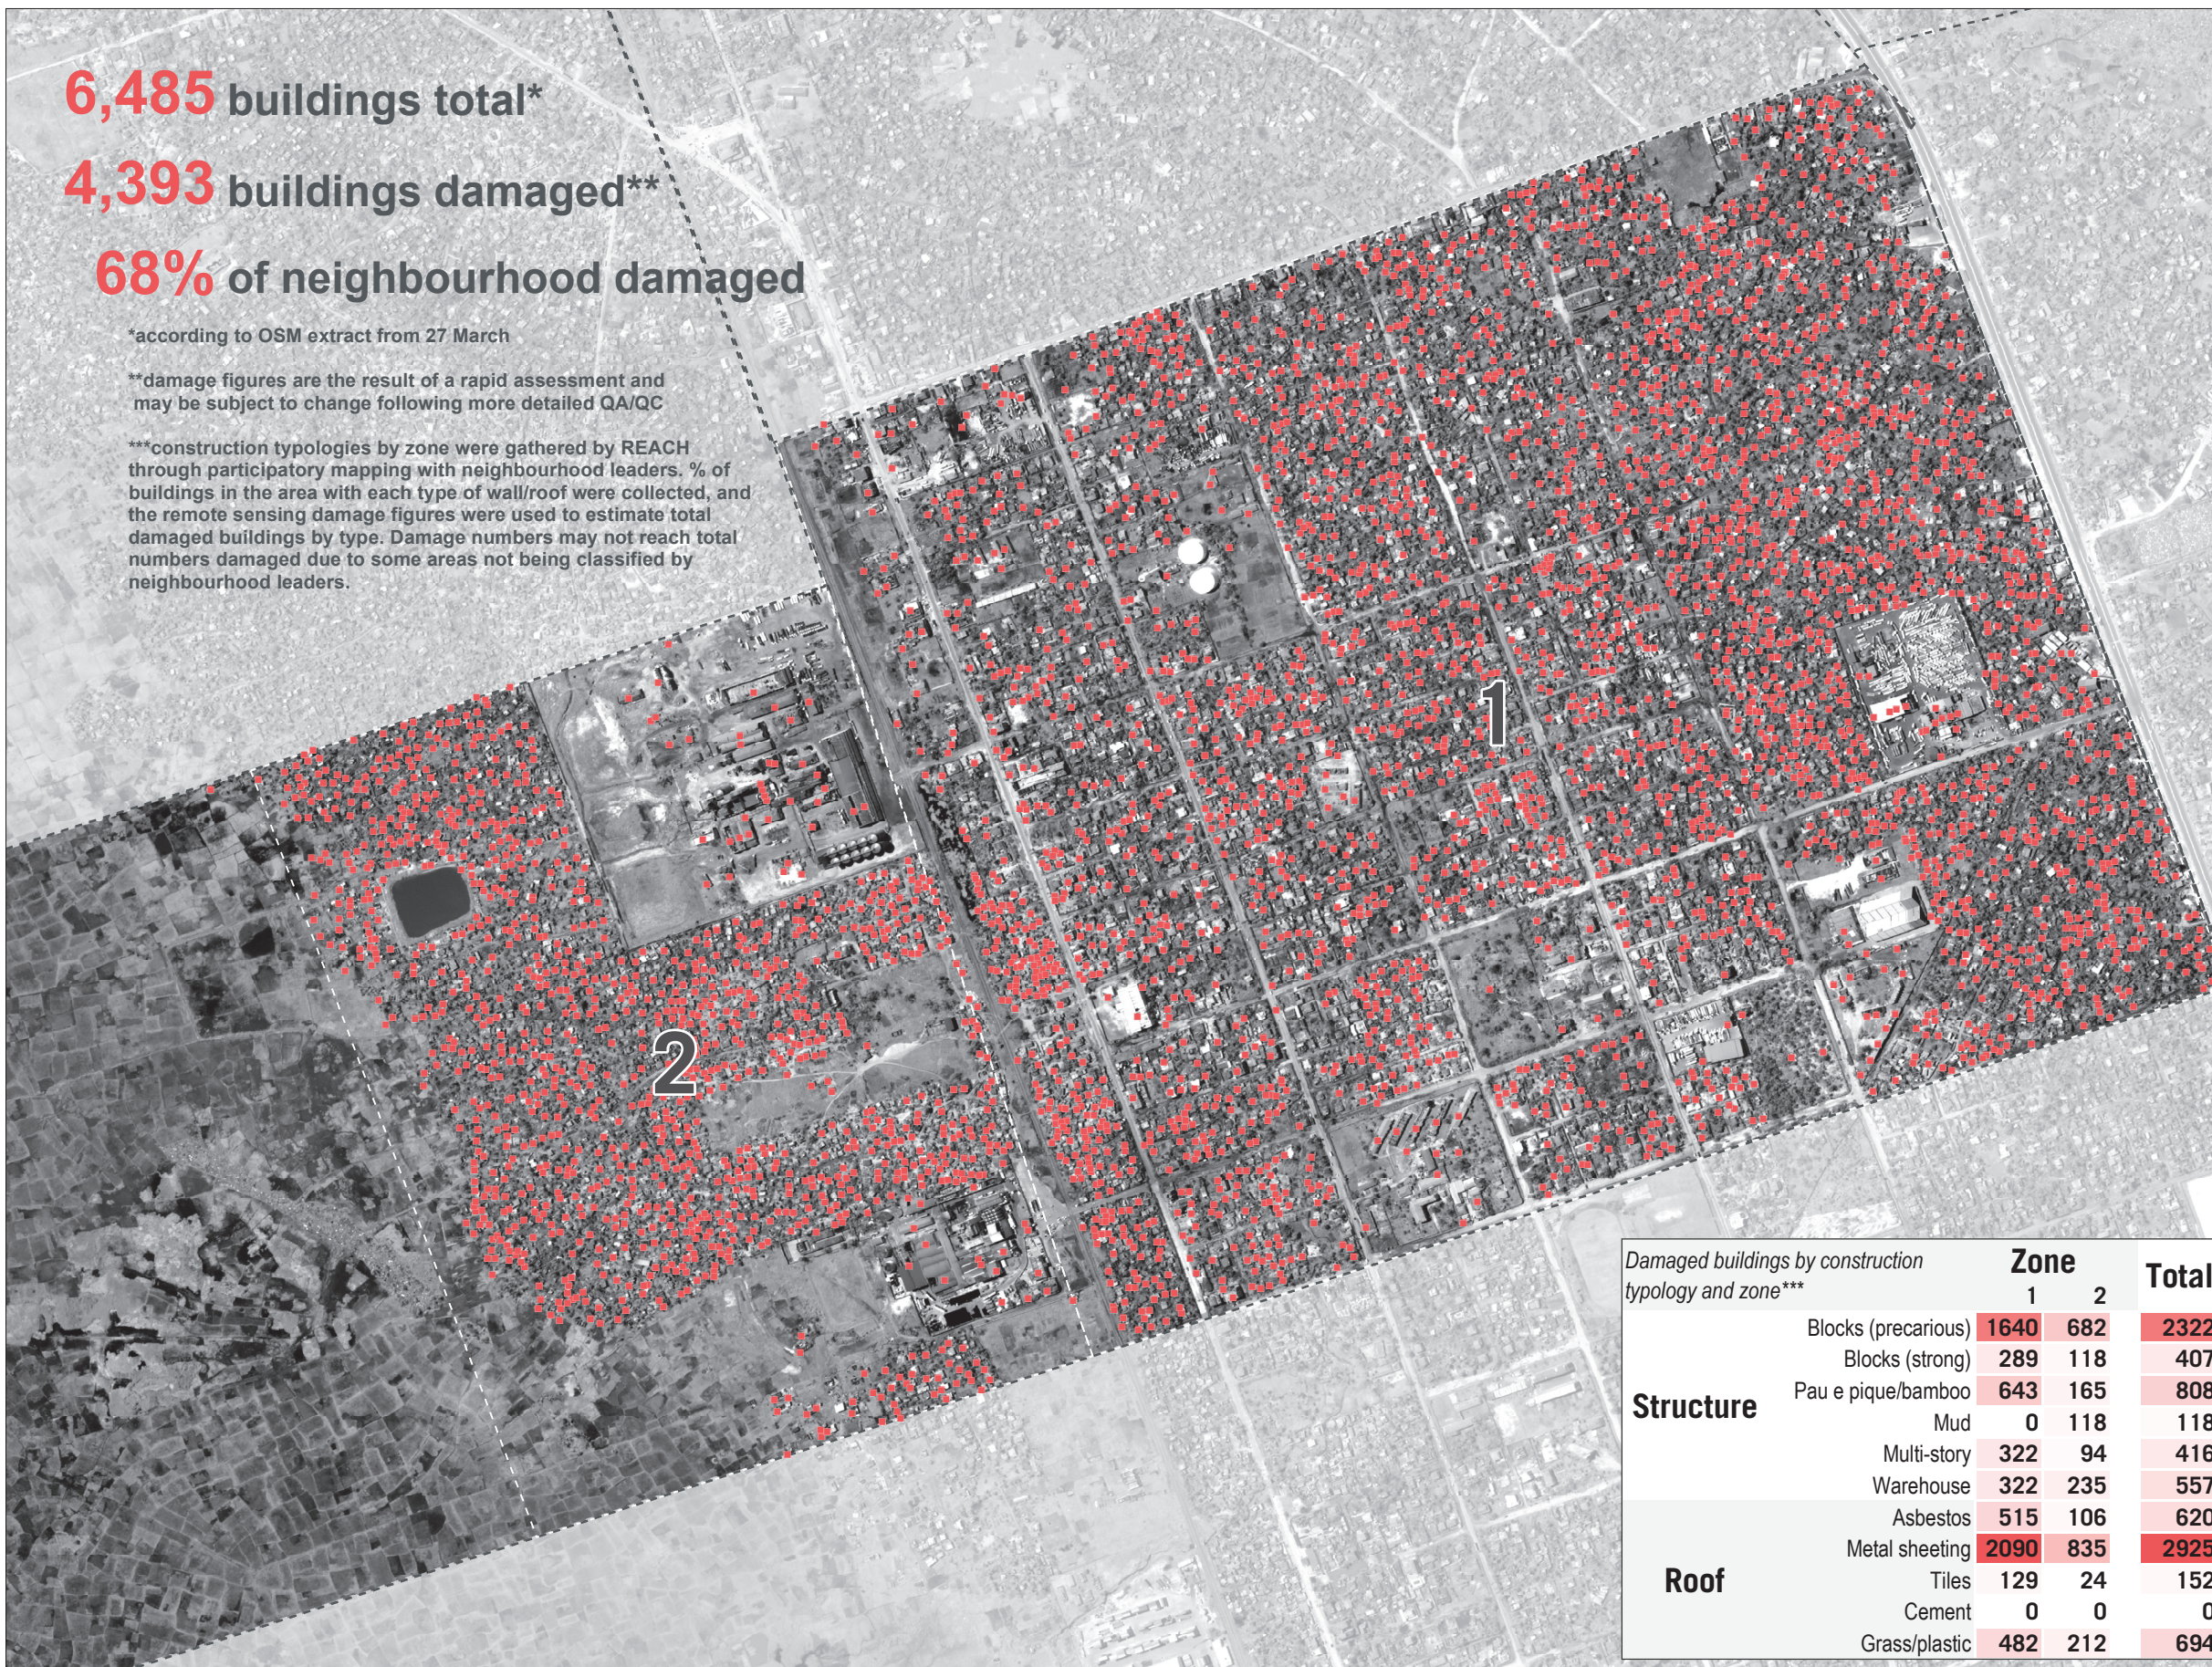
6,485 buildings total*

4,393 buildings damaged**

68% of neighbourhood damaged
