Damage & Rehabilitation Assessment:

Syria - Al-Thawrah (Tabqa)

September 2021

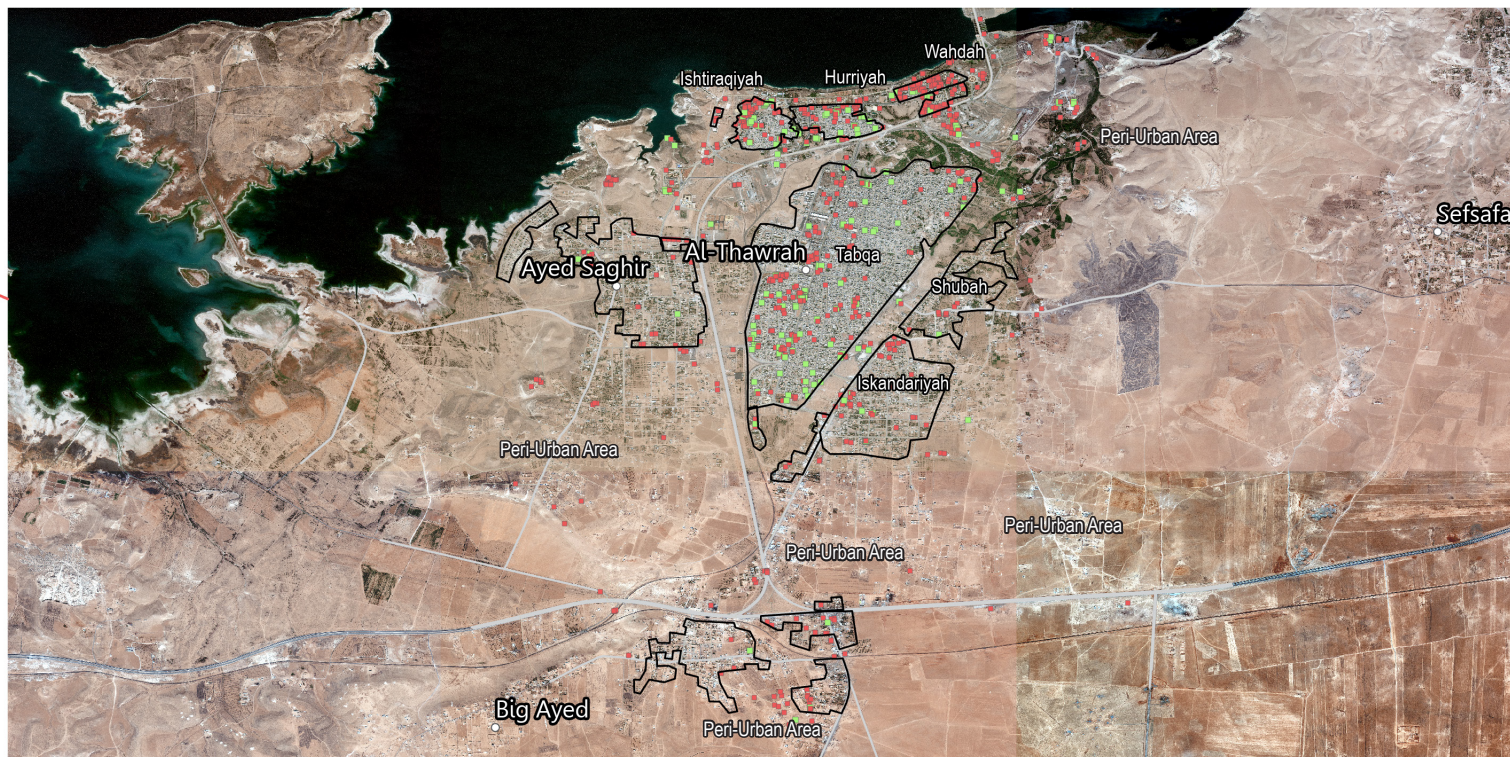
This map illustrates satellite-detected rehabilitated/reconstructed or damaged/demolished structures in the city of Al-Thawrah, Syria compared to previous damage analysis. Using imagery acquired on 11 September 2021, UNITAR-UNOSAT detected a total of 196 rehabilitated/reconstructed buildings.

In particular, efforts of reconstruction and rehabilitation have been undertaken in the area of Tabqa city, where 98 (33%) detected structures have been reconstructed or rehabilitated.

There have also been efforts of reconstruction and rehabilitation in the north of the city in Hurriyah with 24 (37%) detected structures rehabilitated or reconstructed.

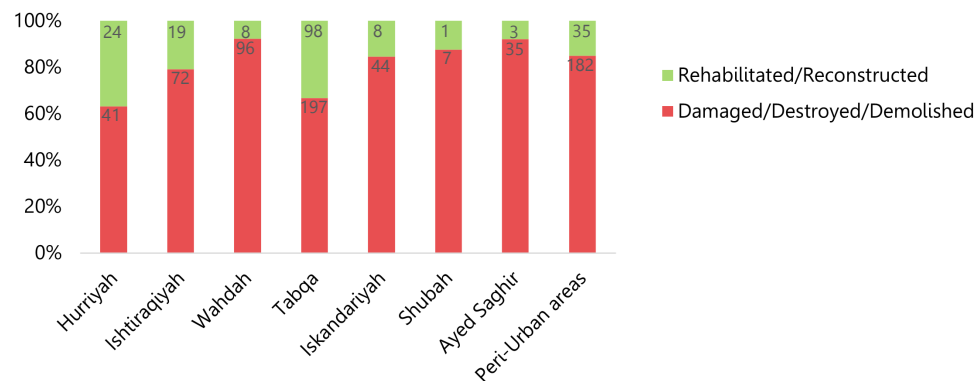
and % of detected affected structures in neighborhoods that were found to be rehabilitated/reconstructed, or damaged/destroyed/demolished as of 2021

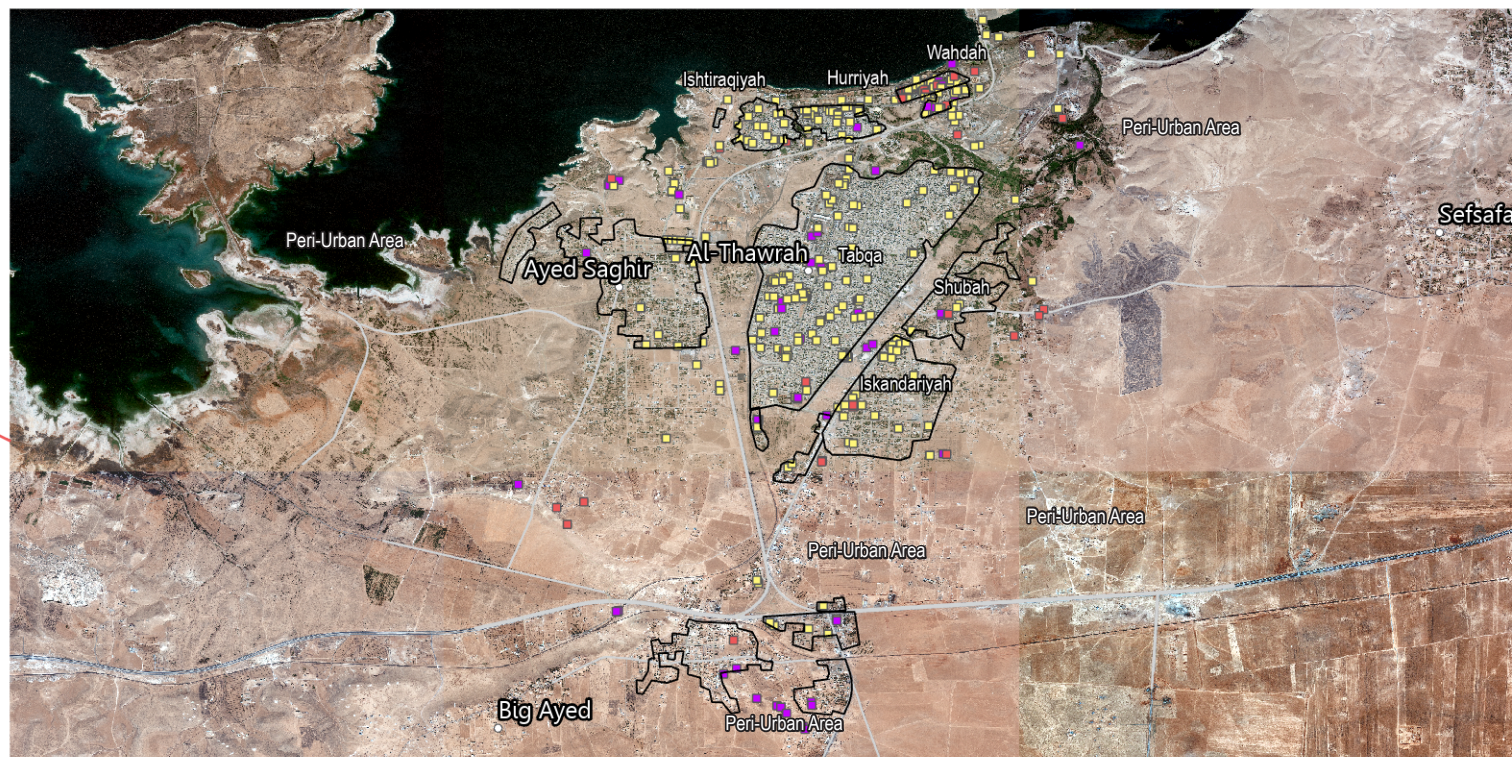
This map illustrates the damage severity of satellite-detected damaged/destroyed structures in the city of Al-Thawrah, and damage density, using imagery acquired on 11 September 2021.

Wahdah neighbourhood has the highest damage density, as a result of its proximity to the dam, where the 2017 clashes were most severe. In Wahdah, 96 (92%) detected structures were observed to be damaged, destroyed or demolished. In December 2019, Information Management Unit (IMU) KIs reported that the majority resident population in this neighbourhood was IDPs, who were residing in multi-story buildings, with poor to average living conditions.²⁵

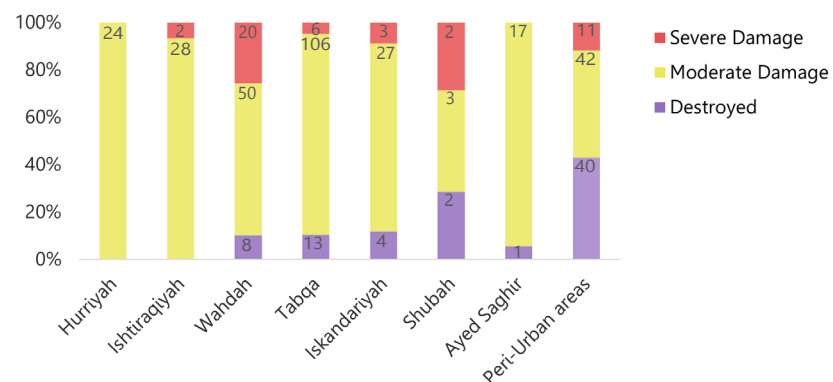
and % of damaged/destroyed structures in neighbourhoods that were found to have severe damage/moderate damage or be destroyed as of 2021
