**Residential building damage assessment
Irpın, Kyivska oblast, February-March 2022**

UKRAINE – Irpin residential damage assessment

Irpin, Kyivska oblast, February-March 2022

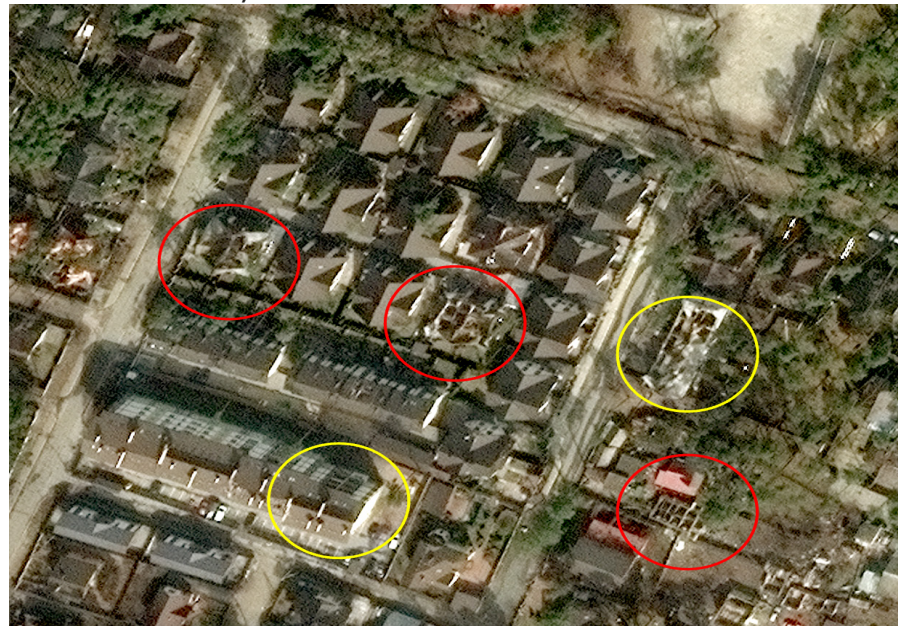
Image 1 and 2: Examples of detected damage to residential buildings in Irpin based on satellite imagery. Red circles - single-household apartments; Yellow circles - apartment buildings; Blue circle - town-house (a group of single-household apartments connected by the common sidewalls).
