# Gwoza Town WASH Infrastructure Mapping

Gwoza LGA, Borno State, Nigeria

March 2021

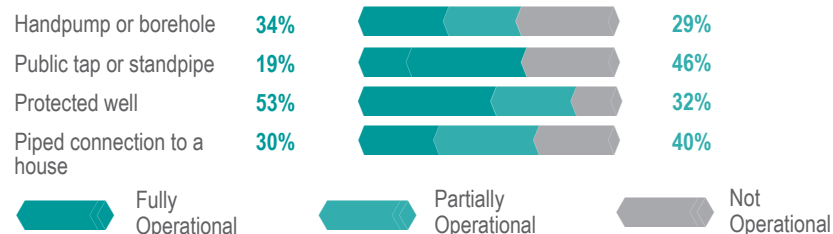
### Improved waterpoints functionality by type

45% of assessed waterpoints were reported to be damaged or in need of repair.
