**Residential building damage assessment  
Izyum, Kharkivska oblast, February-August 2022**

# UKRAINE – Iziium residential damage assessment

## Iziium, Kharkivska oblast, February-August 2022

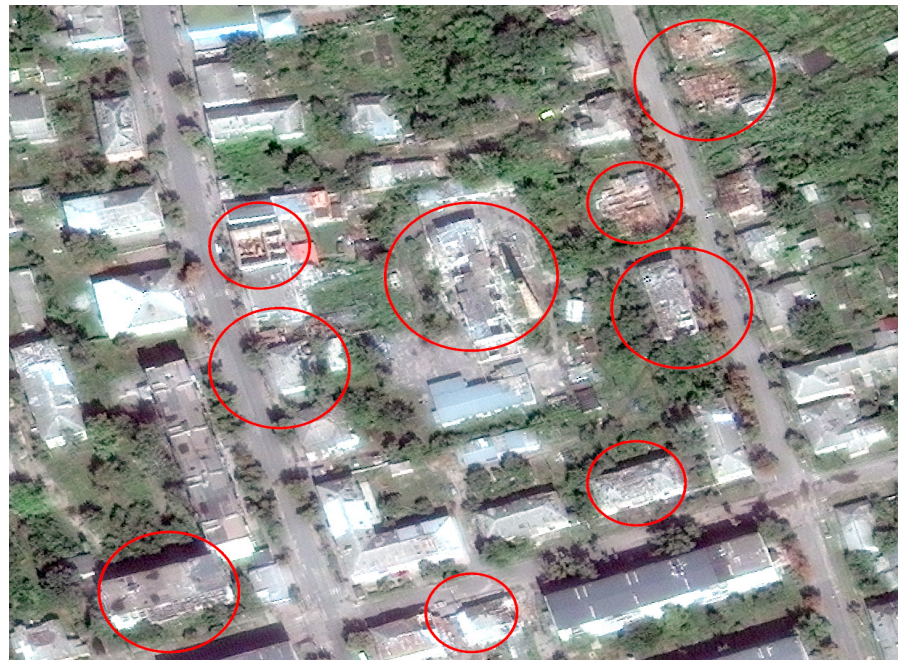
**Image 1 and 2: Examples of detected damage to residential buildings in Iziium based on satellite imagery. Red circles depict single-household apartments and apartment buildings with detected damage. The first image shows a built-up area near the city centre, the second image shows the outskirts of Iziium.**
