# Infrastructure Mapping in Flood Affected Counties - Twic East, Jonglei State

October 2026 | South Sudan

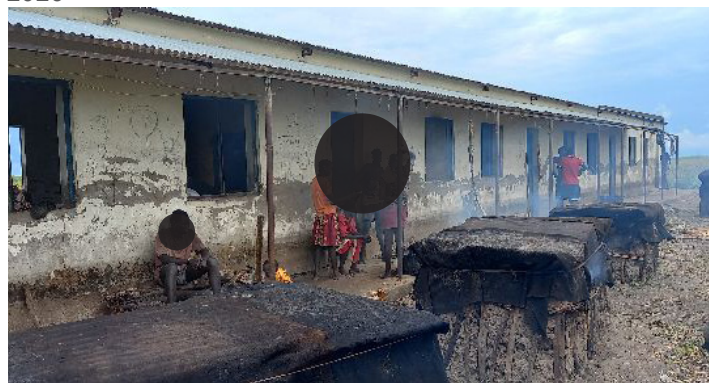
Non functional School in Paker Payam used by fishers; June 2026

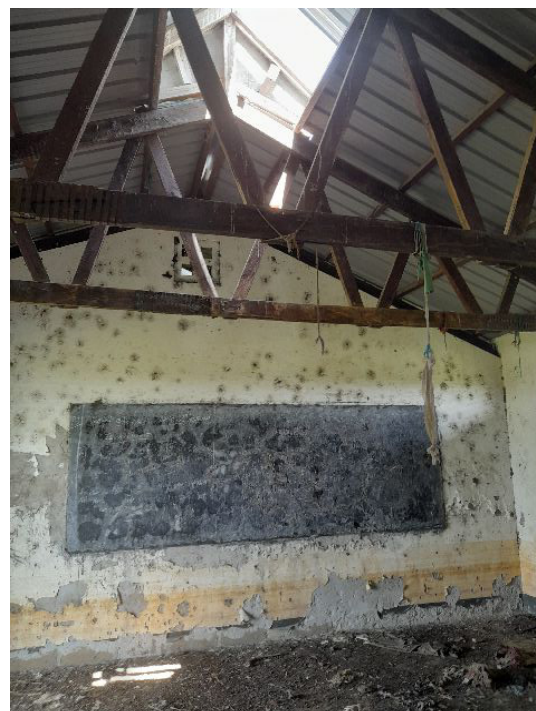
Of the educational facilities mapped, a very higher proportion (97%) have visible damages on them. Reported observable damage to the infrastructure included the following; roofing and ceilings being damaged from rain infiltration or wind (81%), cracks and sinking of the foundation and structure (76%), textbooks, library books, or records being destroyed (75%), and furniture such as desks, chairs, and cupboards being destroyed (73%).

Non functional school in Kongor Payam; June 2026

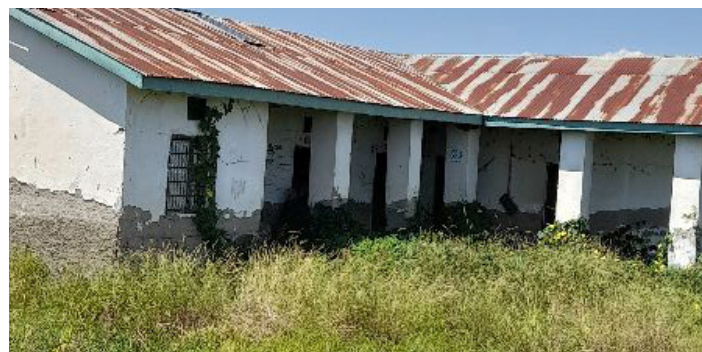
In terms of physical condition, visible damage was reported in the majority of facilities. A high proportion (83%) of mapped facilities were observed as having visible damage, compared to only 11% that showed no visible damage. Visible damages observed during data collection were related to the physical structure (90%), loss of power or fridges for vaccines and sensitive medicines (55%), water damaged stock (48%), and damages to diagnostic tools (48%). This finding suggests that although a substantial proportion of health facilities remain functional, many continue to operate under damaged conditions.

Non-functional Health Facility in Nyuak Payam; June 2026

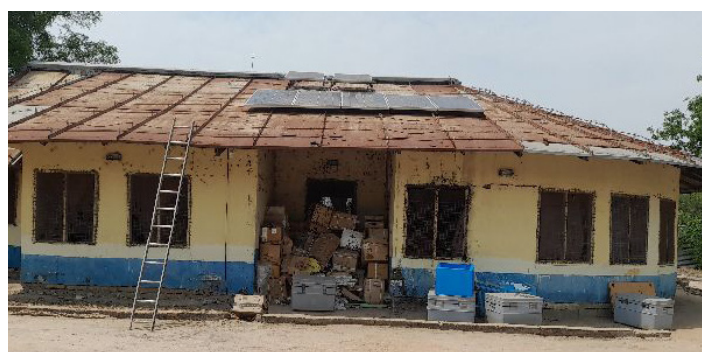
Functional Health Facility in Kongor Payam with no proper storage; June 2026

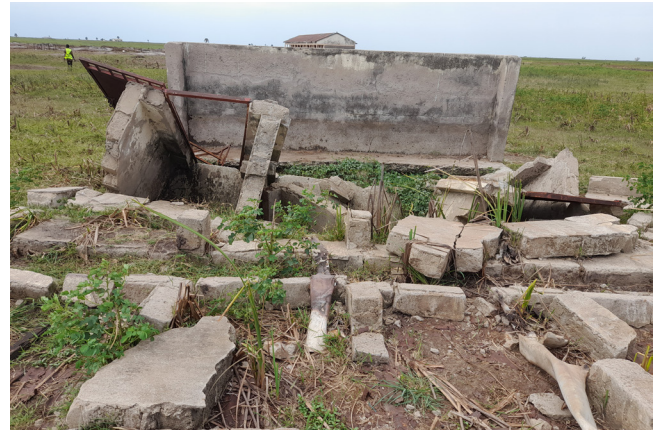
Collapsed toilet in Ajoung Payam; June 2026

Regarding latrines, a high proportion (53%) of mapped latrines were non-functional. Additionally, access to latrines remained relatively low, with only 39% of facilities accessible. The limited accessibility may restrict the ability of the community to use sanitation facilities safely and conveniently, potentially increasing the risk of open defecation and hygiene-related health concerns.

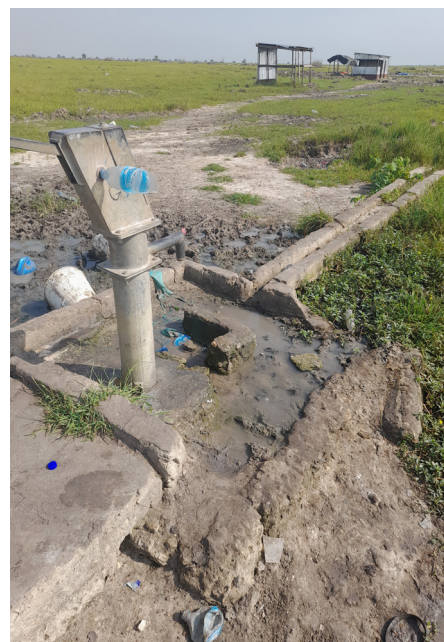
Functional borehole in Kongor Payam without proper apron; June 2026

Despite water points being functional, almost three quarter (72%) were reported to have visible damage, and these mainly included water sources being filled with mud and debris (77%), concrete aprons washed away (68%), handpump components being damaged (56%), and contamination with visible pollutants (54%)
