MOZAMBIQUE - Beira City

Chaimite - Structural Damage by Construction Typology - As of 26 March 2019

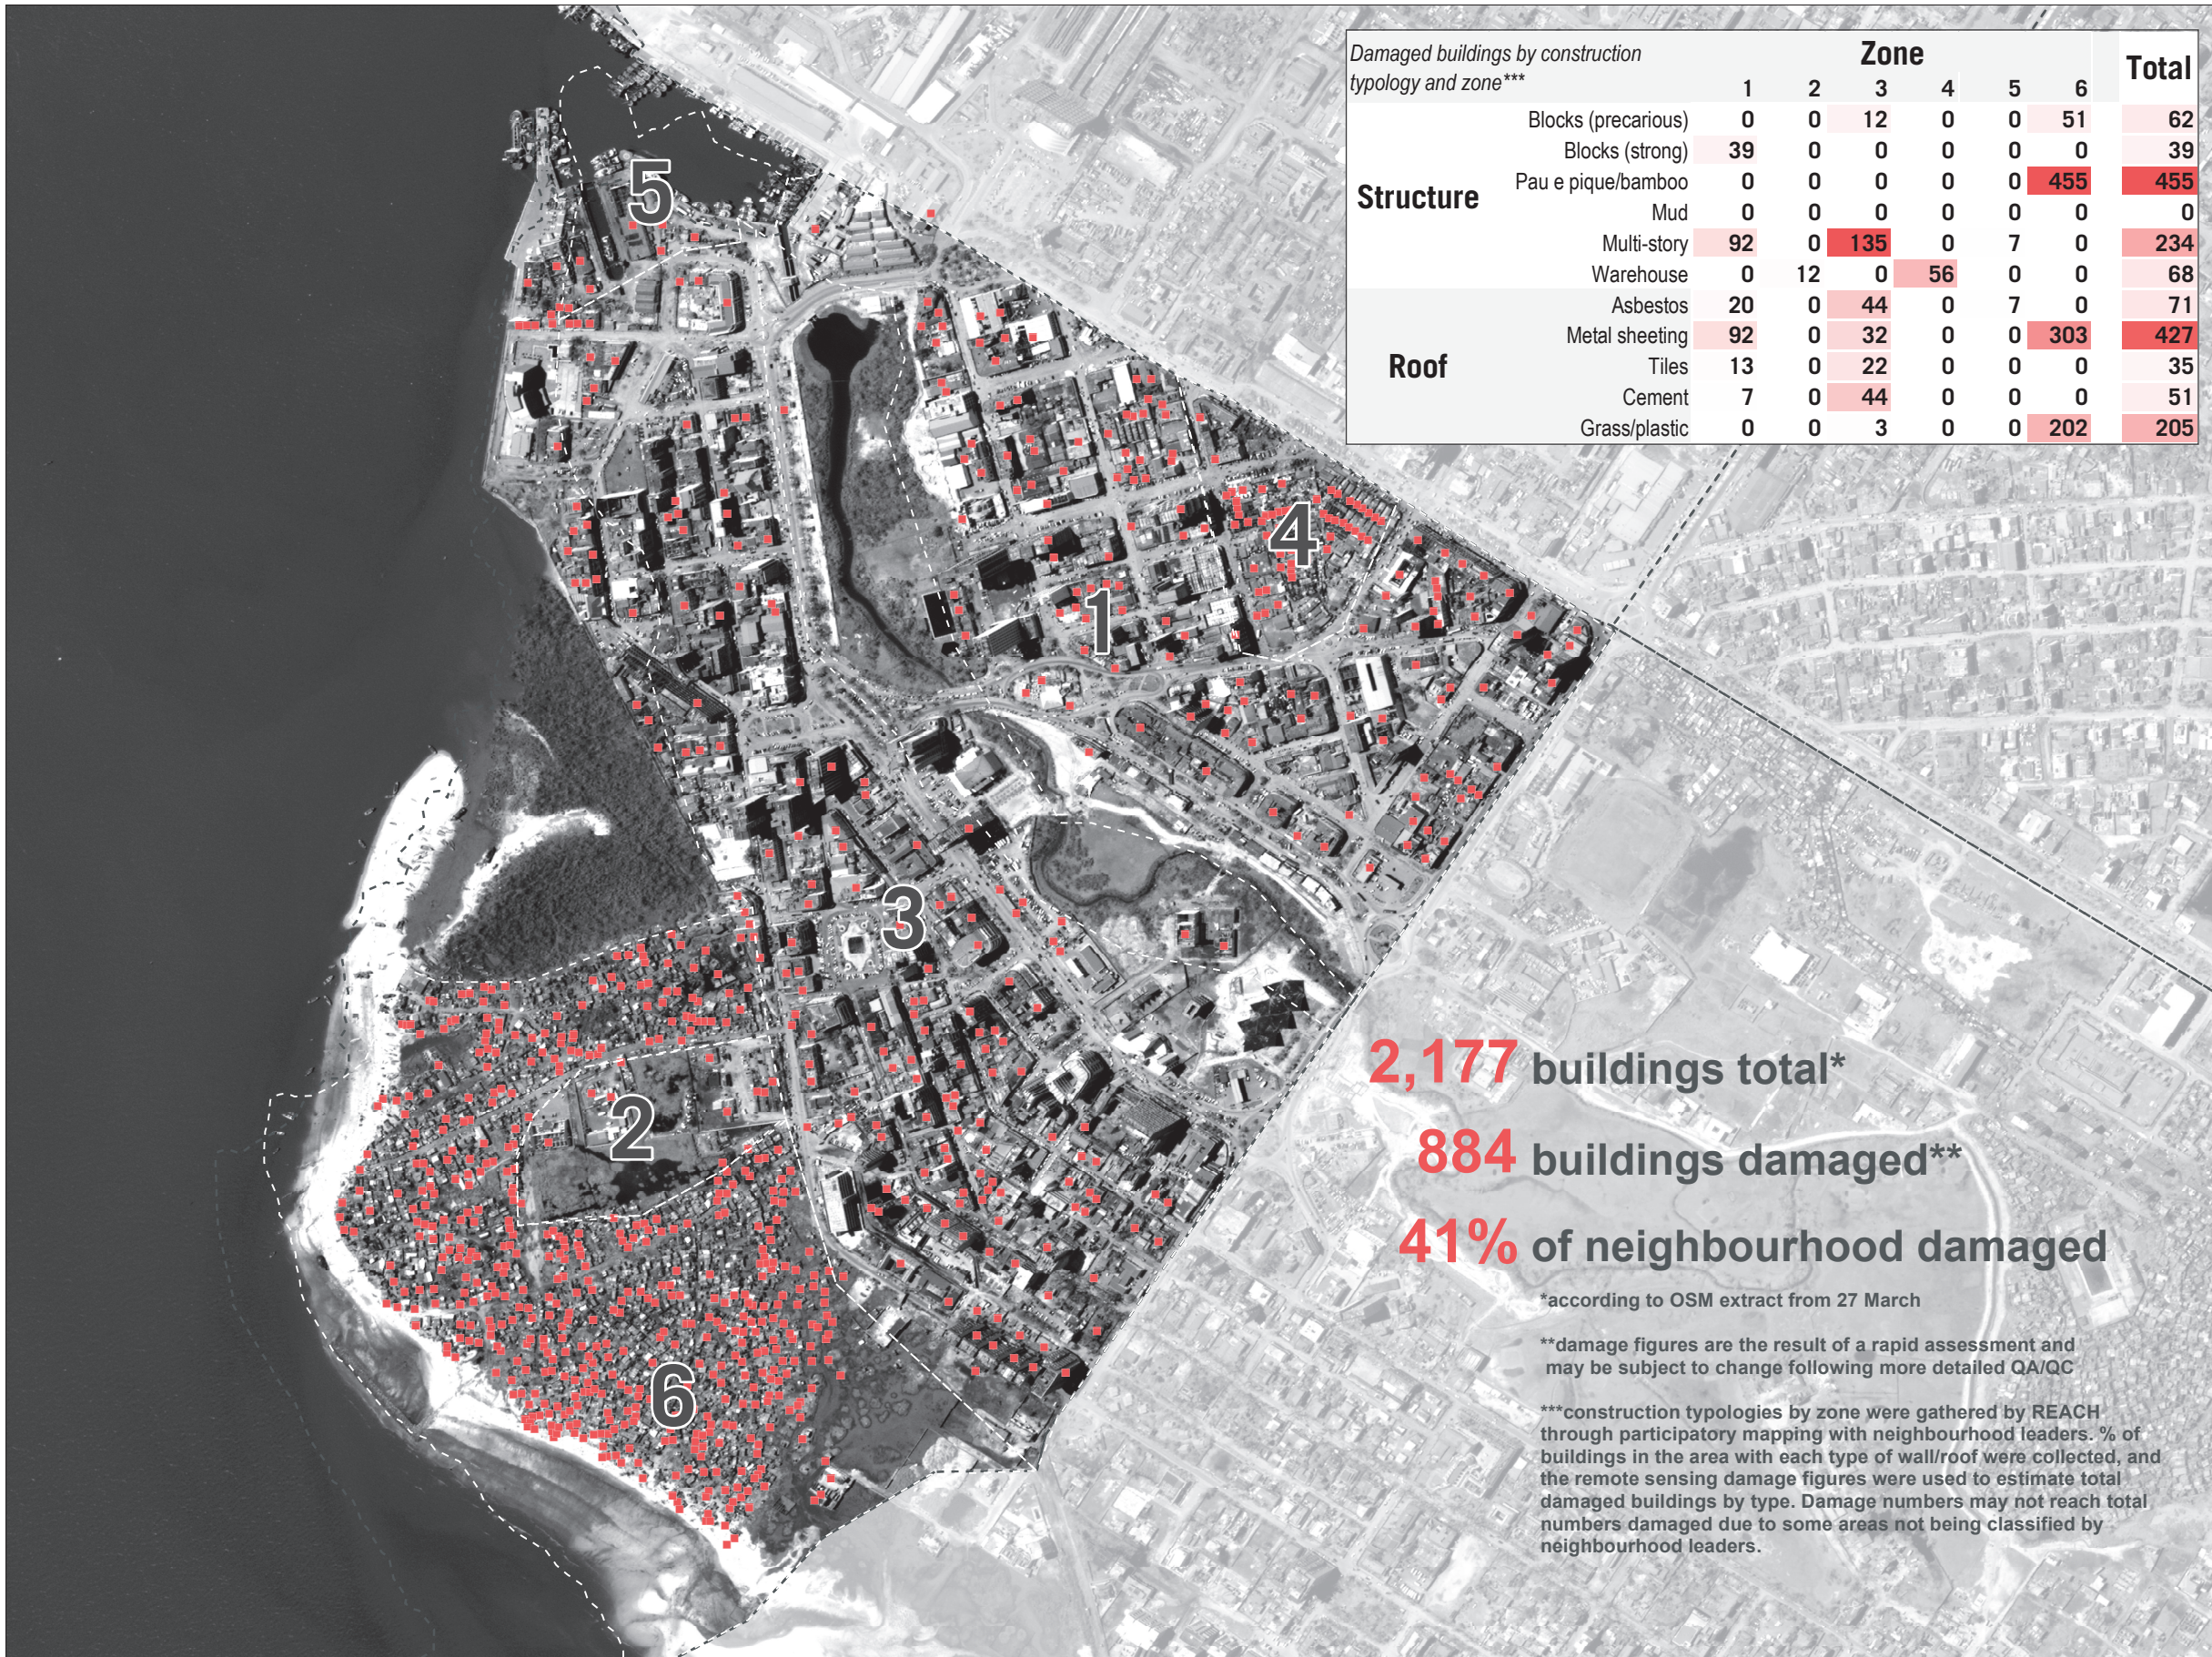
Damaged buildings by construction typology and zone***		Zone						Total
		1	2	3	4	5	6	
Structure	Blocks (precarious)	0	0	12	0	0	51	62
	Blocks (strong)	39	0	0	0	0	0	39
	Pau e pique/bamboo	0	0	0	0	0	455	455
	Mud	0	0	0	0	0	0	0
	Multi-story	92	0	135	0	7	0	234
Roof	Warehouse	0	12	0	56	0	0	68
	Asbestos	20	0	44	0	7	0	71
	Metal sheeting	92	0	32	0	0	303	427
	Tiles	13	0	22	0	0	0	35
	Cement	7	0	44	0	0	0	51
	Grass/plastic	0	0	3	0	0	202	205

2,177 buildings total*
884 buildings damaged**
41% of neighbourhood damaged
