# Damage Atlas Ar-Raqqa City

**Satellite-Detected Damage Severity  
Assessment**

**April 2021**

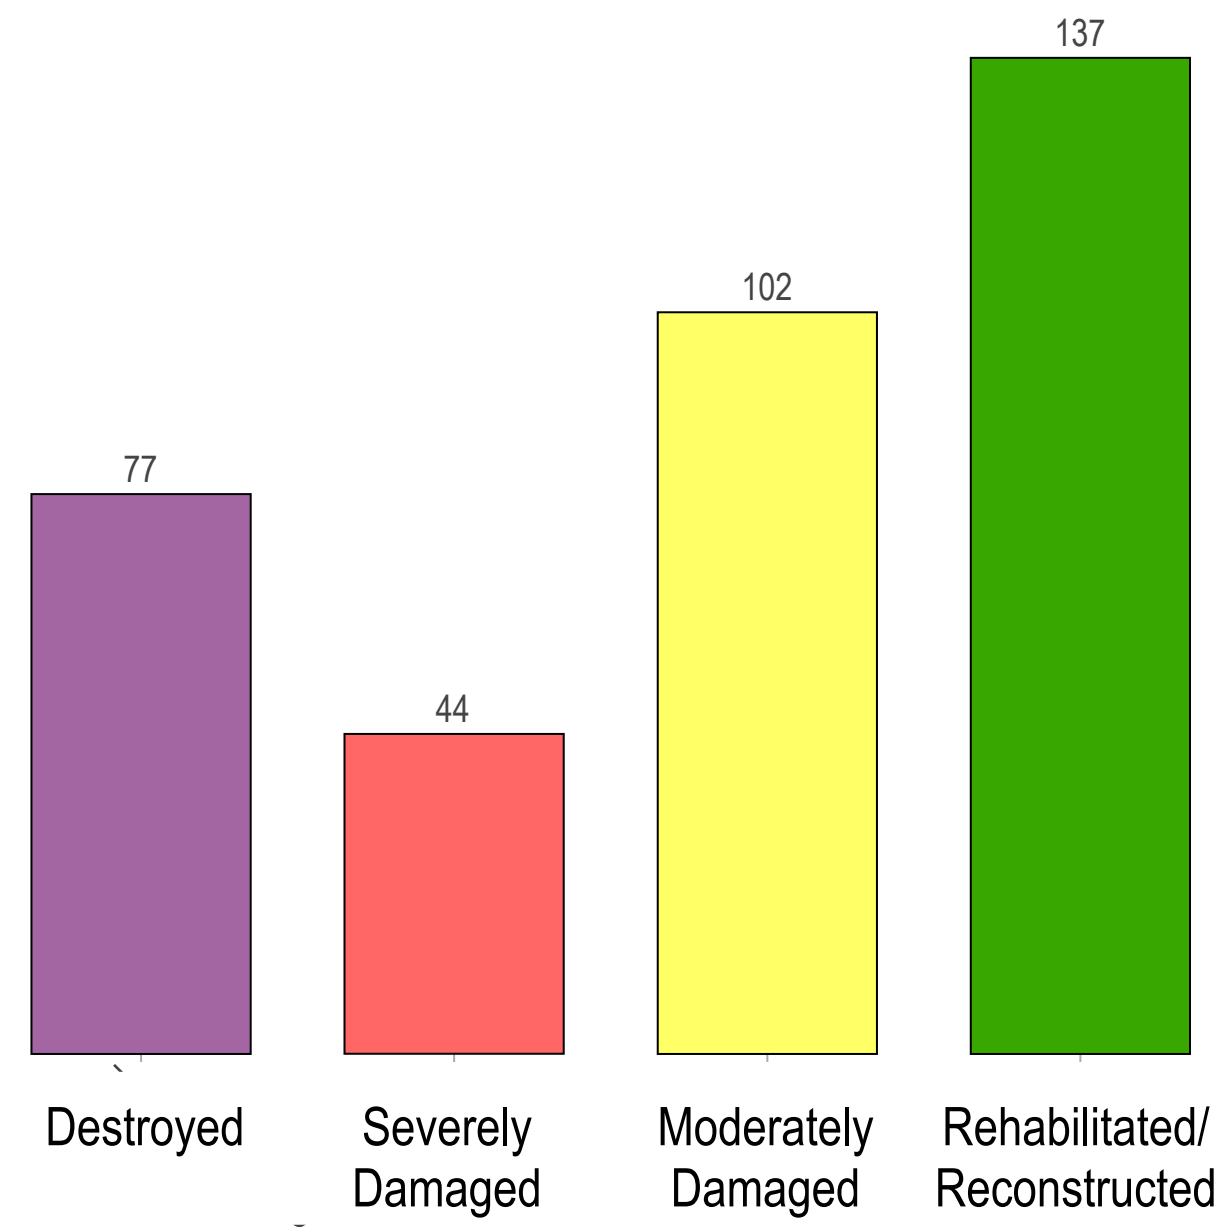
Baath Damage Counts,  
by # of identified structures

\*Severity calculated based on density of damaged infrastructure and weighted by scale of damage based on: destroyed, severely damaged or moderately damaged

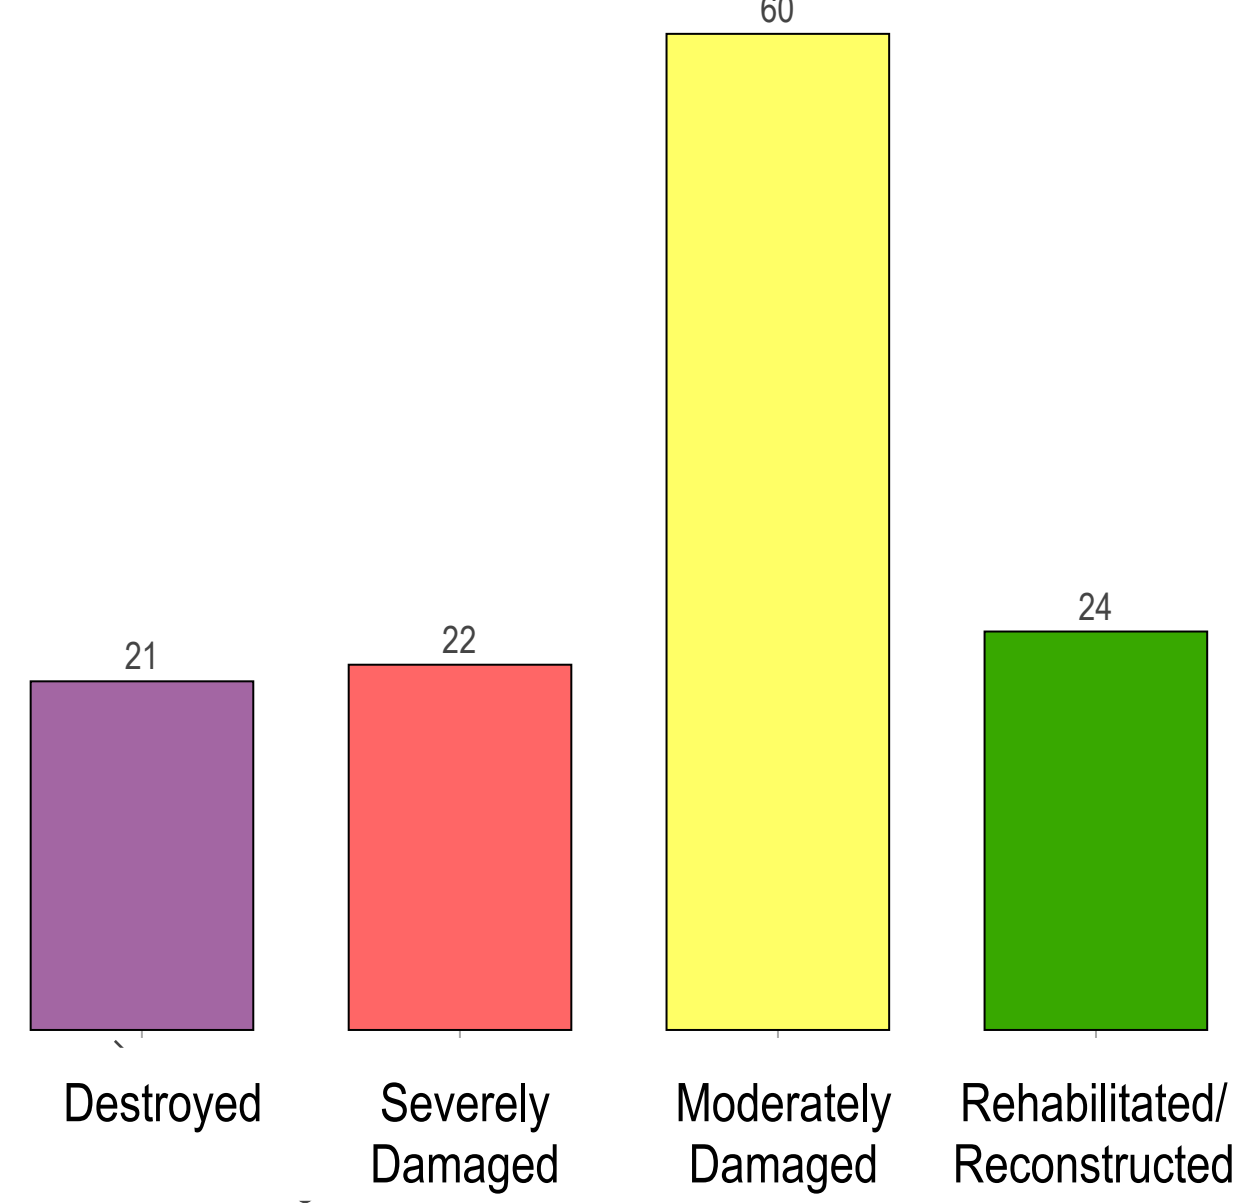
Andalus Damage Counts, by # of identified structures

\*Severity calculated based on density of damaged infrastructure and weighted by scale of damage based on: destroyed, severely damaged or moderately damaged

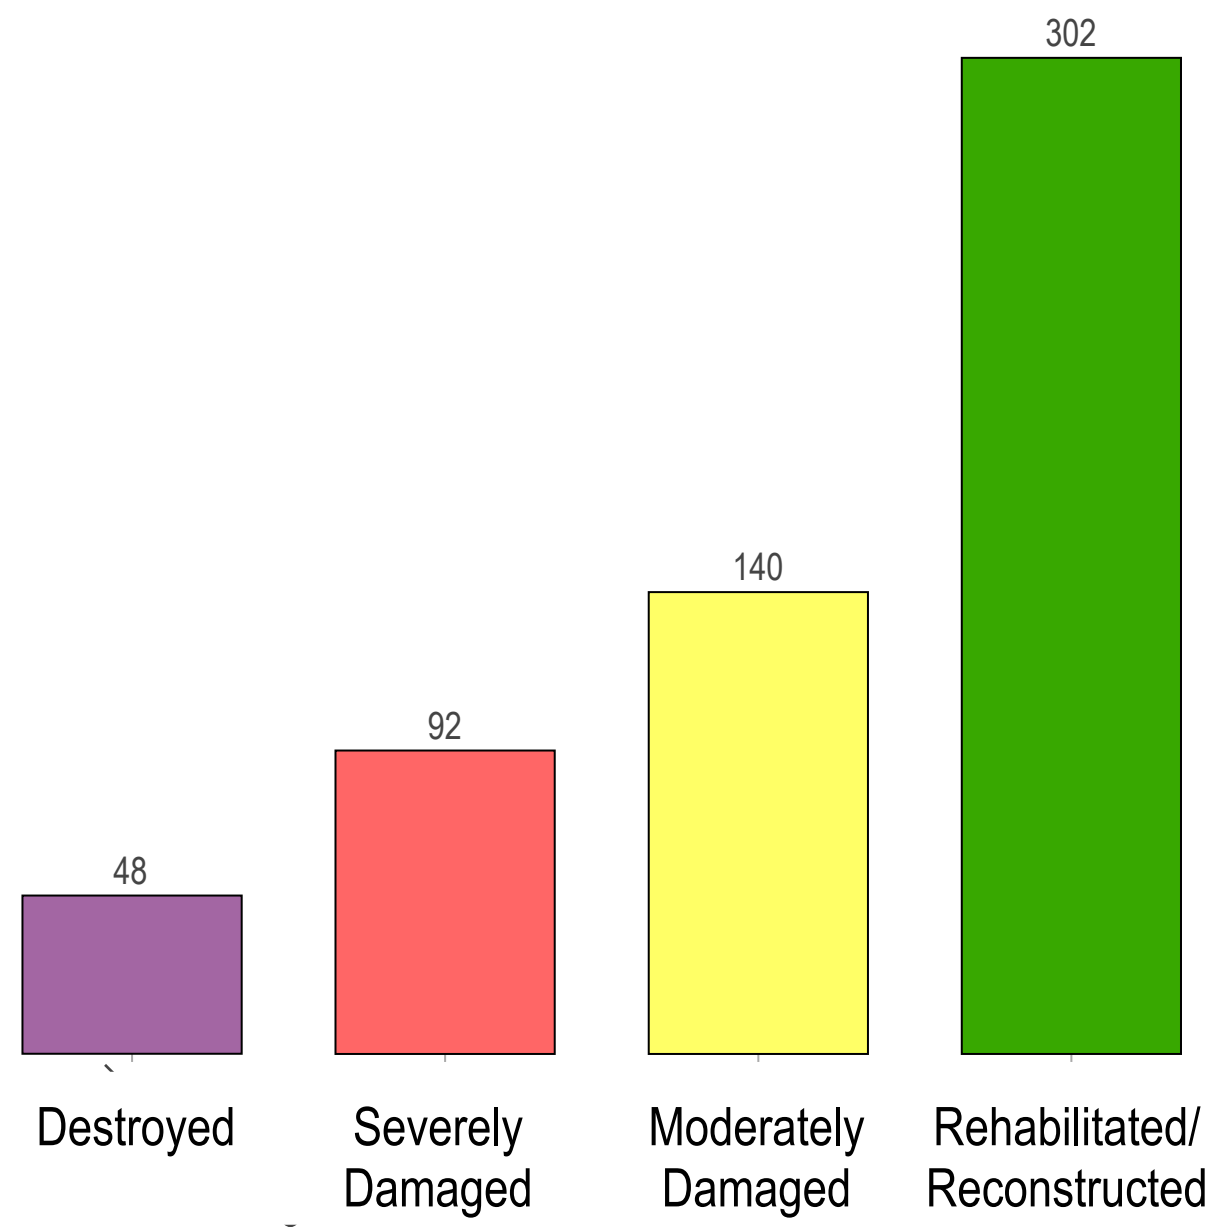
Al- Thawrah Damage Counts, by # of identified structures

\*Severity calculated based on density of damaged infrastructure and weighted by scale of damage based on: destroyed, severely damaged or moderately damaged

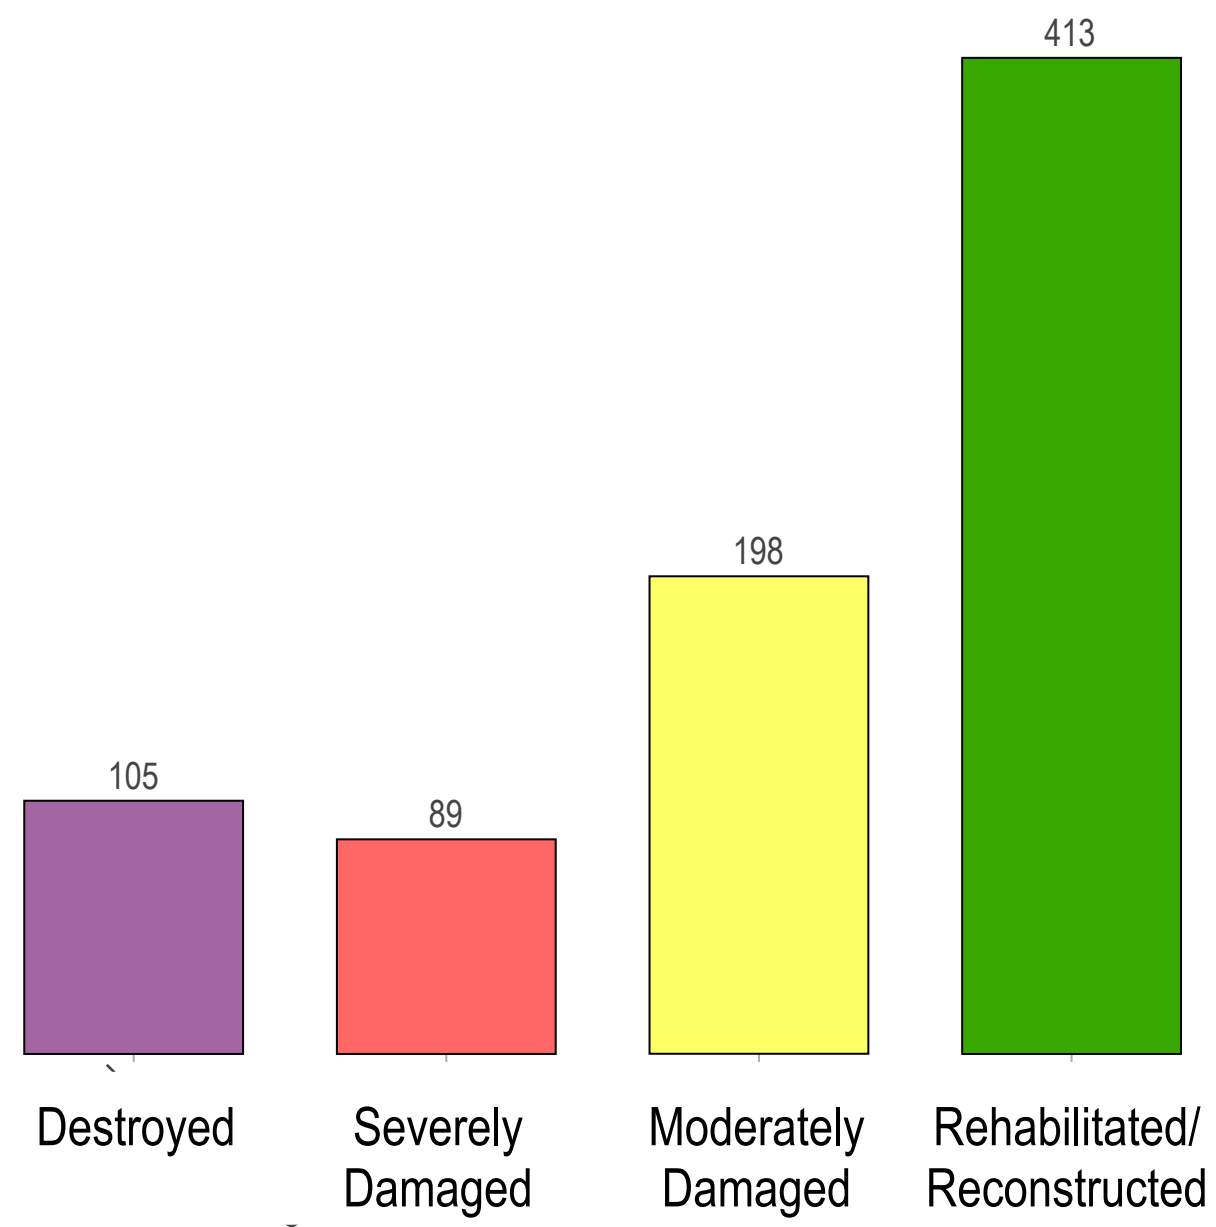
Hurriyeh Damage Counts, by # of identified structures

\*Severity calculated based on density of damaged infrastructure and weighted by scale of damage based on: destroyed, severely damaged or moderately damaged

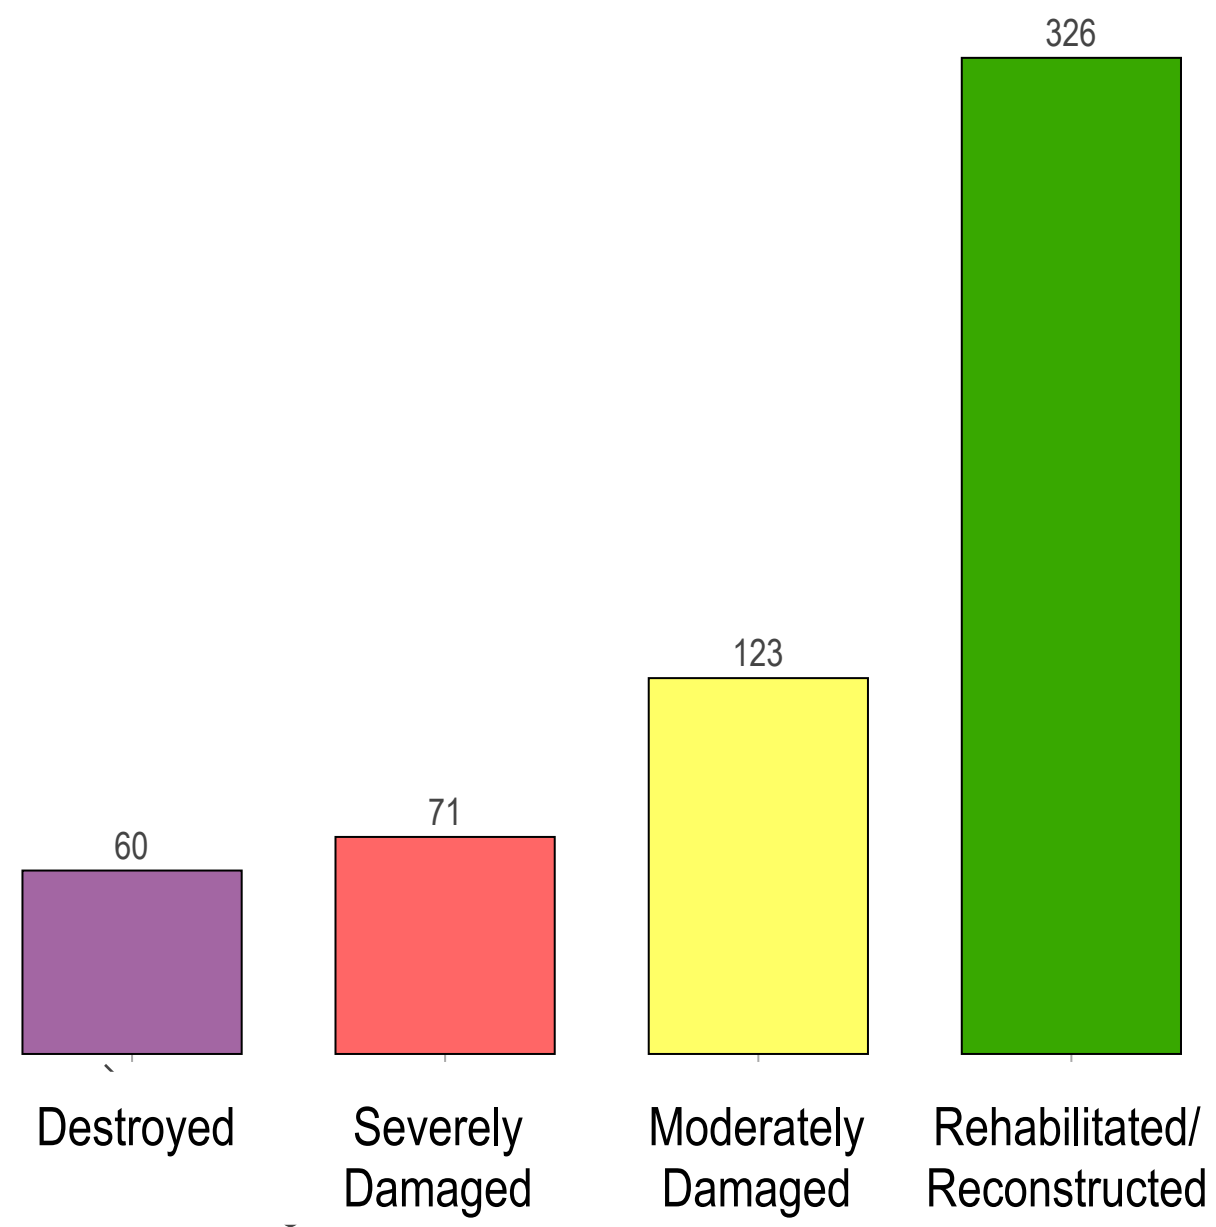
Wihdeh Damage Counts,  
by # of identified structures

\*Severity calculated based on density of damaged infrastructure and weighted by scale of damage based on: destroyed, severely damaged or moderately damaged

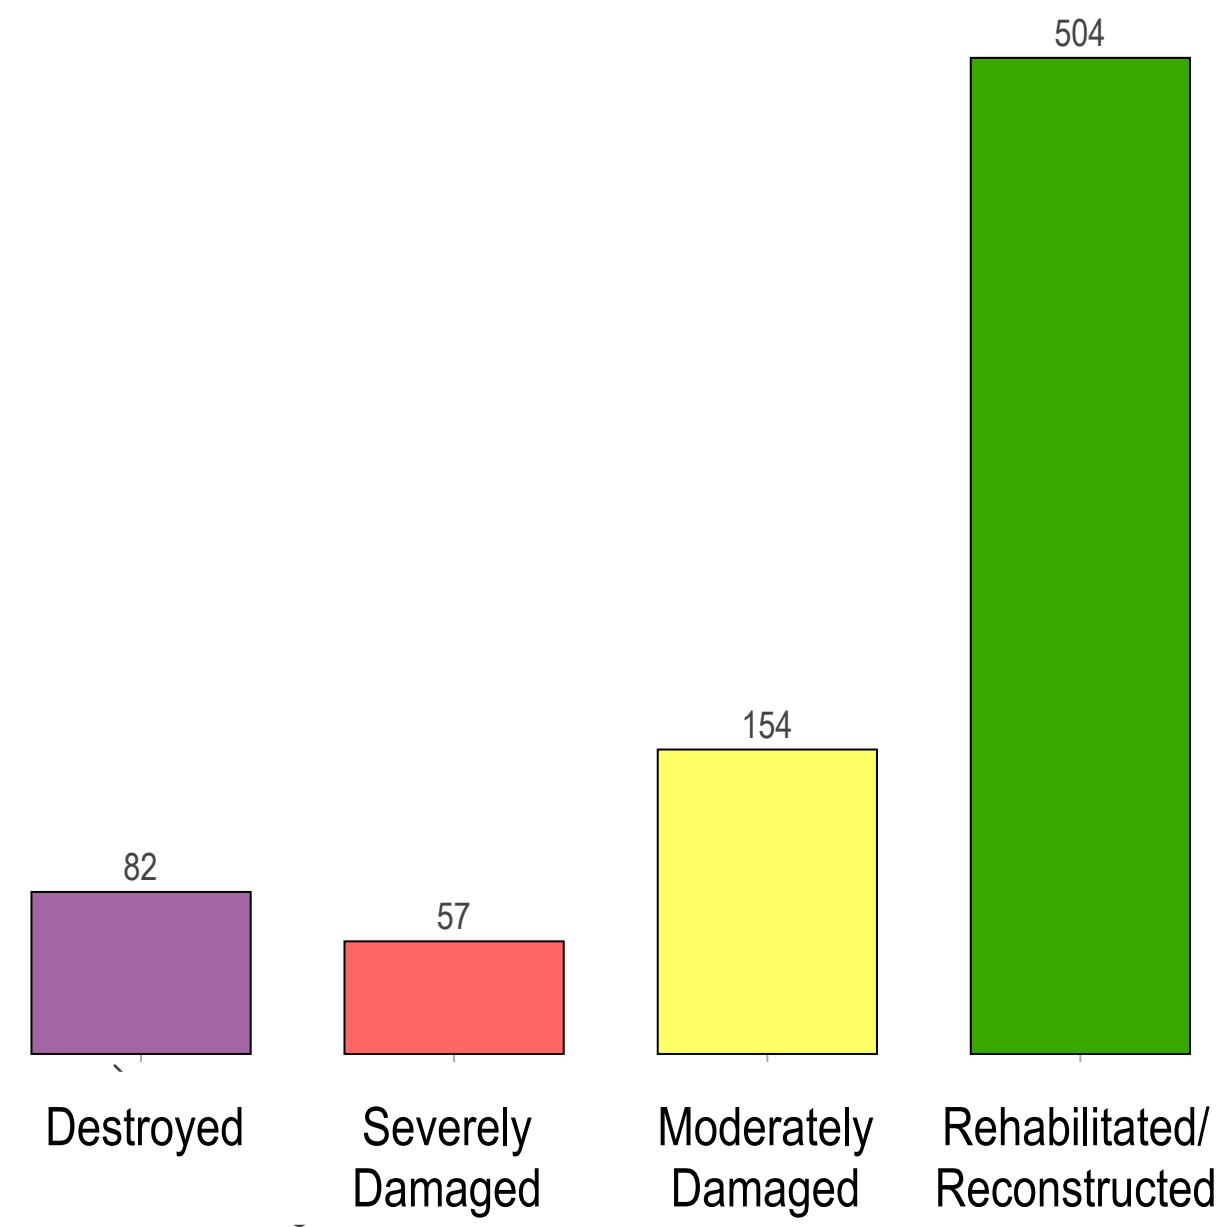
Tishrine Damage Counts,  
by # of identified structures

\*Severity calculated based on density of damaged infrastructure and weighted by scale of damage based on: destroyed, severely damaged or moderately damaged

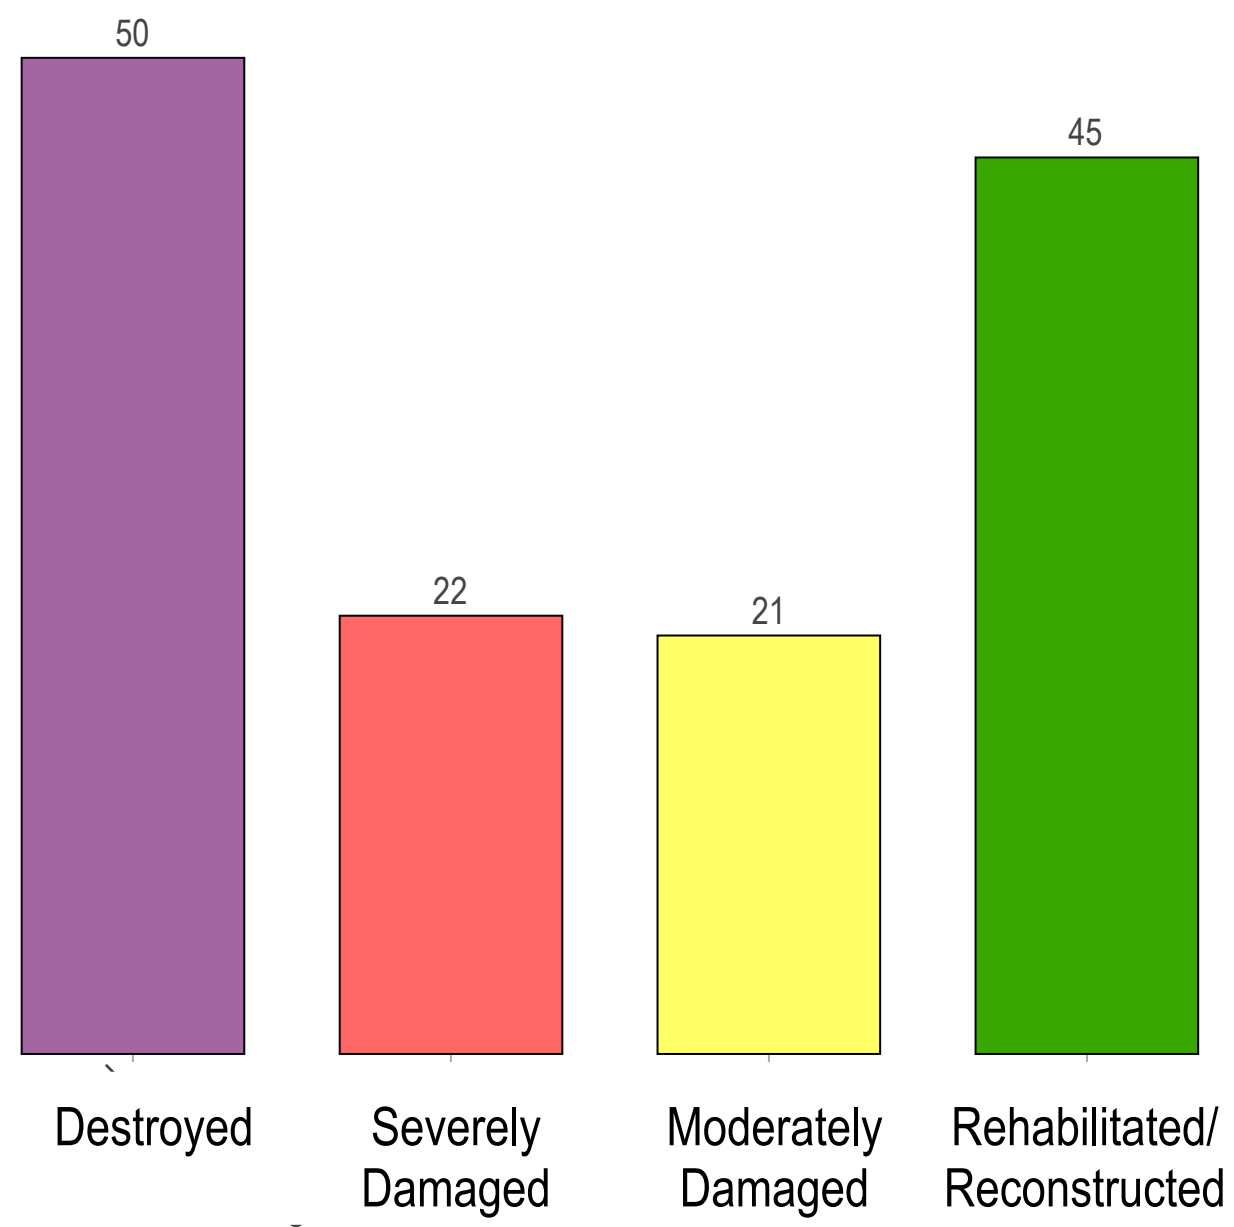
Ad Dari'yeh Damage Counts, by # of identified structures

\*Severity calculated based on density of damaged infrastructure and weighted by scale of damage based on: destroyed, severely damaged or moderately damaged

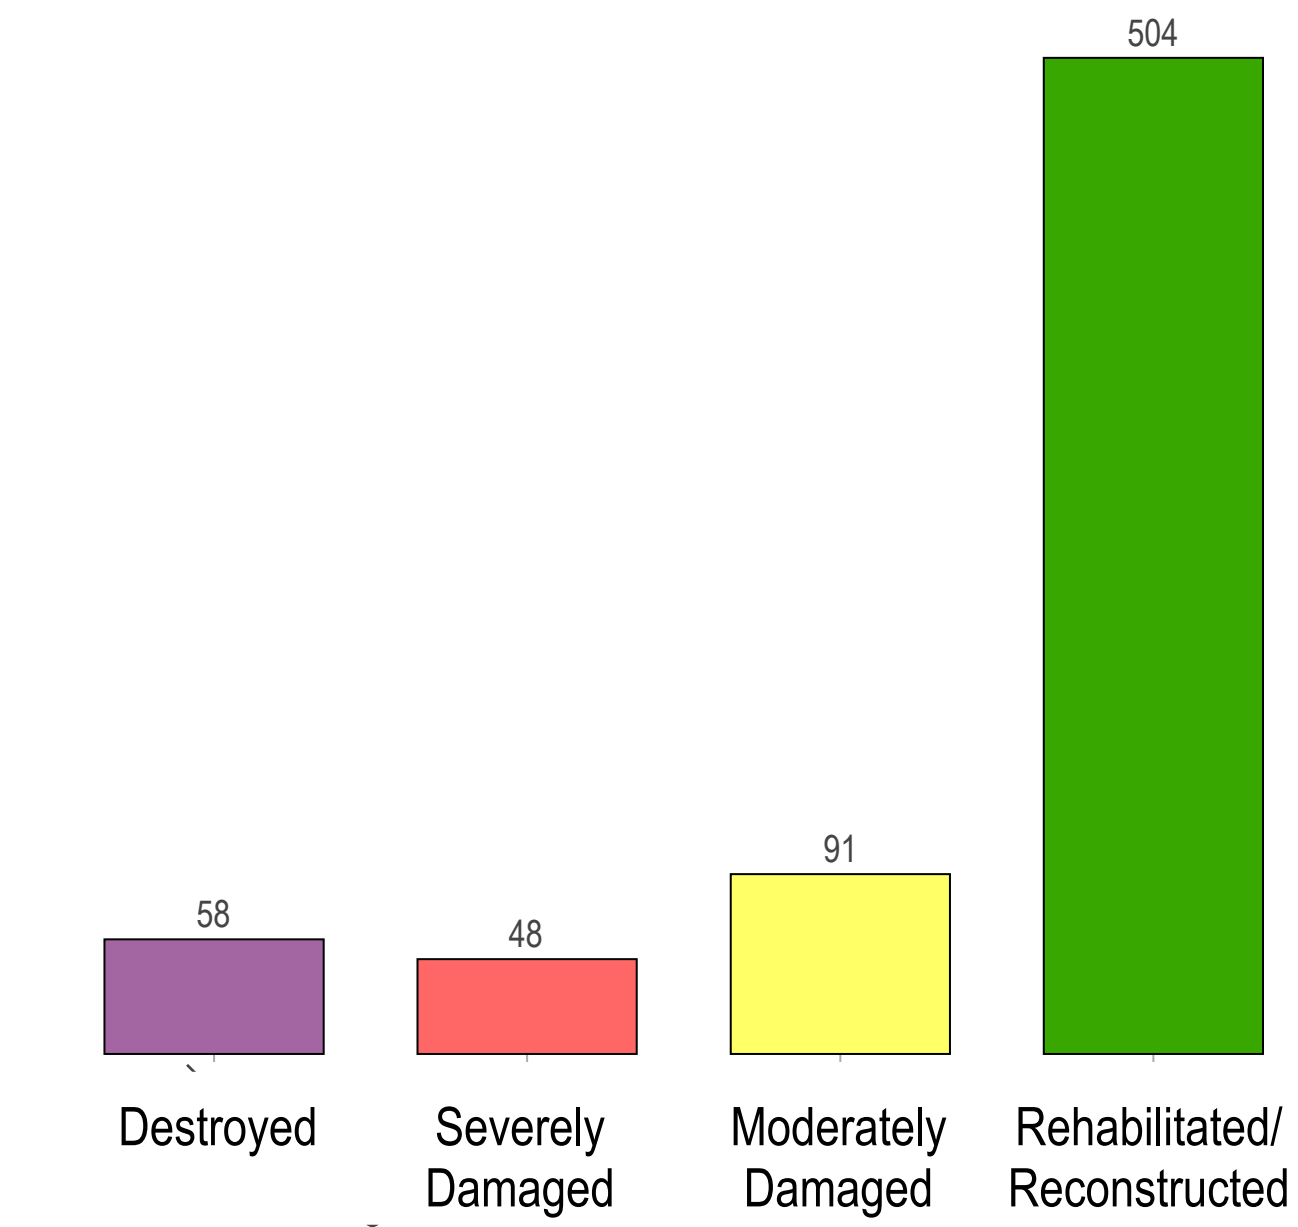
Salhiyeh Damage Counts, by # of identified structures

\*Severity calculated based on density of damaged infrastructure and weighted by scale of damage based on: destroyed, severely damaged or moderately damaged

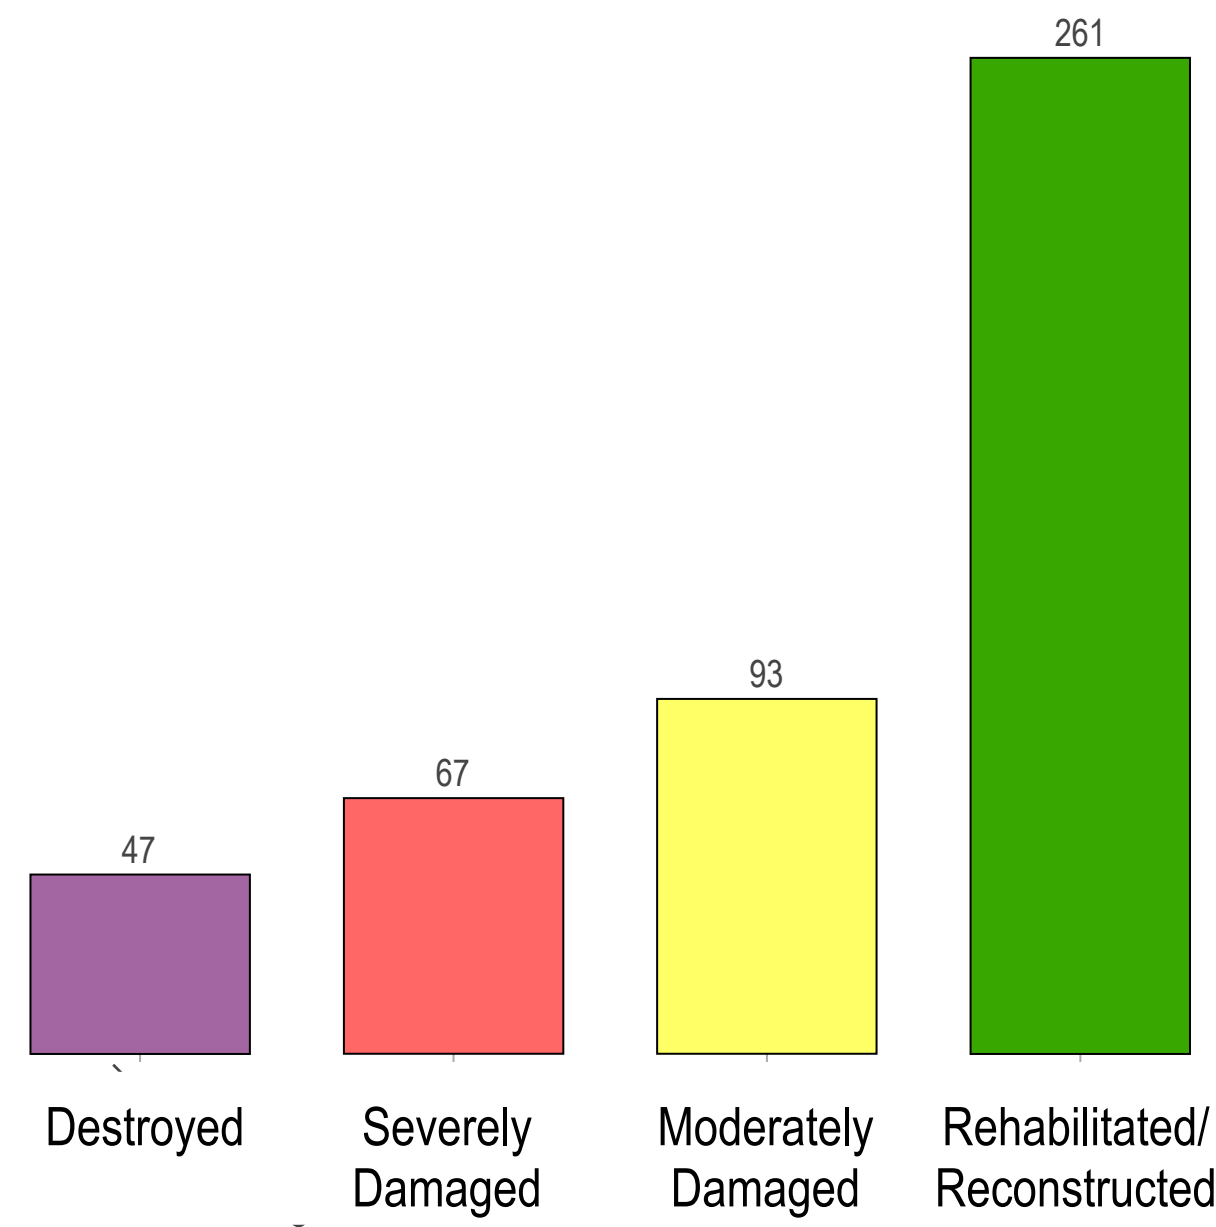
Nahda Damage Counts, by # of identified structures

\*Severity calculated based on density of damaged infrastructure and weighted by scale of damage based on: destroyed, severely damaged or moderately damaged

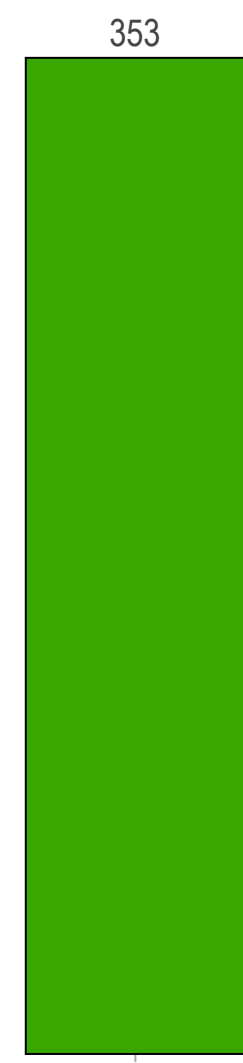
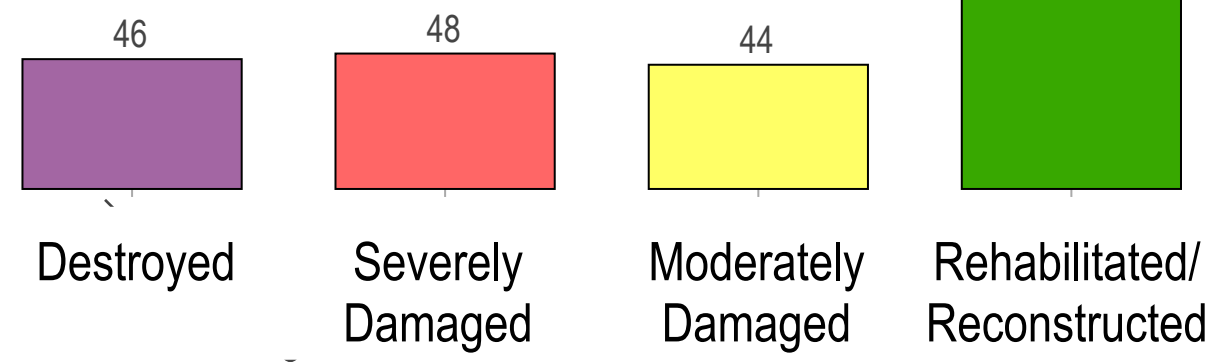
Mansour Damage Counts, by # of identified structures

\*Severity calculated based on density of damaged infrastructure and weighted by scale of damage based on: destroyed, severely damaged or moderately damaged

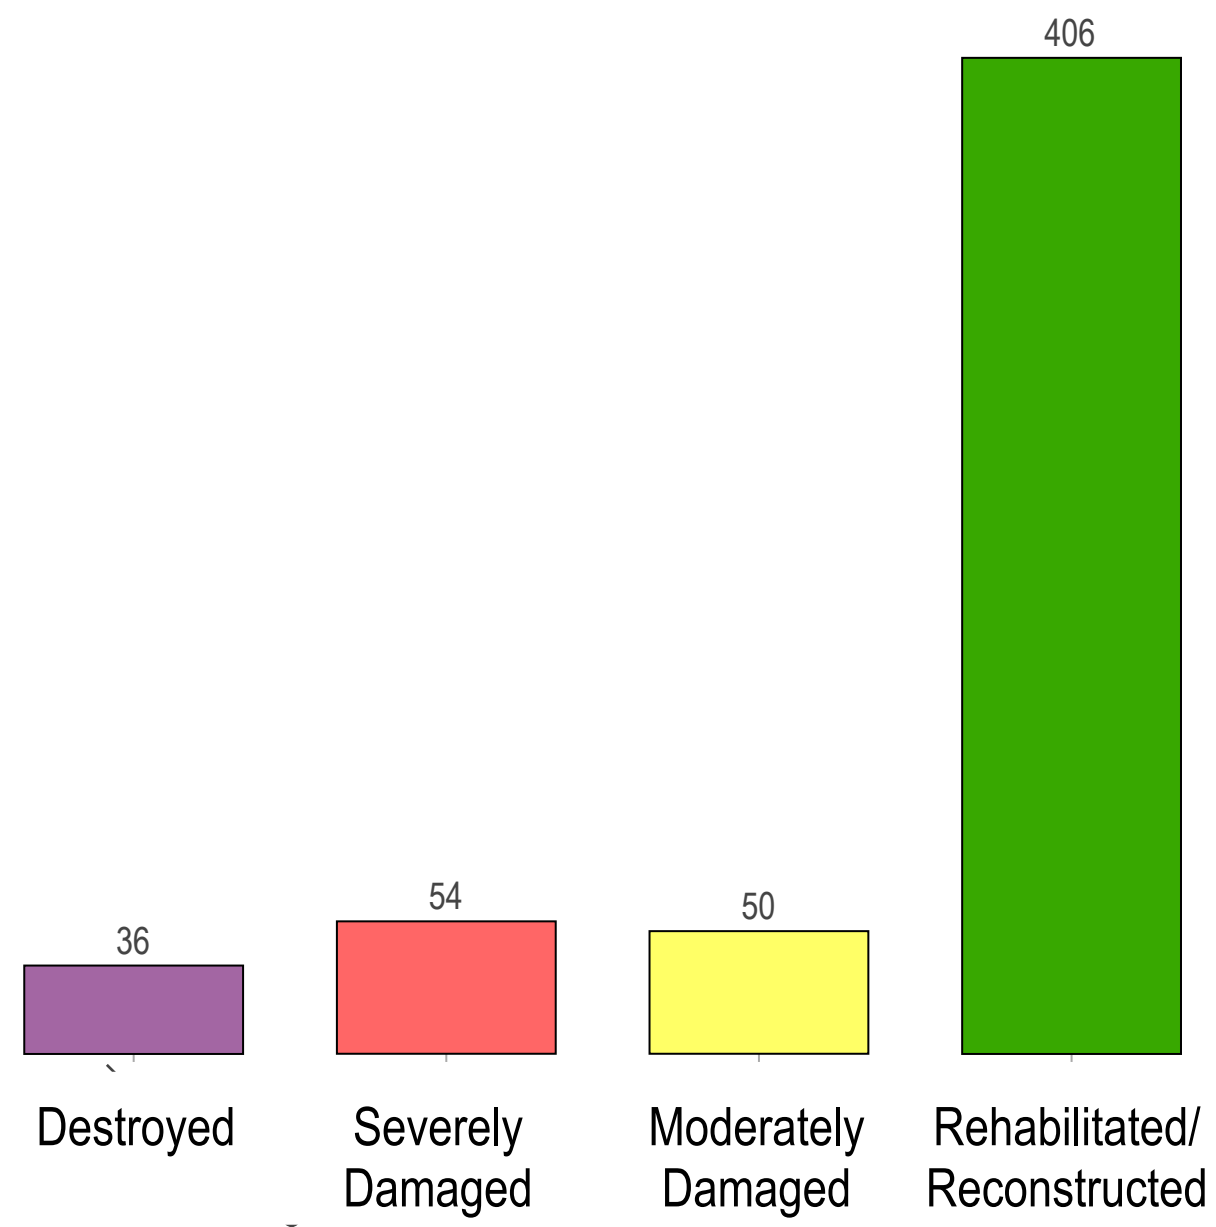
Mahdi Damage Counts,  
by # of identified structures

\*Severity calculated based on density of damaged infrastructure and weighted by scale of damage based on: destroyed, severely damaged or moderately damaged

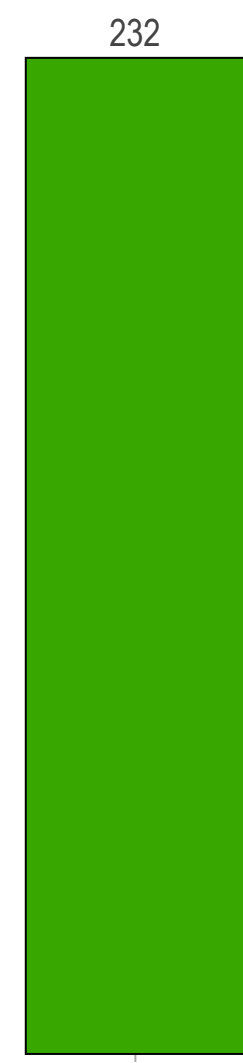
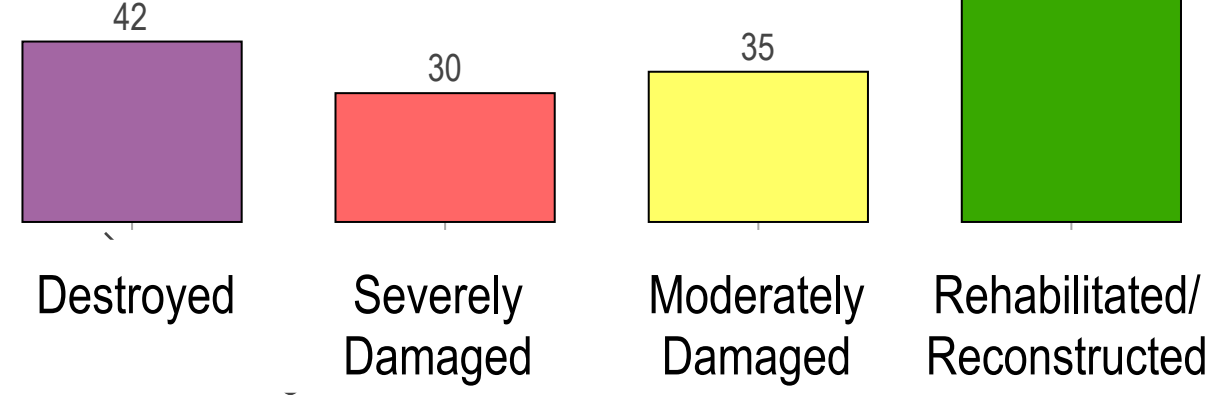
Batani Damage Counts,  
by # of identified structures

\*Severity calculated based on density of damaged infrastructure and weighted by scale of damage based on: destroyed, severely damaged or moderately damaged

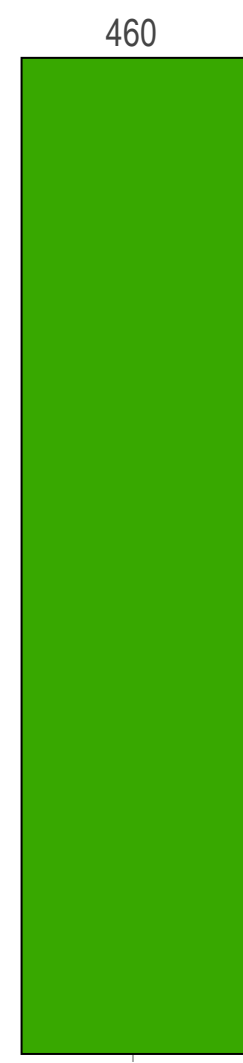
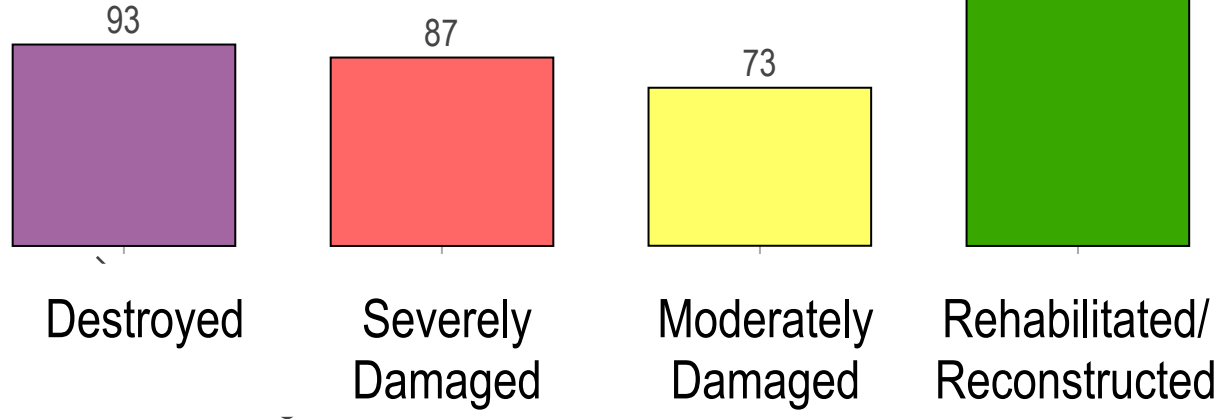
Amin Damage Counts,  
by # of identified structures

\*Severity calculated based on density of damaged infrastructure and weighted by scale of damage based on: destroyed, severely damaged or moderately damaged

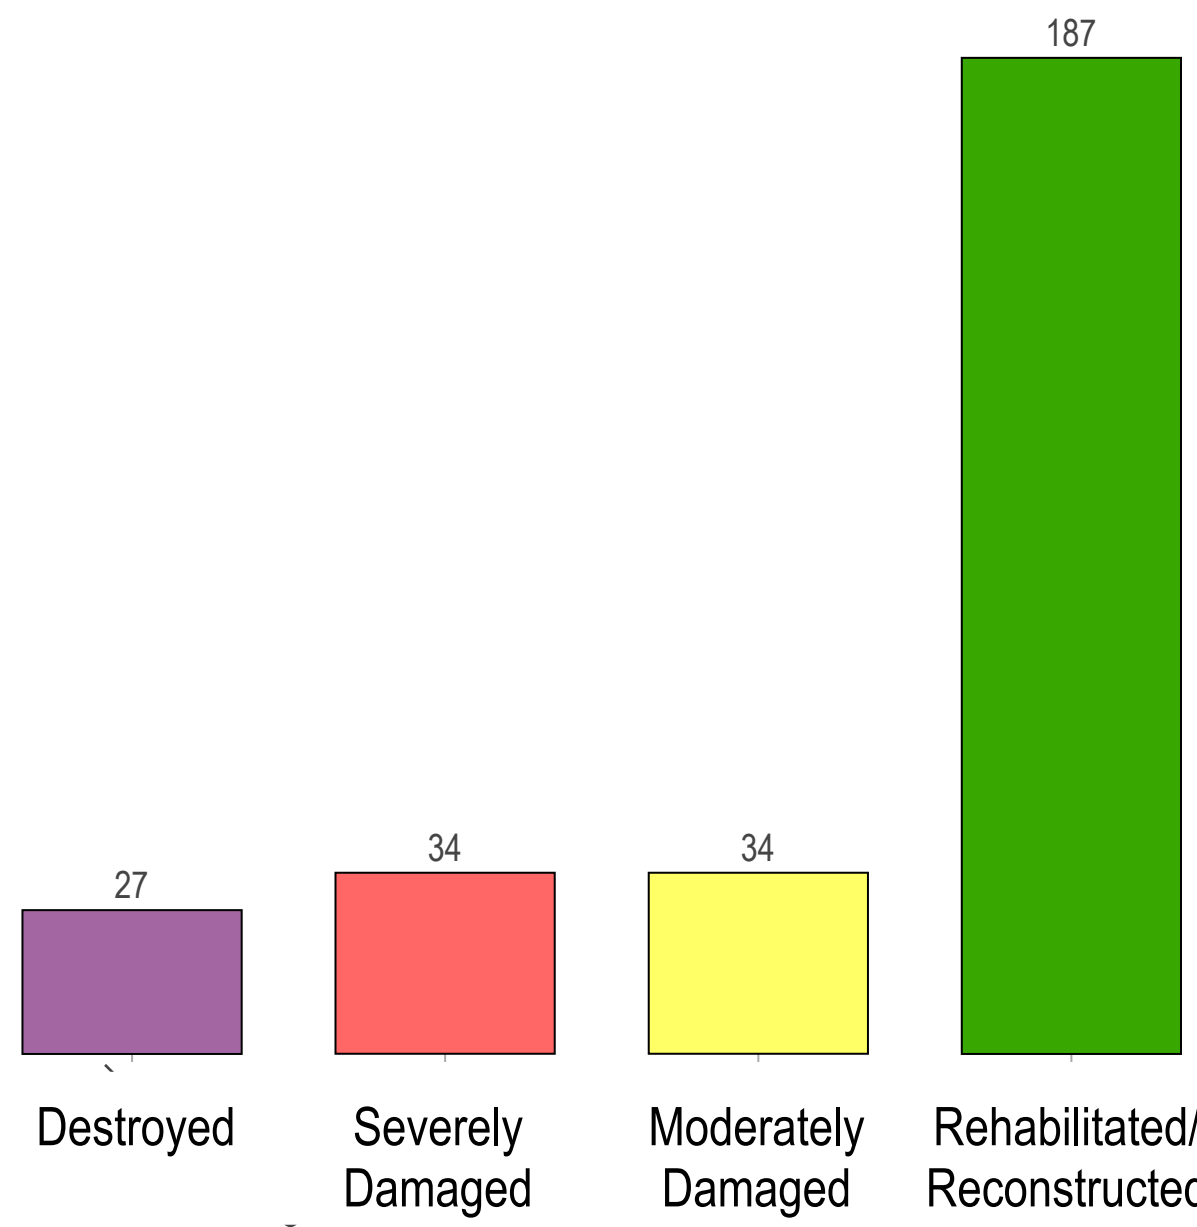
Qadessiyeh Damage Counts, by # of identified structures

\*Severity calculated based on density of damaged infrastructure and weighted by scale of damage based on: destroyed, severely damaged or moderately damaged

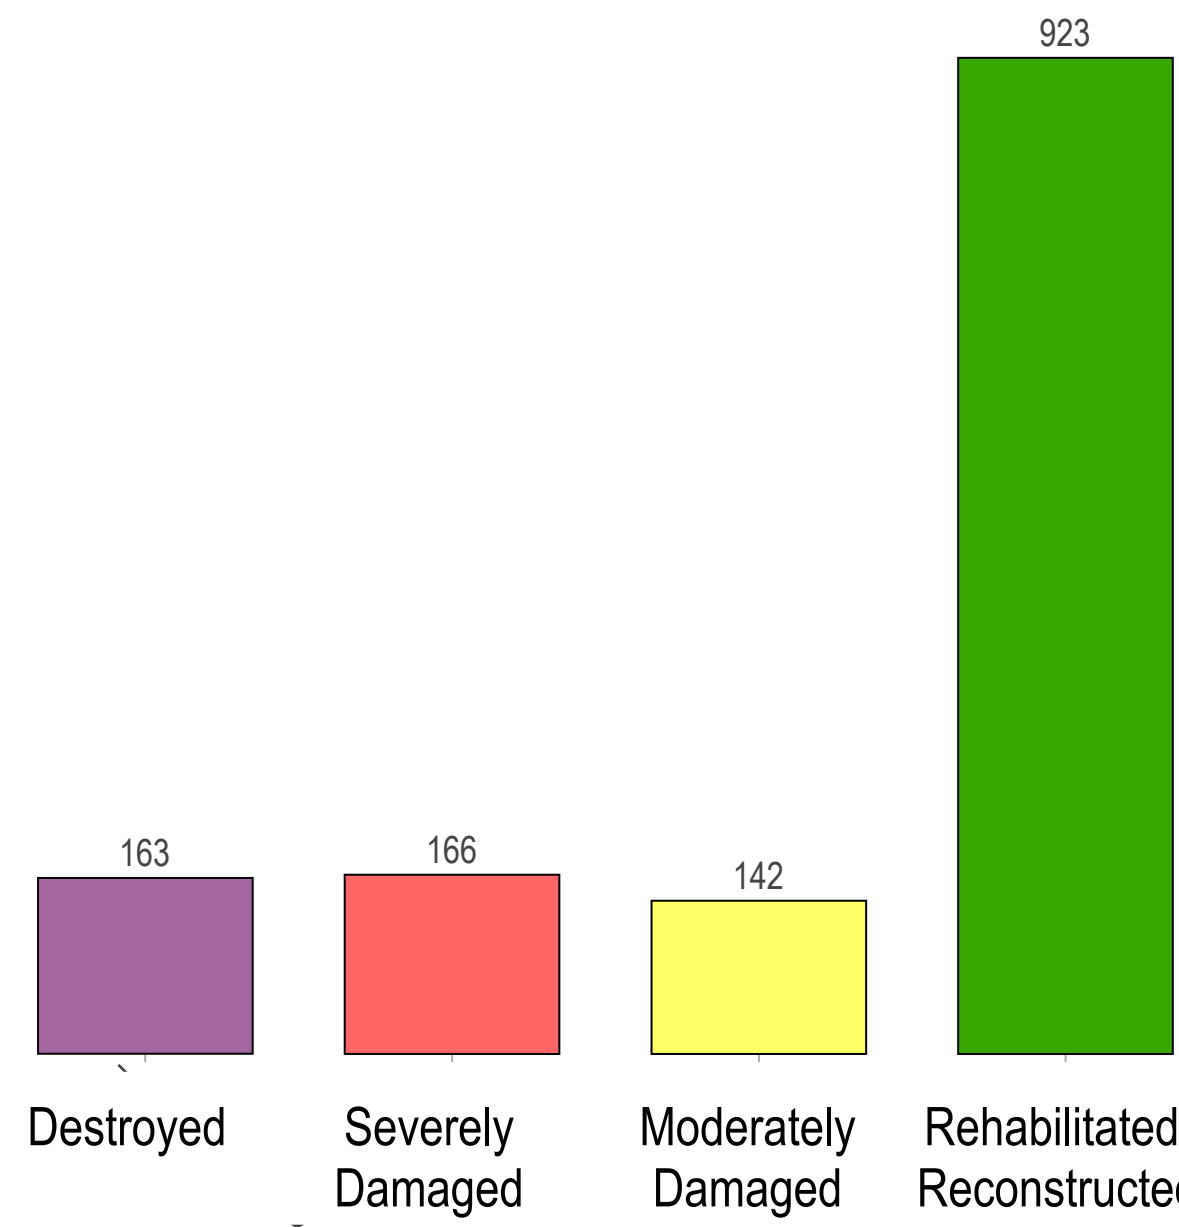
Tas-heeh Damage Counts,  
by # of identified structures

\*Severity calculated based on density of damaged infrastructure and weighted by scale of damage based on: destroyed, severely damaged or moderately damaged

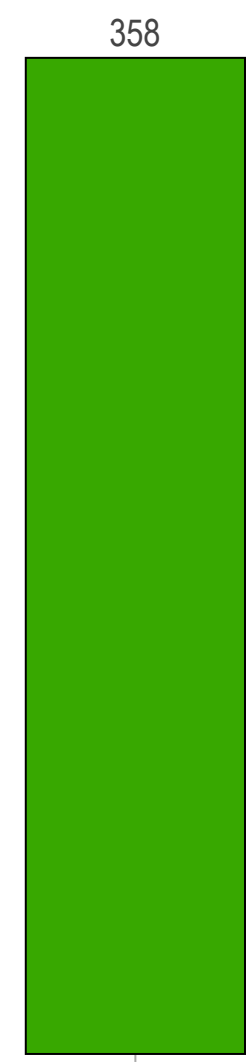
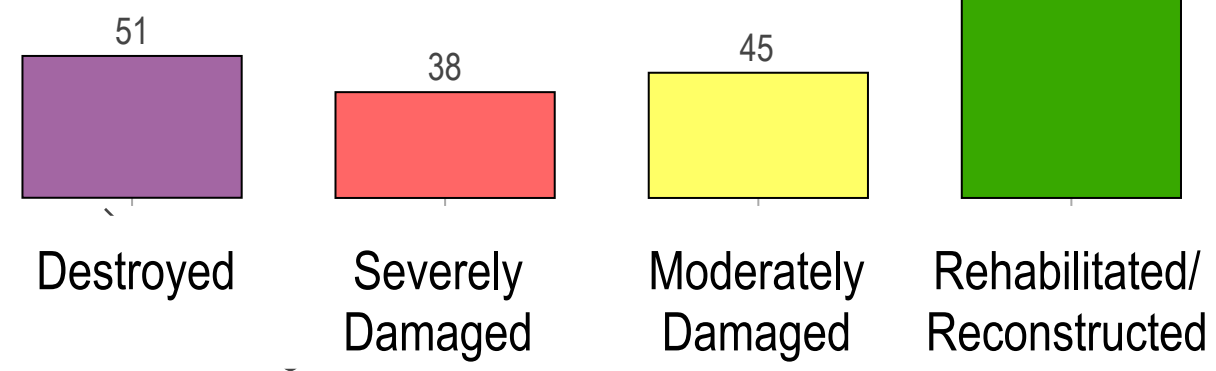
Rashidiyeh Damage Counts, by # of identified structures

\*Severity calculated based on density of damaged infrastructure and weighted by scale of damage based on: destroyed, severely damaged or moderately damaged

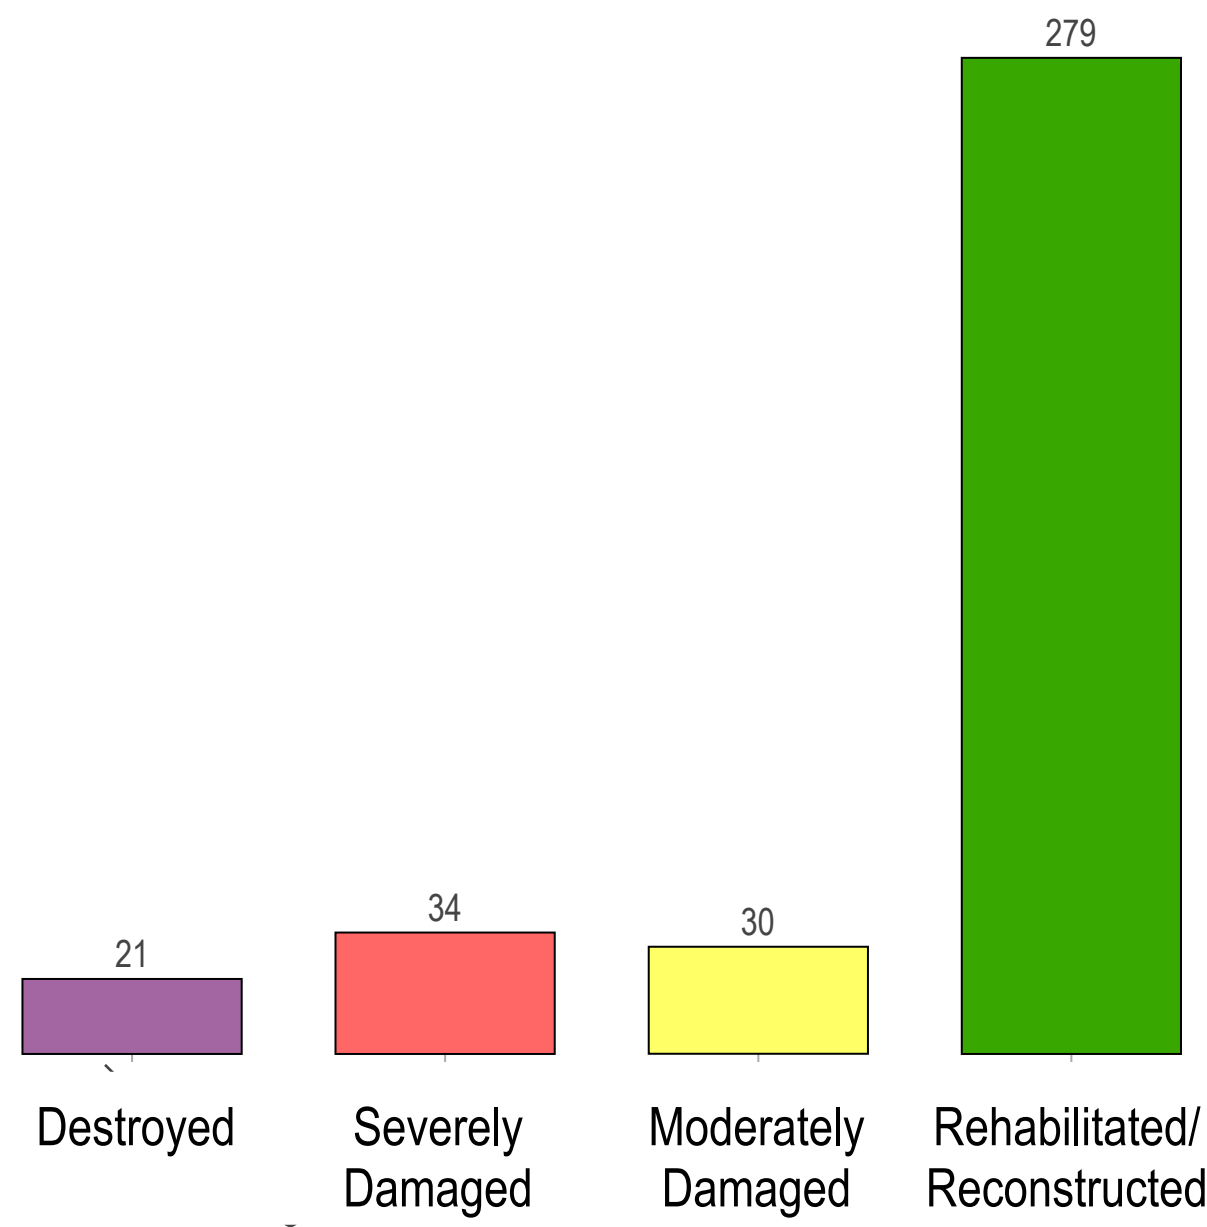
Rafqa Damage Counts, by # of identified structures

\*Severity calculated based on density of damaged infrastructure and weighted by scale of damage based on: destroyed, severely damaged or moderately damaged
