# Damage Atlas Ar-Raqqa City

**Satellite-Detected Damage Severity  
Assessment**

**April 2021**

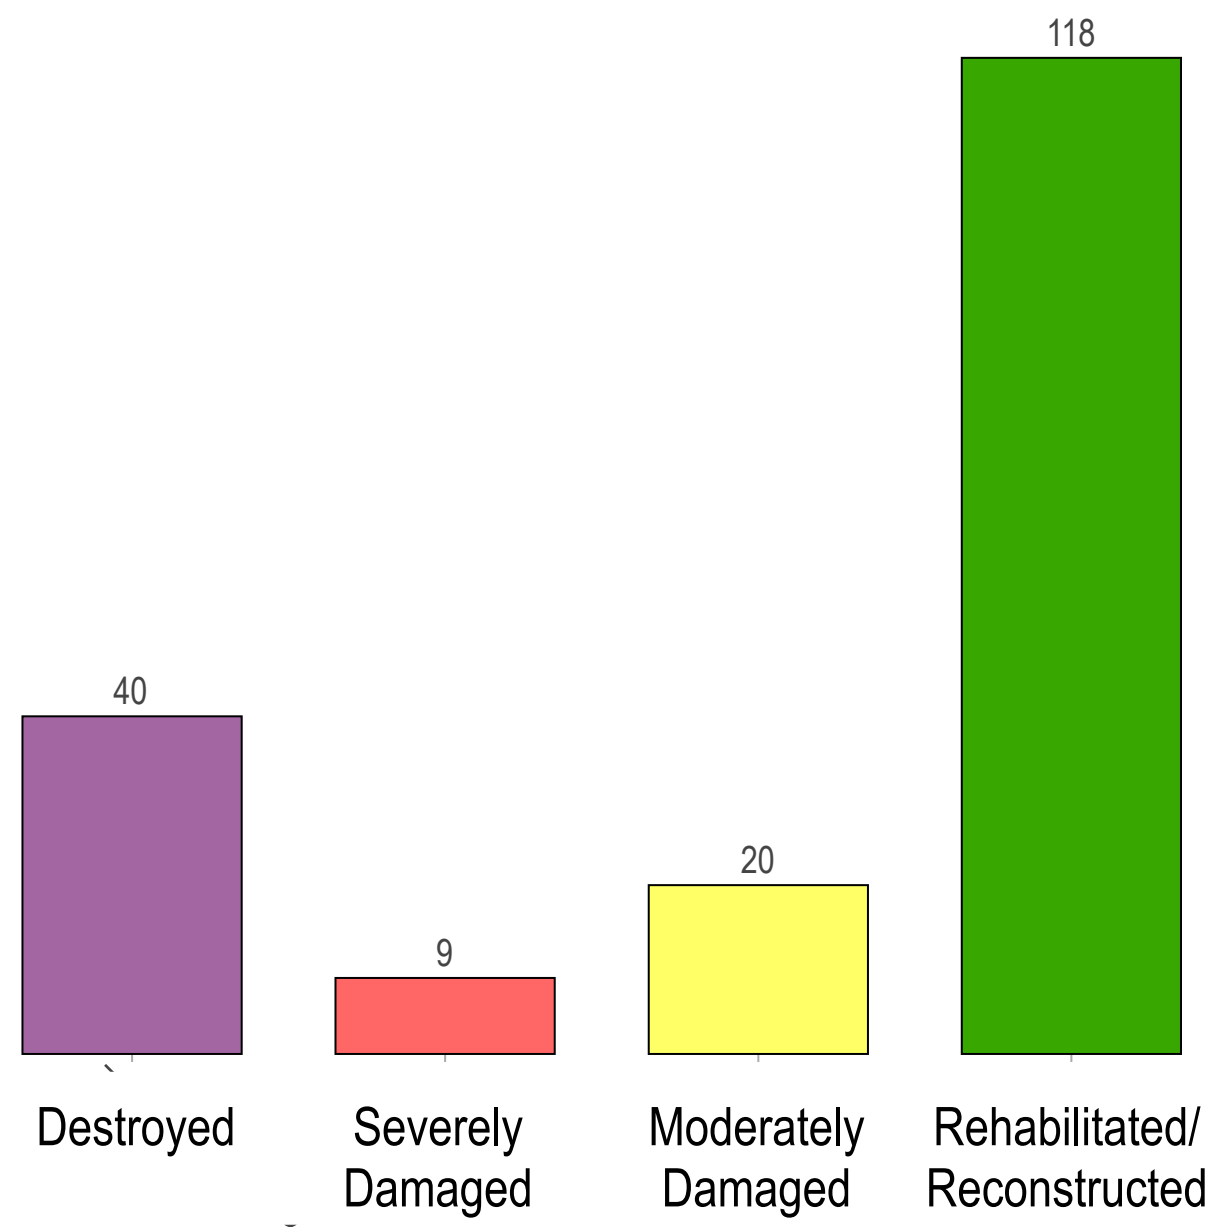
Ammar Ibn Yaser Damage Counts, by # of identified structures

\*Severity calculated based on density of damaged infrastructure and weighted by scale of damage based on: destroyed, severely damaged or moderately damaged

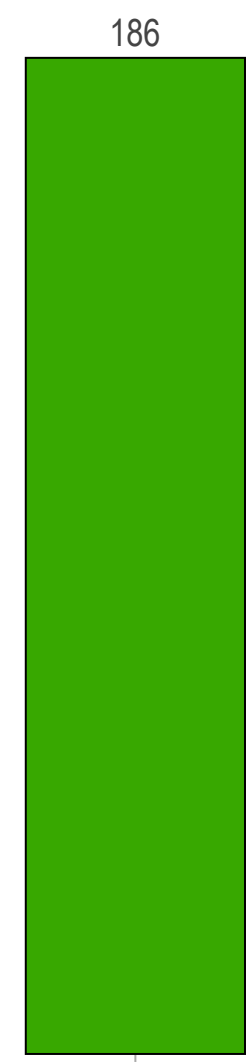
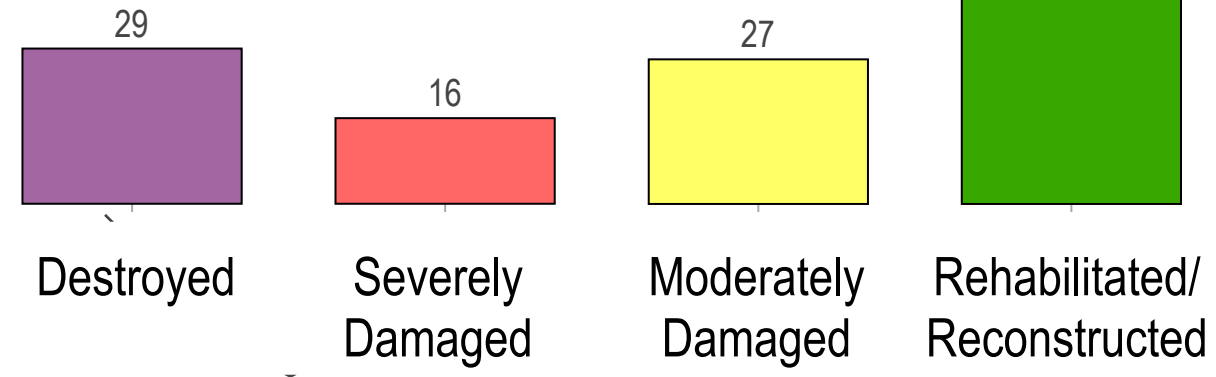
Ma'amoun Damage Counts,  
by # of identified structures

\*Severity calculated based on density of damaged infrastructure and weighted by scale of damage based on: destroyed, severely damaged or moderately damaged

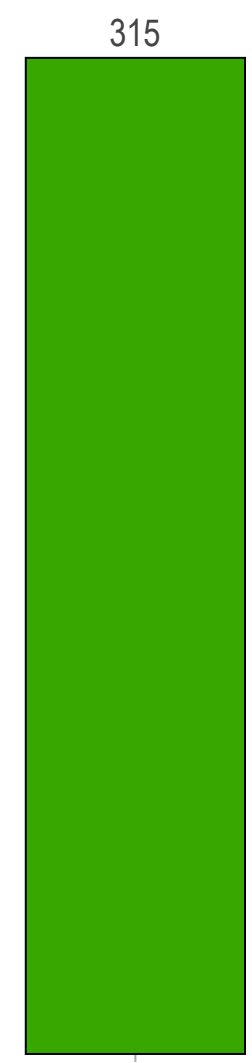
Hisham Ibn Abd Al Malek Damage Counts, by # of identified structures

\*Severity calculated based on density of damaged infrastructure and weighted by scale of damage based on: destroyed, severely damaged or moderately damaged

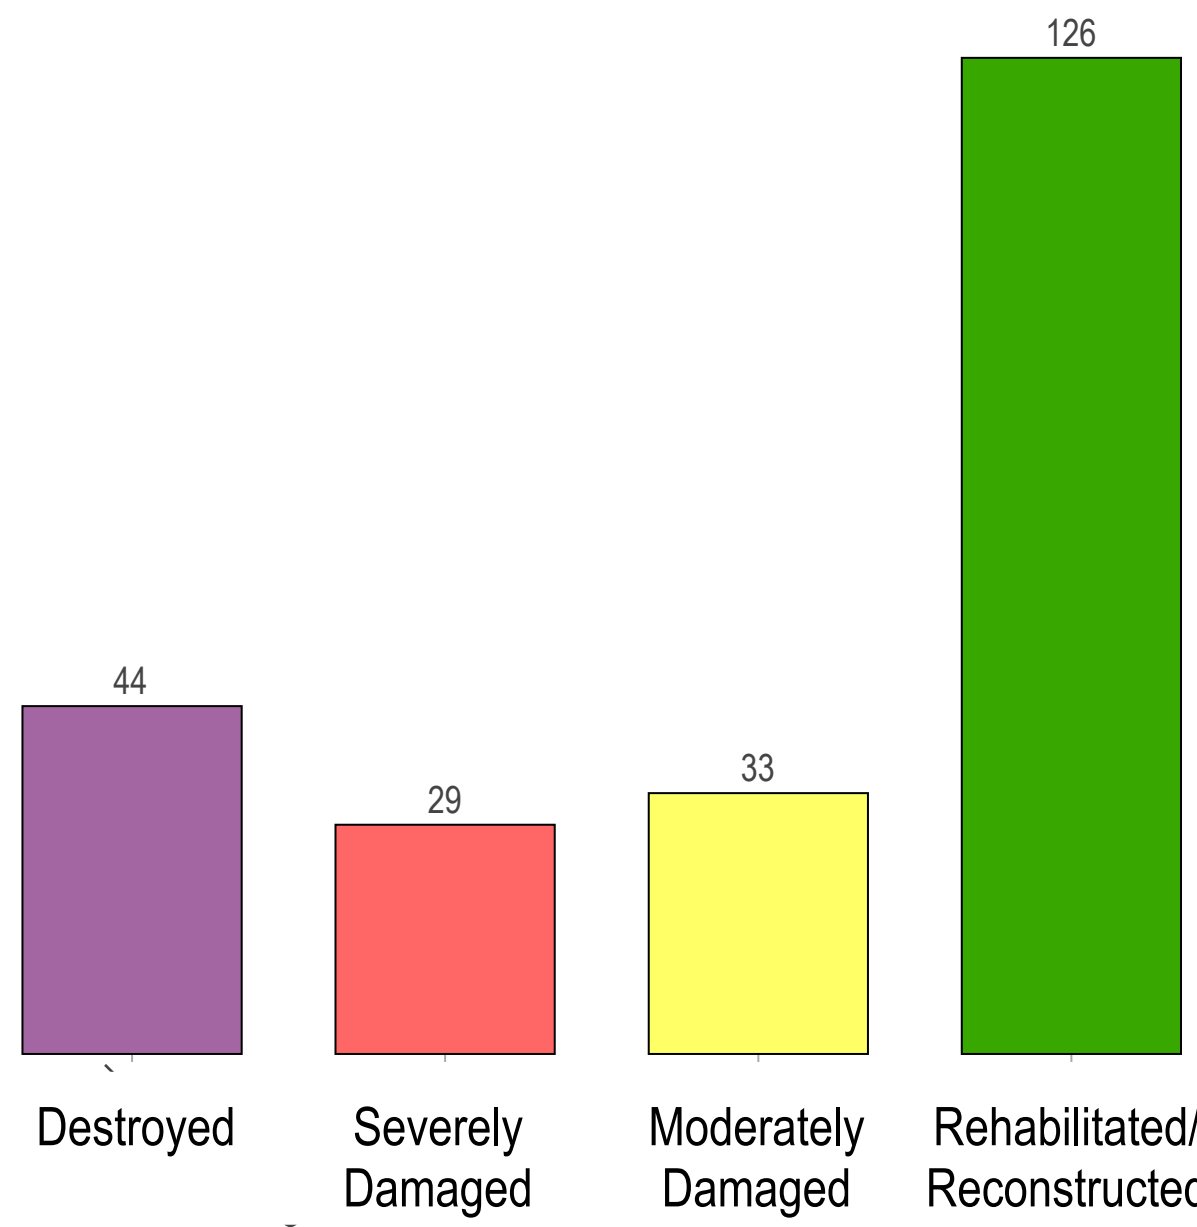
Yarmuk Damage Counts,  
by # of identified structures

\*Severity calculated based on density of damaged infrastructure and weighted by scale of damage based on: destroyed, severely damaged or moderately damaged

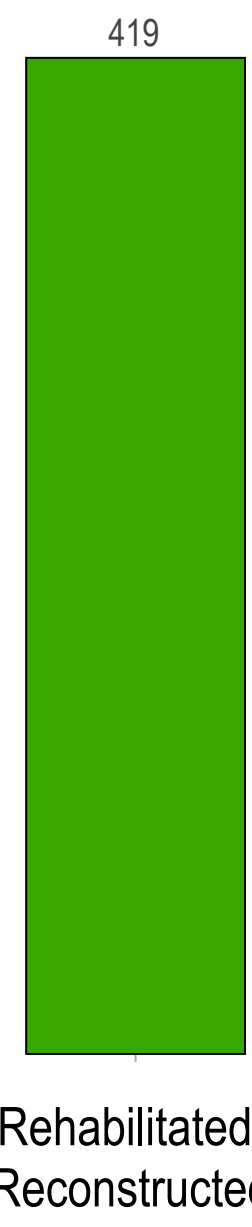
Furat Damage Counts, by # of identified structures

\*Severity calculated based on density of damaged infrastructure and weighted by scale of damage based on: destroyed, severely damaged or moderately damaged
