## Assessment of damage to residential infrastructure in Nikopol, Dnipropetrovska Oblast

June 2024 | Ukraine

This situation overview presents the findings of an assessment of conflict-induced damage to residential infrastructure in Nikopol and surrounding areas conducted by REACH.

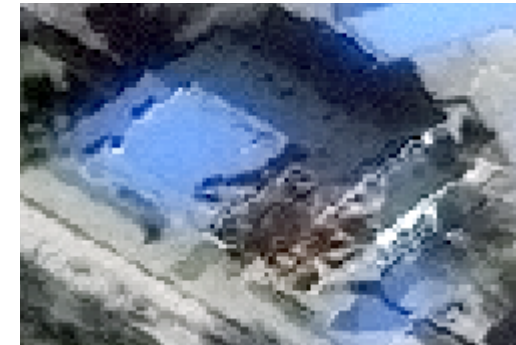
**Image 1.** Building with damage to the roof, April 2024.<sup>13</sup>

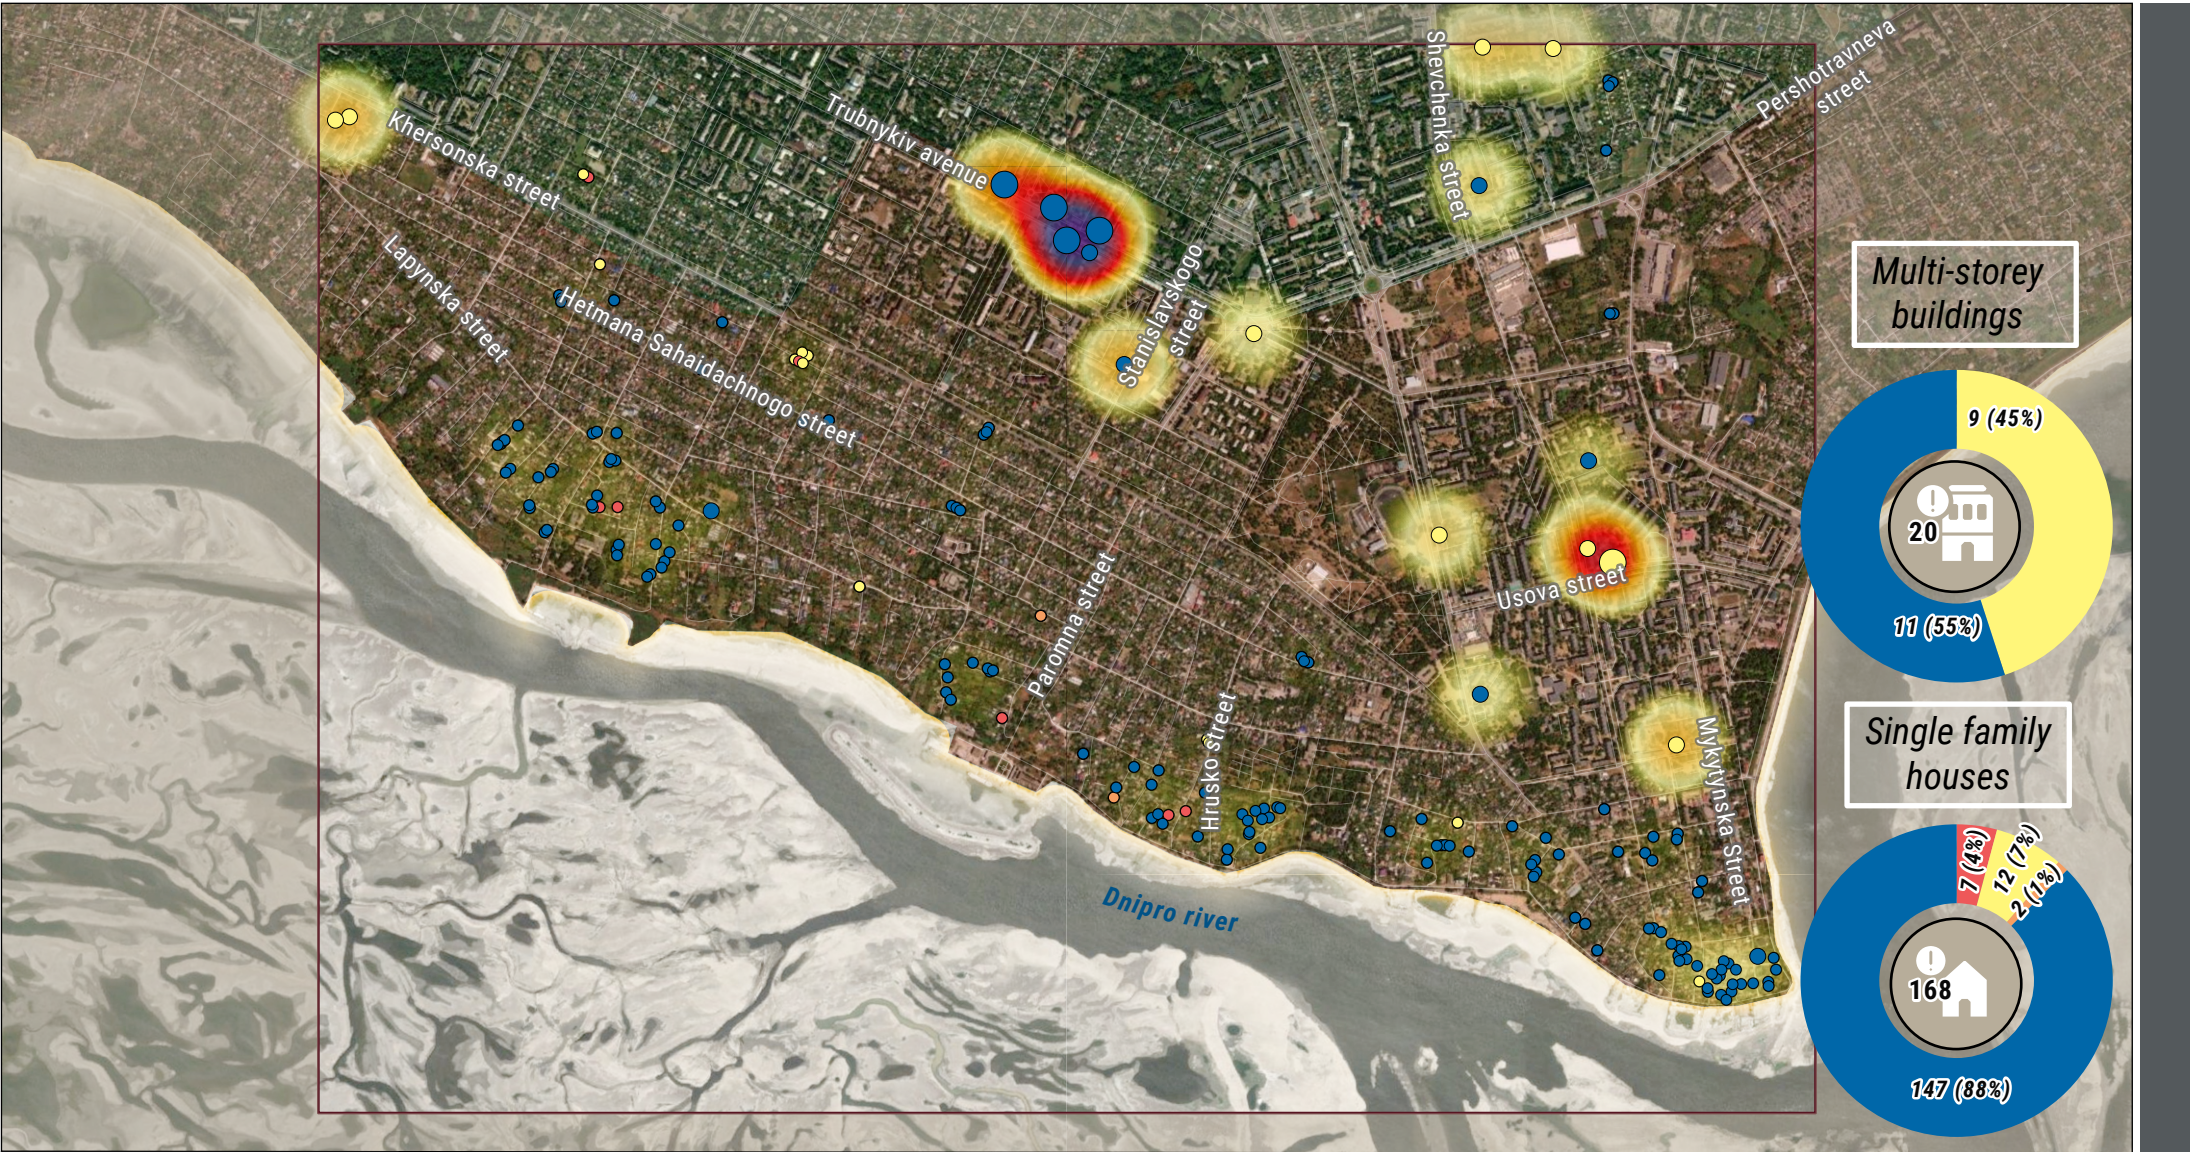
## PART 1

This part shows central Nikopol. The pink-shaded area near to the river bank shows the “area of significant damage” identified by research participants.

There are clusters of visibly damaged and repaired single-family houses running down the length of the riverbank. Additionally there are damaged multi-story buildings present in this area, for example around Trubnykiv Avenue.

Accounting for the relative capacity of single-family and multi-story buildings, the map indicates how exposure to the effects of damage are potentially concentrated around the larger buildings.

However, the qualitative findings and desk review indicate that in reality, buildings across this region are highly exposed to damage. 88% of single-family houses that were identified showed signs of repair, indicating that people continue to try to maintain connections to the area despite the risk.

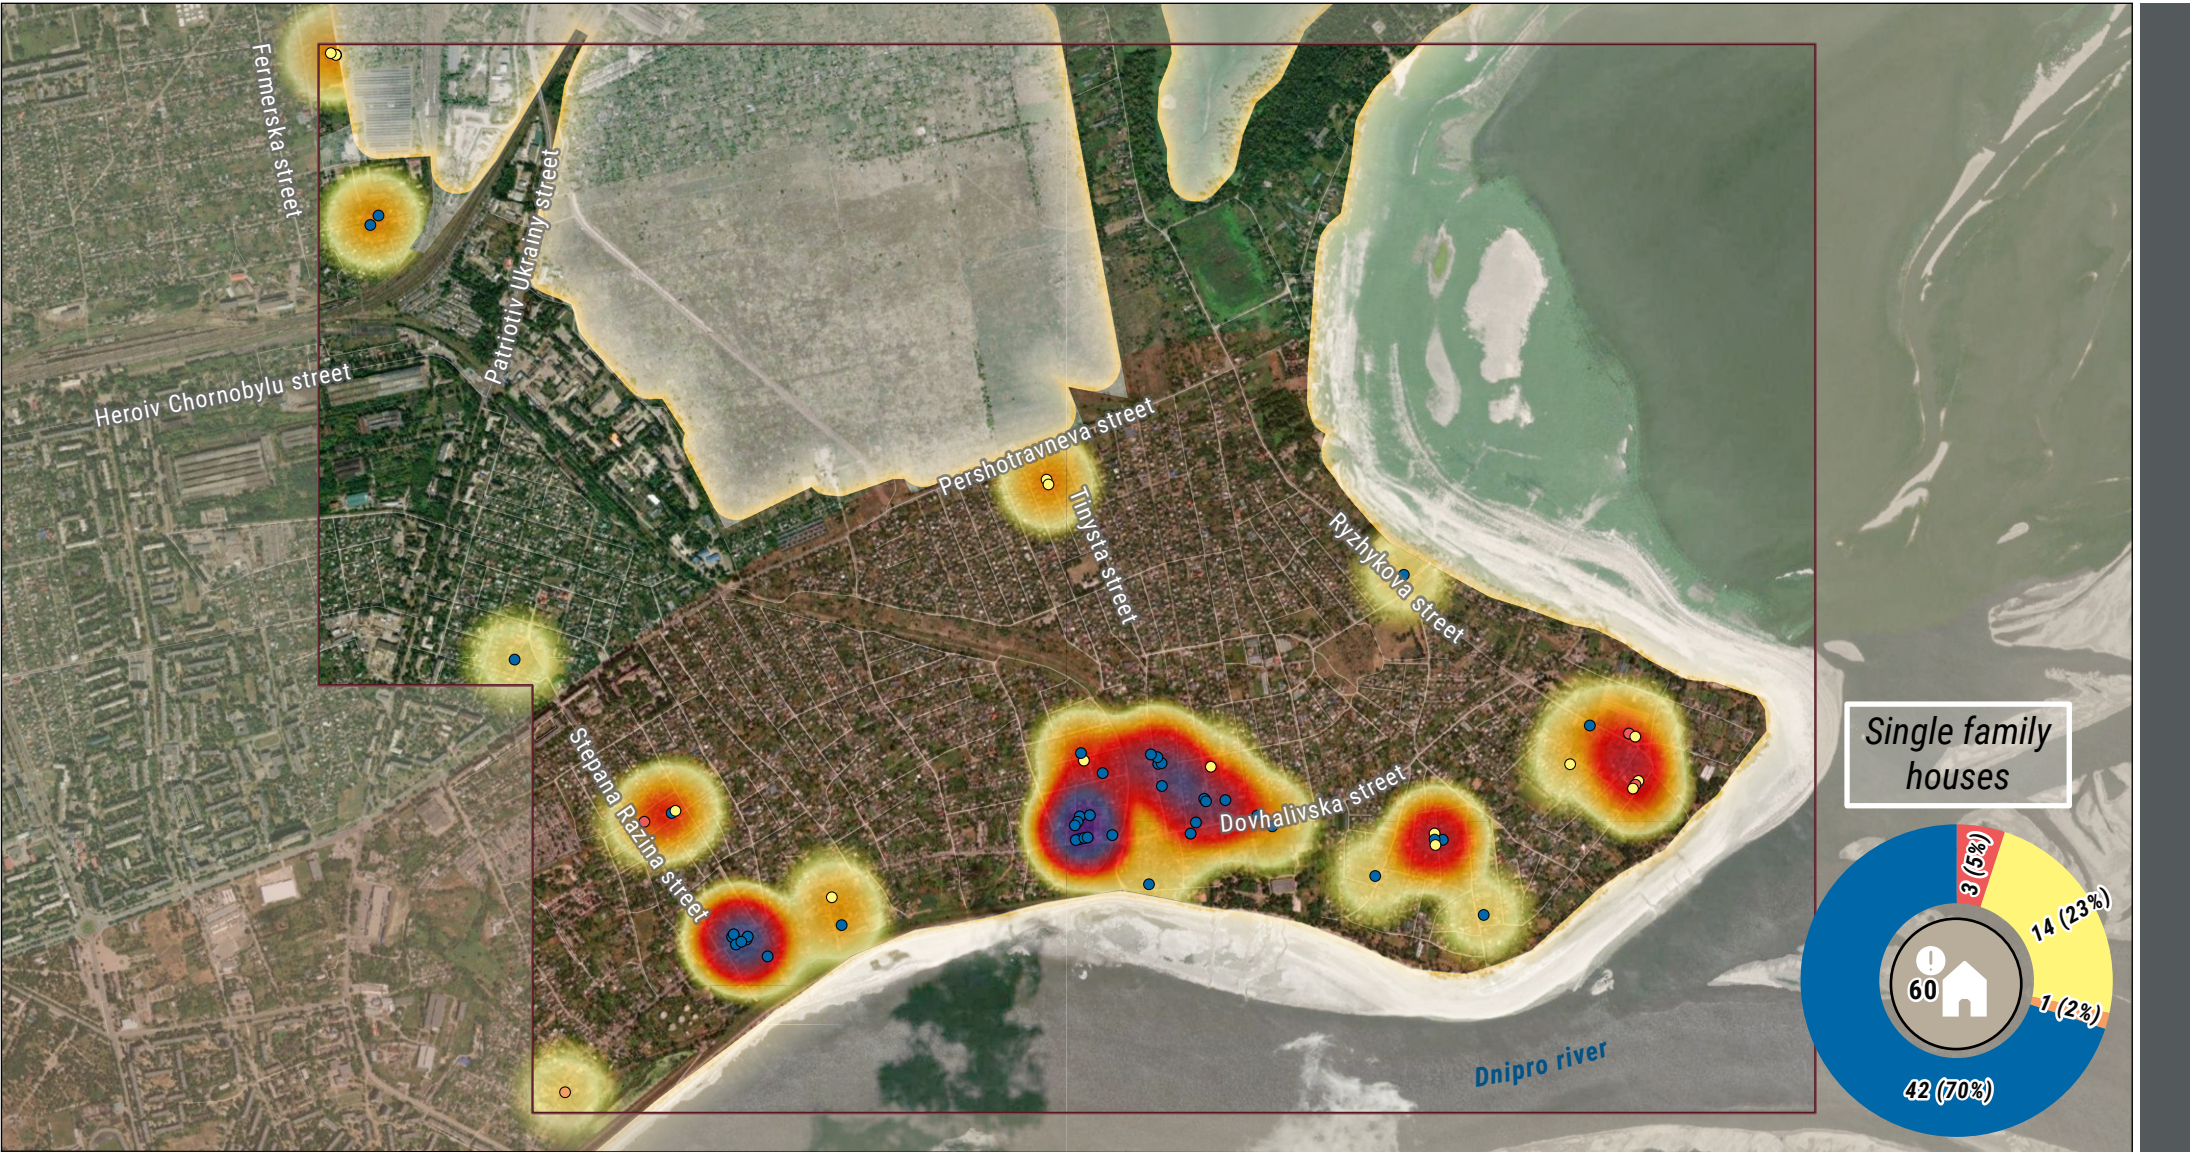
## PART 2

The eastern part of the city is characterised more by single-family houses. Again, this area sits within the “area of significant damage”. There are clusters of visible damage or repair close to the river bank.

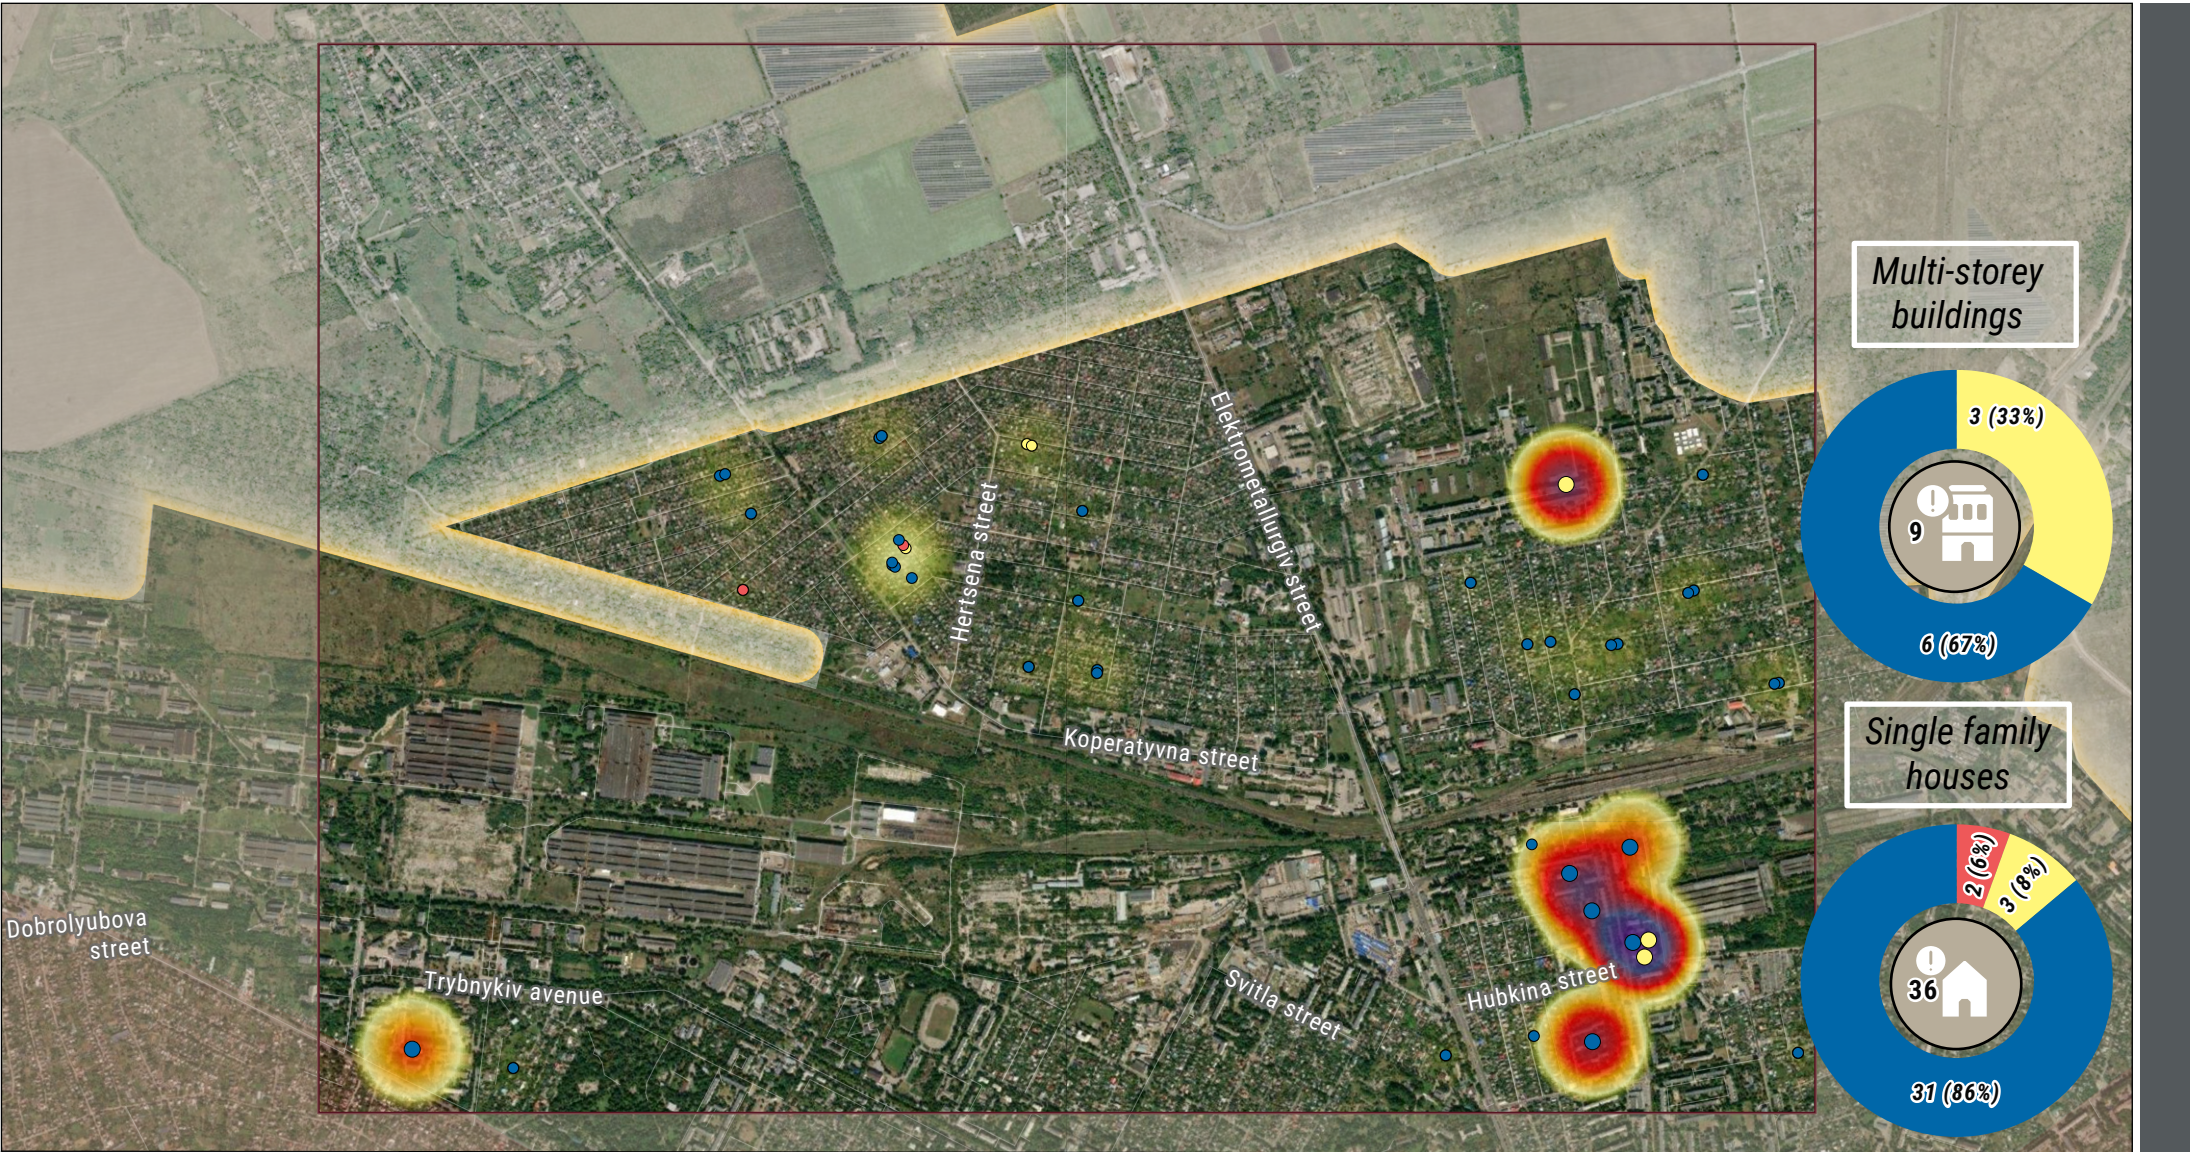
## PART 3

To the north, there are a mixture of single-family and multi-story buildings. Although this part of the city is outside of the “area of significant damage”, there is still evidence of damage dispersed across the whole area. There were two visibly destroyed buildings in this area, relatively far from the riverbank.

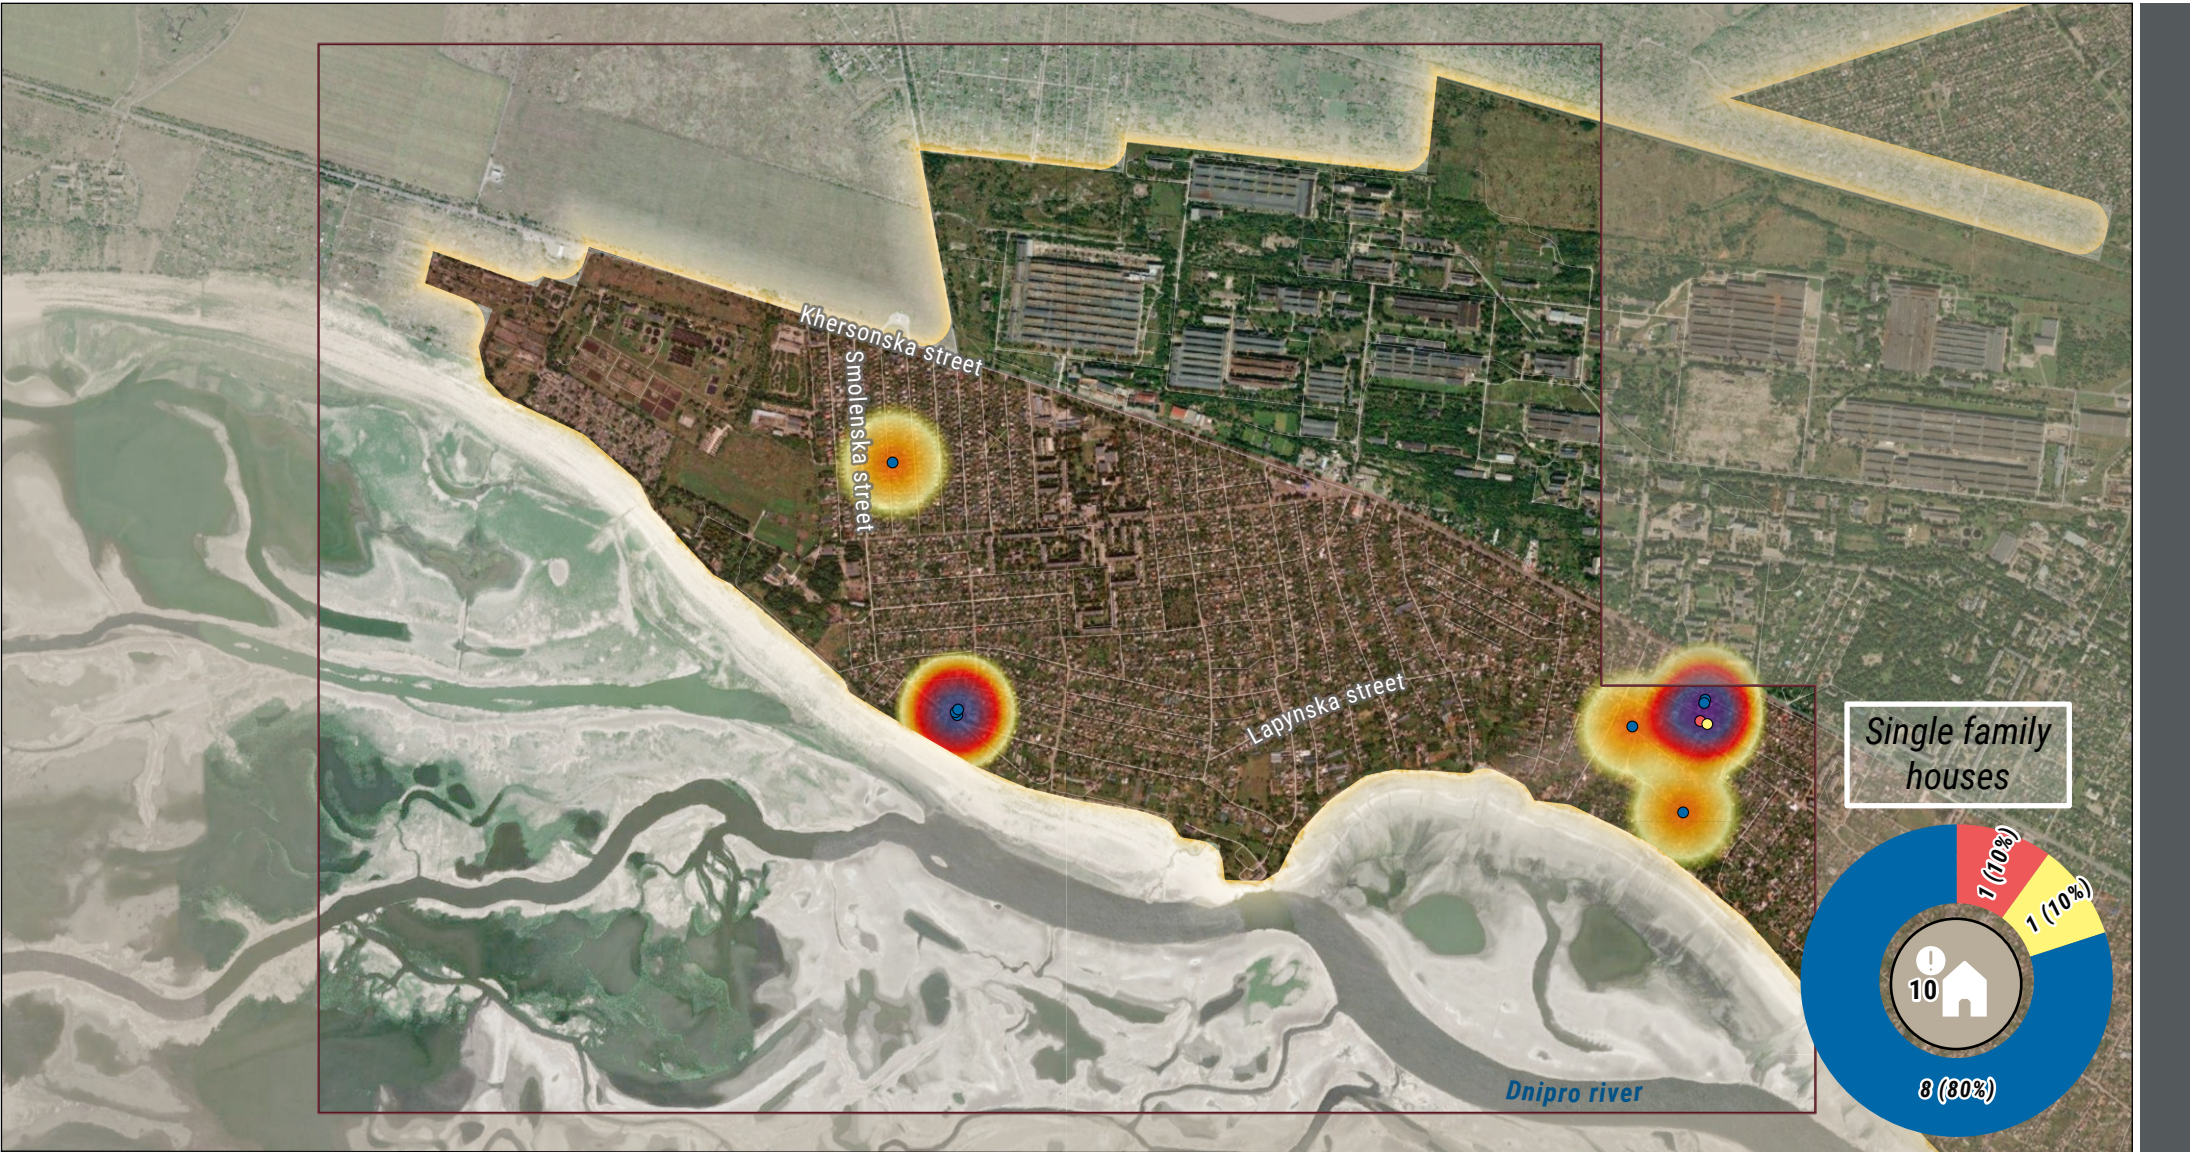
## PART 4

The “areas of significant risk” run right along to the western-most part of the city. Again, this suburban area is characterised by single-family houses.

As in other parts of the city, there are signs that houses are being repaired, suggesting that people are maintaining a connection to the area.

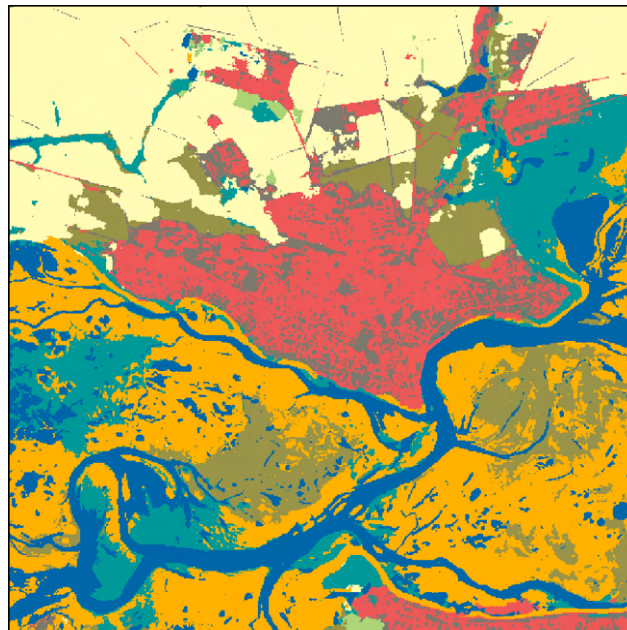
5 August 2023

In August 2023 (central image), two months after the explosion of the Kakhovka Hydro Power Plant, water only remained in the deepest parts of the reservoir.

The city's water supply was affected. In assessing damage, REACH found indications of shelling around water pumping infrastructure on the exposed ground.<sup>18</sup> At this time, the environment was in a state of water stress, and people had limited access to water.<sup>19 6</sup>

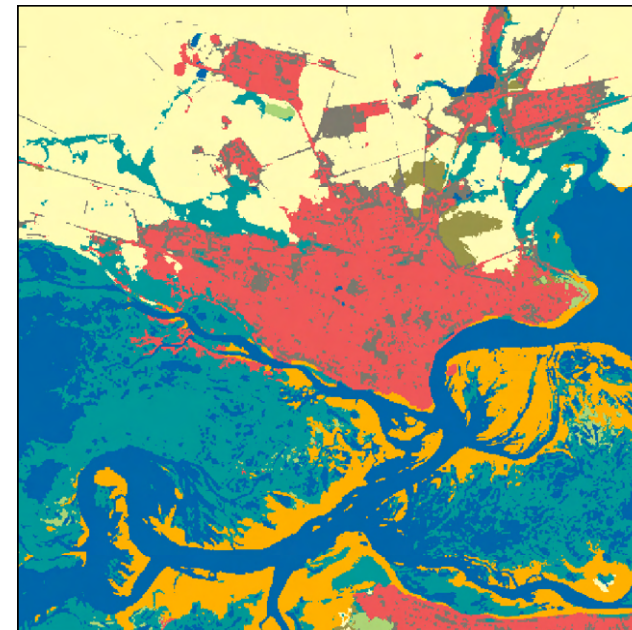
22 May 2024

A year after the disaster (in the image on the right), the reservoir remains emptied. Ecologically speaking, the environment now is similar to how it would have been before the reservoir was made.<sup>20</sup>

The sandy and muddy bottom is covered with diverse vegetation, and wetlands have formed on the floodplain; biodiversity has increased.<sup>21</sup>
