Langtang Valley Assessment, Nepal

Langtang Valley, May 2015

SITUATION OVERVIEW

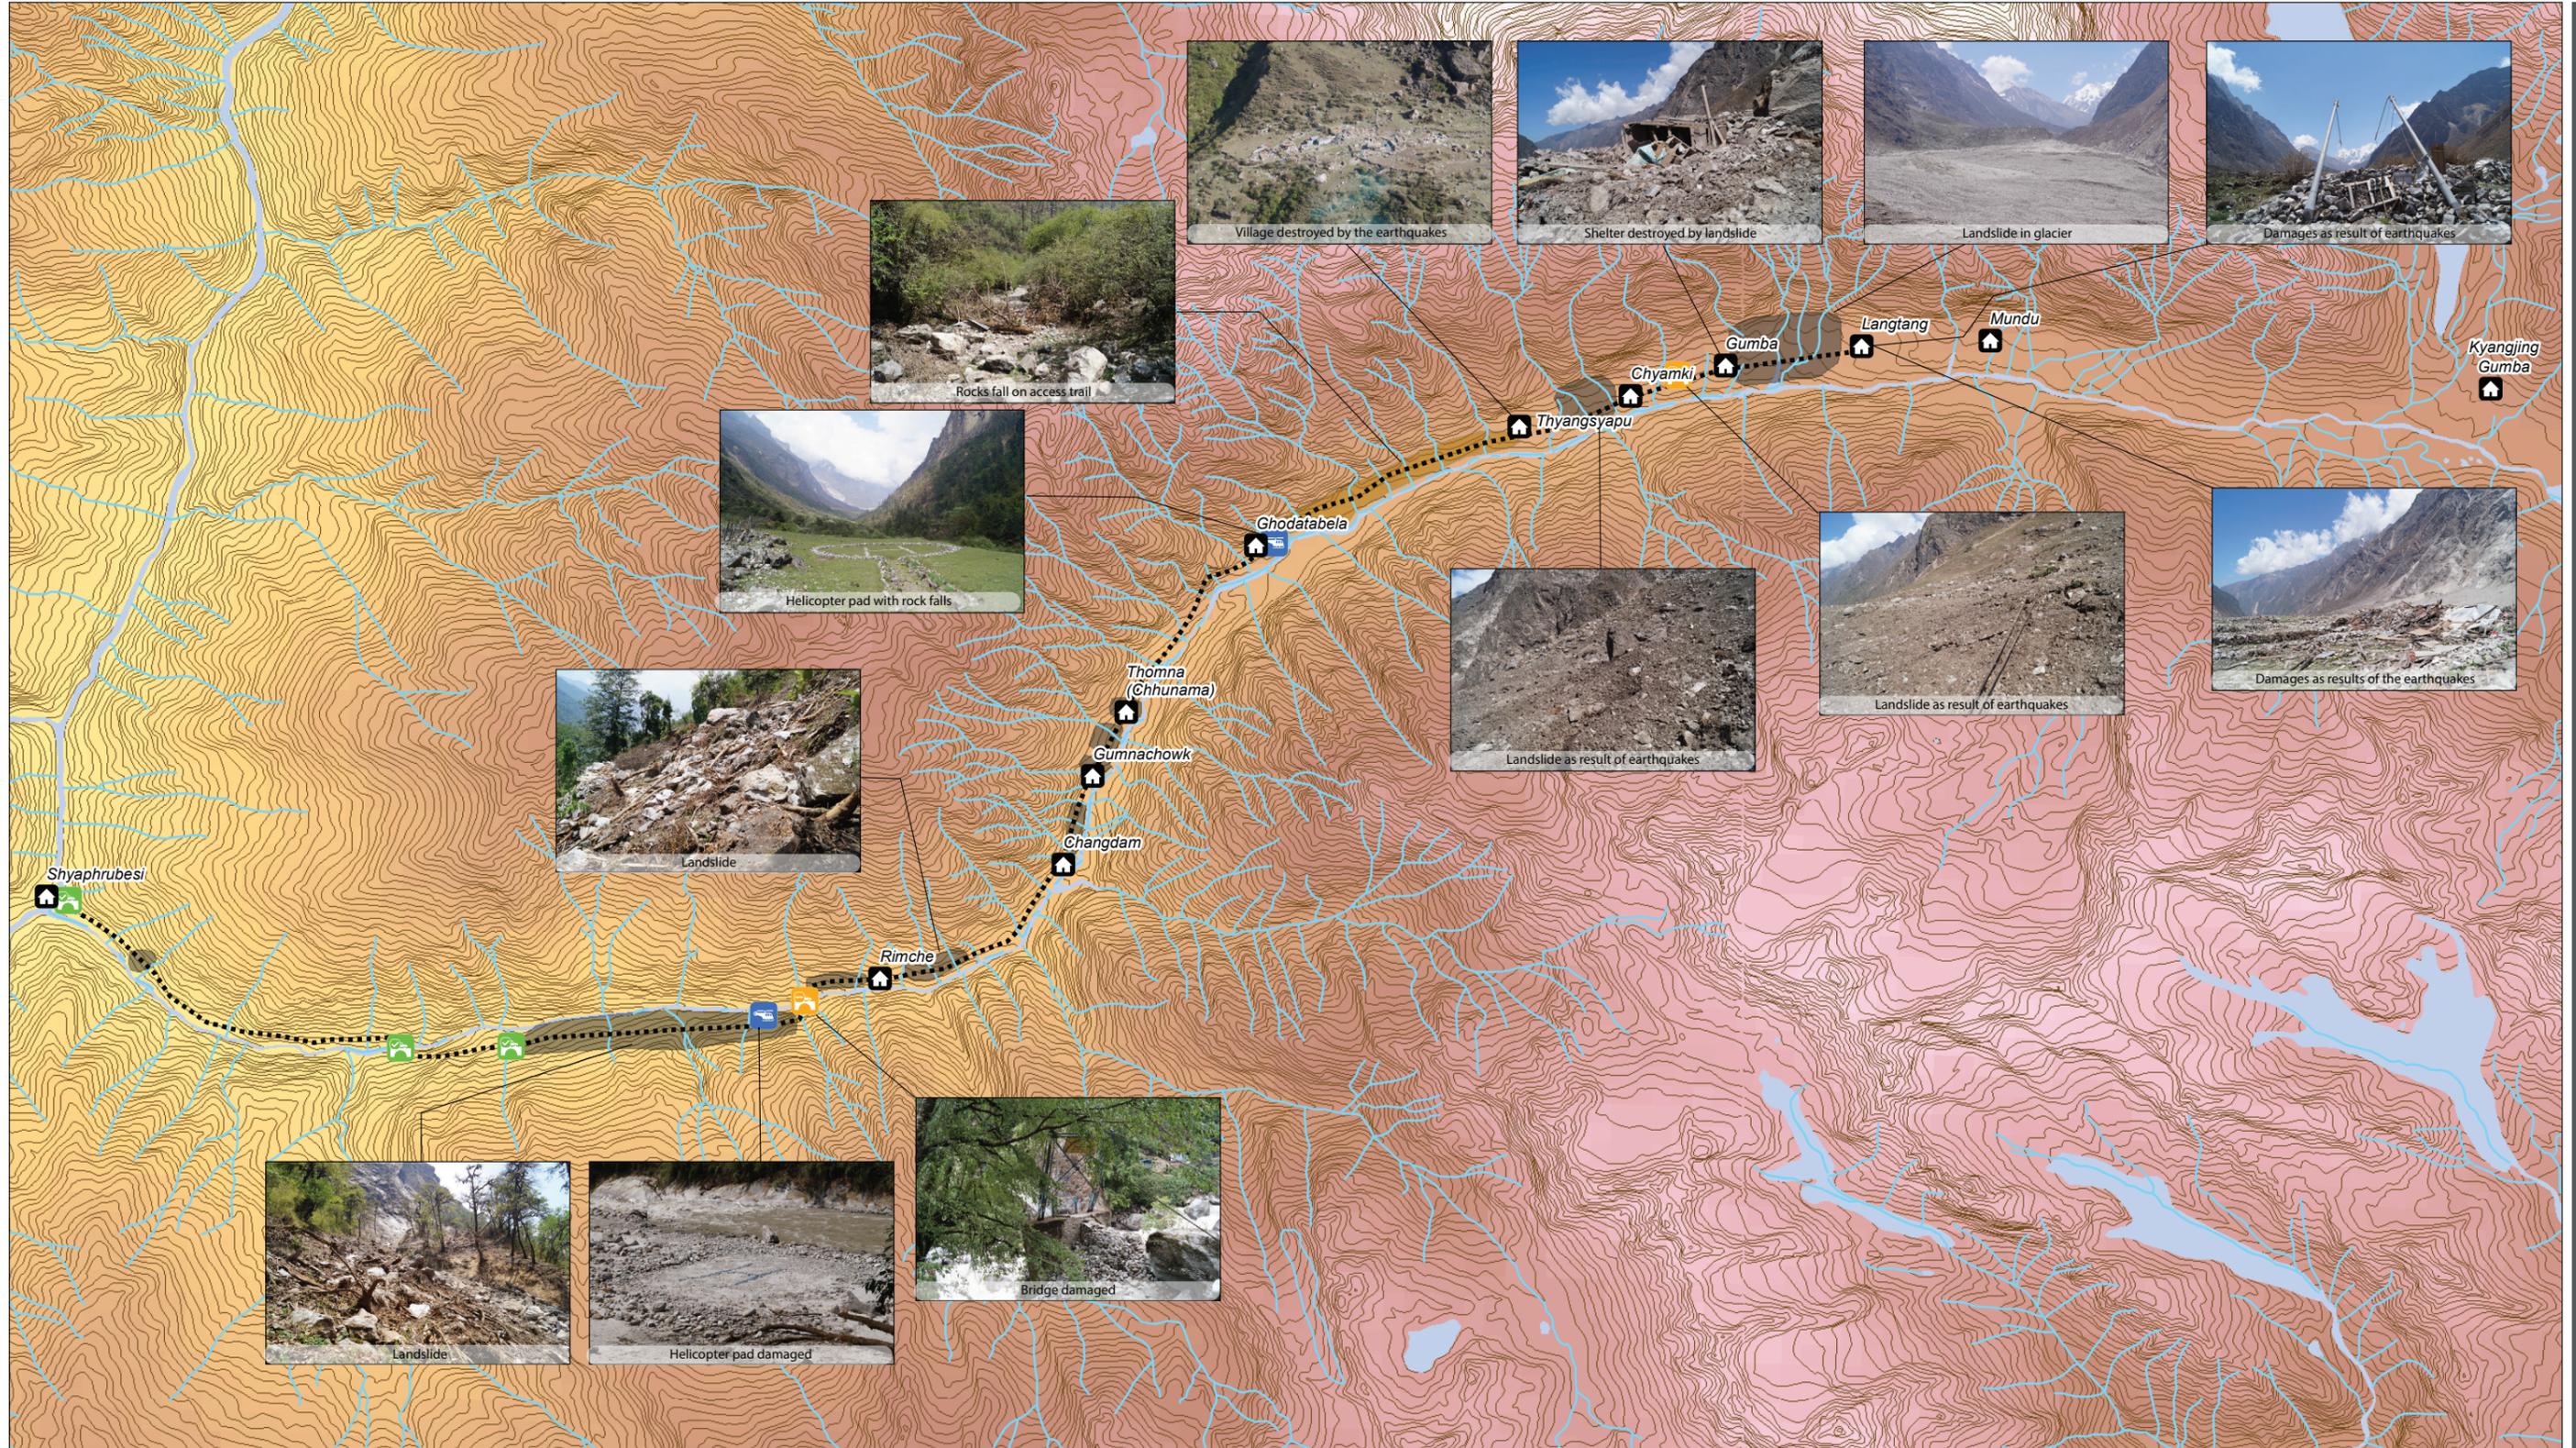
- Observation Trail
- 🏠 Observed Village
- 🚧 Damaged Bridge
- 🟢 Functional Bridge
- 🚁 Helicopter Pads

- Area of required debris removal
- Areas of Rockfall / Landslide
- Altitude (m)
 - High : 8791
 - Low : 1500

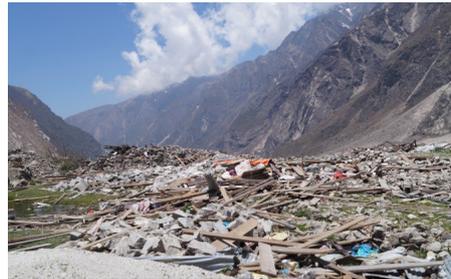
Structures within the village had been completely destroyed, with almost all shelters exhibiting visible damage from shaking, or covered by landslide debris. The assessment team estimated that around 20-30% of the debris from the village may be salvageable.

Picture 1: Debris from damaged houses in Langtang Village

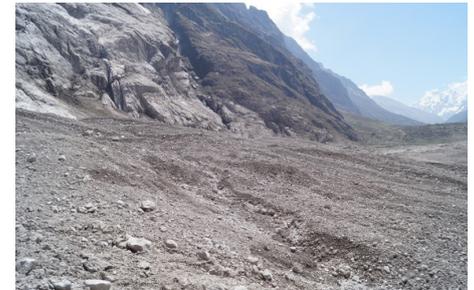
Gumba Village, located to the west of the Langtang mudslide, consisted of approximately 15-20 houses/structures that had been totally destroyed by the earthquakes and resulting mudslides. At the time of assessment, no households remained, with no visible potential to salvage materials.

Picture 2: Large scale mudslides in Gumba Village

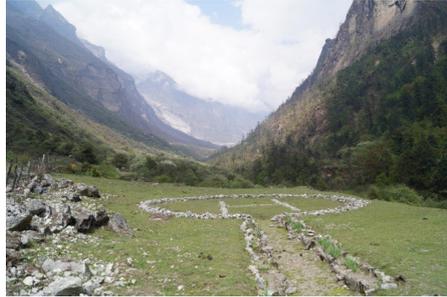
This village had clear damage from the earthquake, with approximately 50% of the structures damaged. Ghodatabela served the community in terms of having functional helicopter landing zones and army base.

Picture 3: Helicopter landing strip in Ghodatabela Village

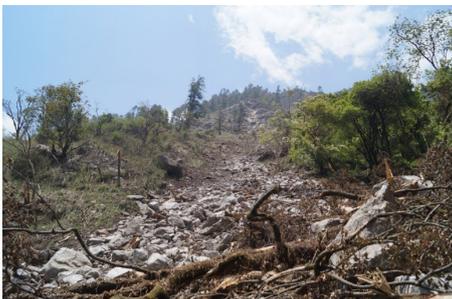
As the valley becomes steeper, more frequent rock fall and smaller landslides create the largest access problems, at points fully removing the footpath from the side of the valley and leaving a sheer drop to the valley floor over 30 metres below. Crossing and clearance of the valley in these areas will therefore be extremely difficult and dangerous in such places.

Picture 4: Damaged footpaths

The severe loss of access due to footpath collapse, obstruction by landslides, mudslides, rock fall and forest debris currently makes any form of overland assistance impossible. Thus, helicopter support would be the only possible modality for provision support for community recovery until footpaths are repaired or rebuilt.

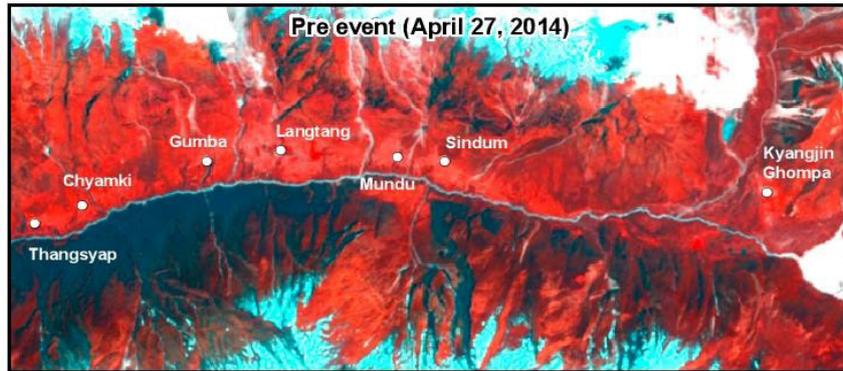
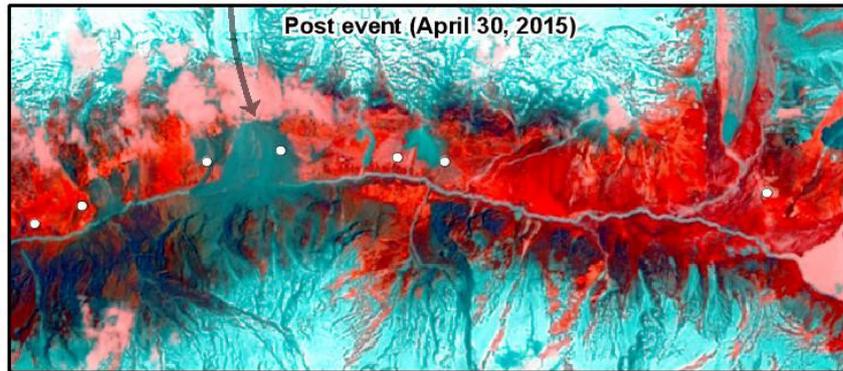
Annex: Satellite analysis of landslides in the community areas of Langtang Valley

Landsat 8
RGB=643
