SUDAN CRISIS: AREA-BASED ASSESSMENT FOR MALAKAL POC SITE

August 2024 | South Sudan

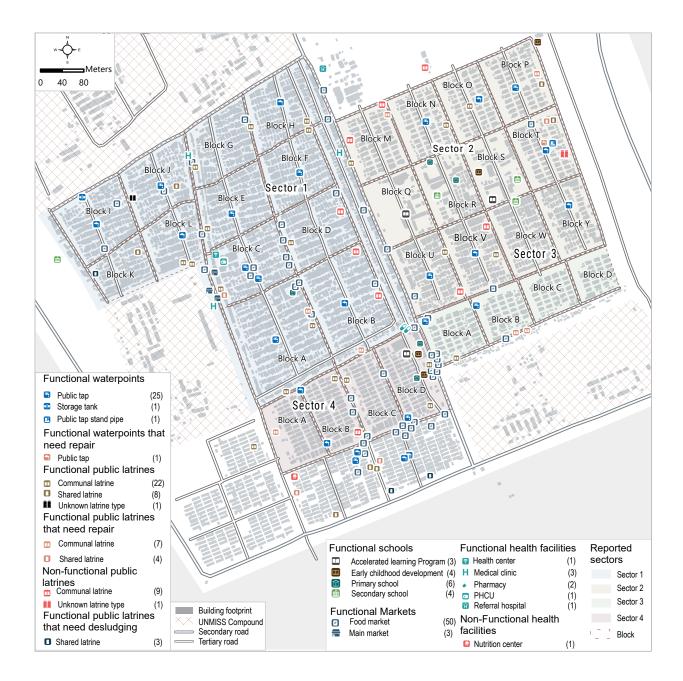
Map 1: All assessed infrastructure in Malakal PoC Site across the sectors of WASH, markets⁵, education, and health:

In the first phase of data collection, community leaders and experts participated in two Mapping Focus Group Discussions (MFGDs). The second phase involved Key Informant Interviews (KIIs) focused on facilities for water access (28 infrastructures), sanitation (55), healthcare (9), markets (53), and education (17). Data collection occurred from April 22 to May 2, 2024. For more information, please see the terms of reference (ToR).

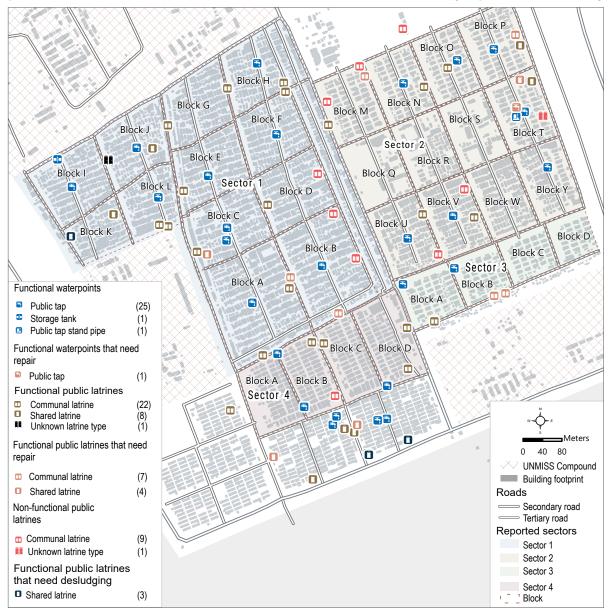
Map 2: The location of assessed WASH infrastructure in Malakal PoC Site by reported functionality:

A total of 28 water points exist within the PoC site, mainly consisting of public taps, storage tanks, and standpipes as displayed in Map 2 below. Although all water points are reportedly functional (n=28), the vast majority of respondents (n=27) reported the water quantity they are able to collect to be insufficient in meeting their needs.

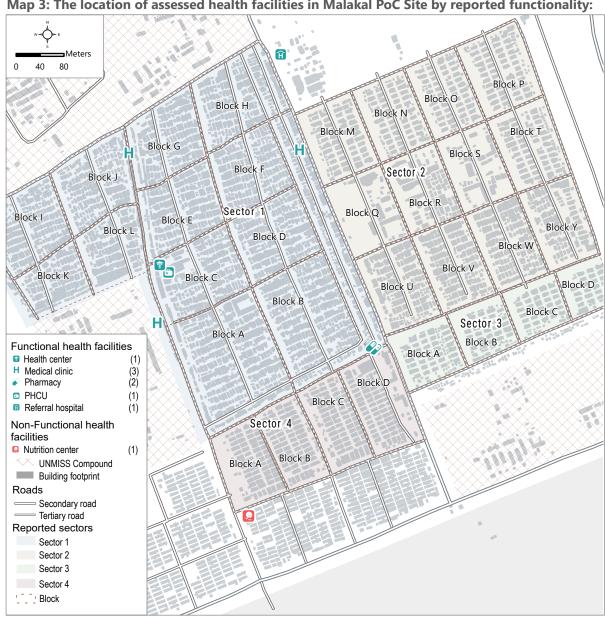
A total of 9 health facilities were assessed in Malakal PoC site as depicted in map 3 below. Key informants (KIs) involved in the assessment included doctors (3), pharmacists (3), a cleaner and a nutrition officer from the facilities assessed. These facilities comprise both private health facilities (5) and public health facilities (4), with one public facility reportedly non-functional due to lack of funding.

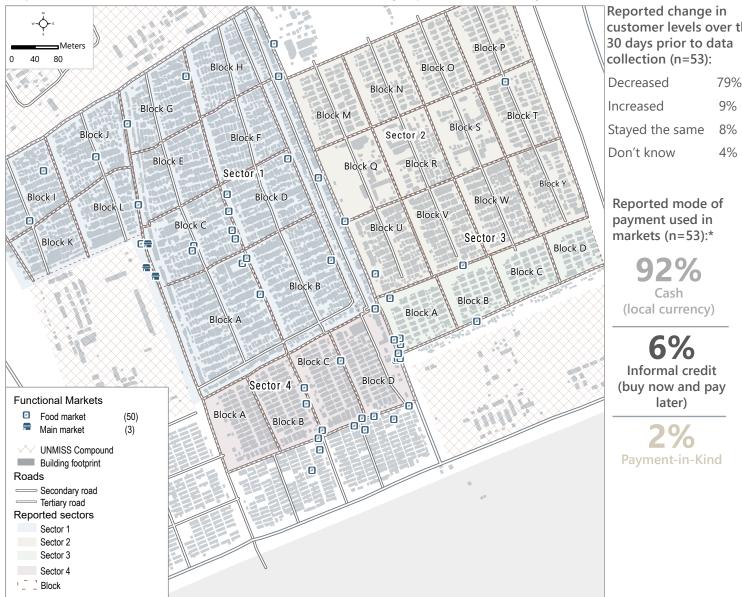
Map 4: The location of assessed markets in Malakal PoC Site by reported functionality:

A total of 53 individuals were engaged to investigate the food item stalls (50) and main markets (3) available in the PoC site as depicted in map 4 below. No livestock market was reported to be available within the site. The three main markets and an additional six food stalls were reported to be open at night. Food markets reportedly provide access to a wide variety of foods, with the most commonly mentioned items available being rice, milk products, sugar, oils, and cereals.

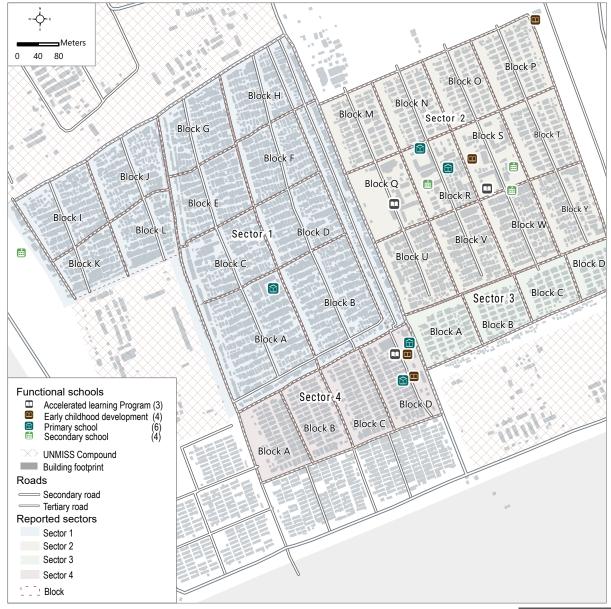
Map 5: The location of assessed education infrastructure in Malakal PoC Site by reported functionality:

A total of 17 educational facilities were identified and assessed in the Malakal PoC site as depicted in map 5 below. All schools have mixed classrooms accommodating both male and female students.
