BANGLADESH - Teknaf Upazila - Camp 24

Hazard Mapping- Standing Water Analysis- Maximum Extent Detected

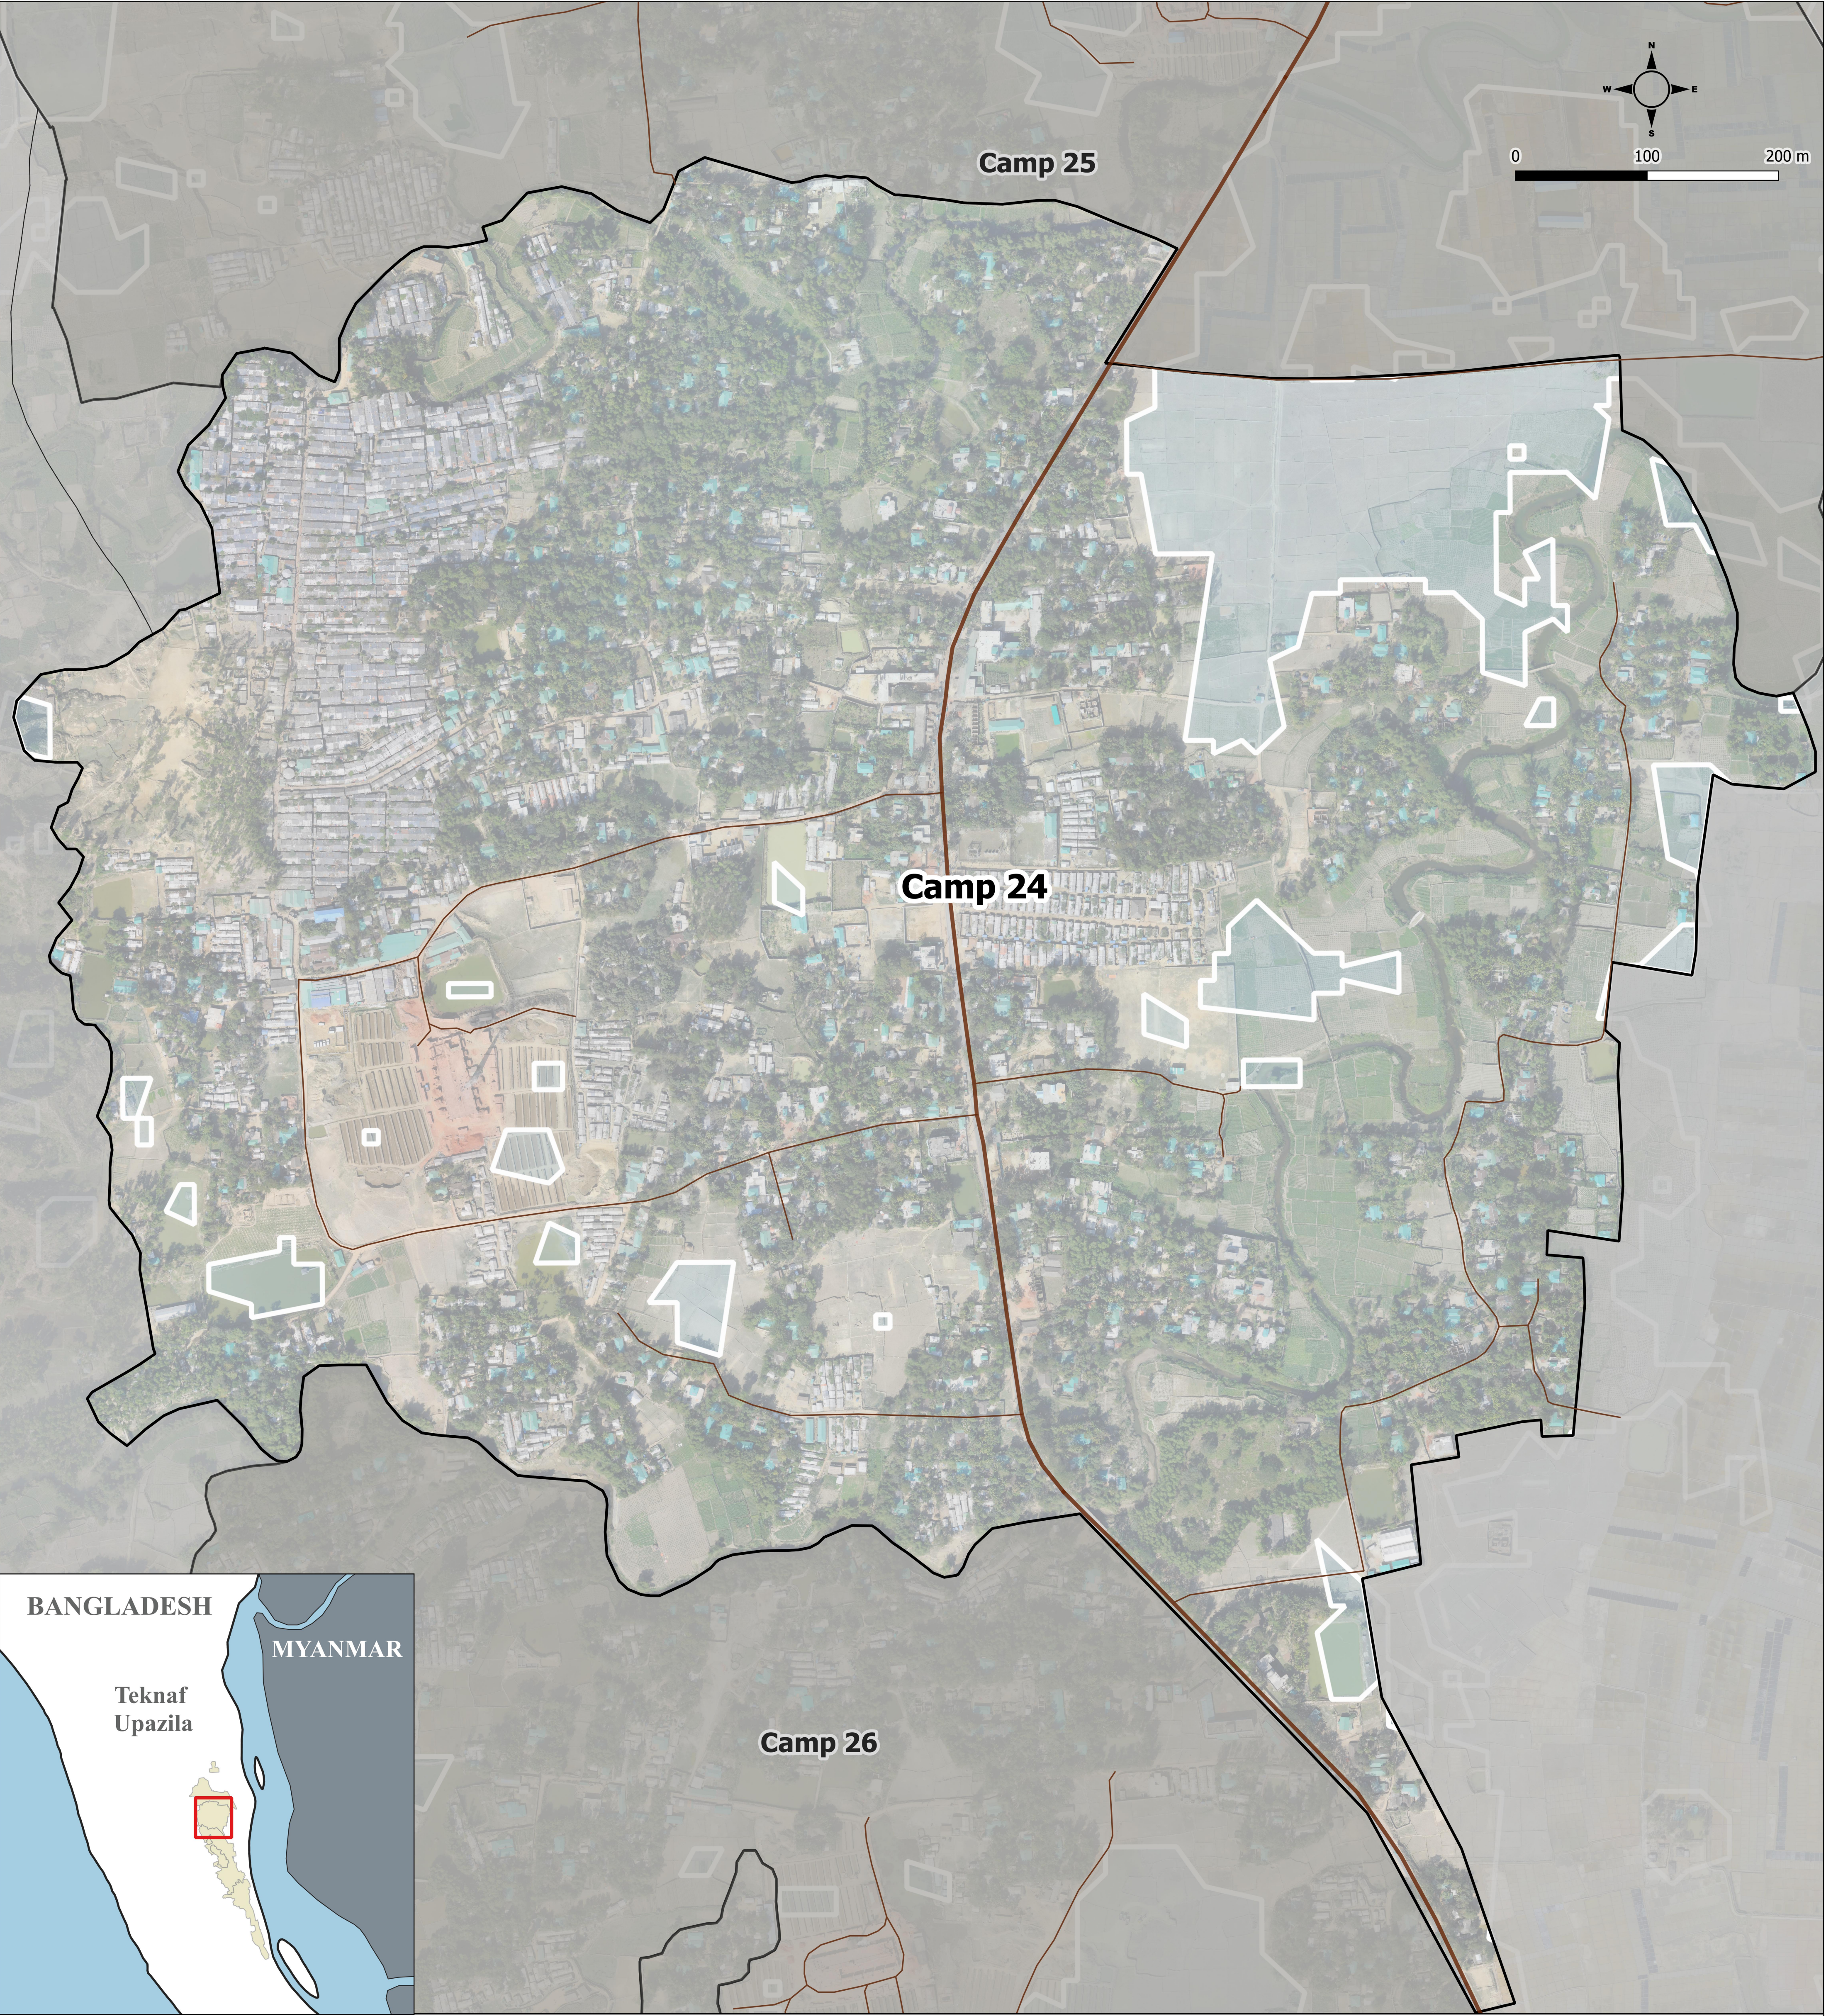
Summary:
This map displays standing water detected from remote sensing analyses of twenty Sentinel-1 images with 10 m resolution (table 1). The outline represents the maximum extent of standing water detected from the composite analysis of the twenty dates selected. These results represent a preliminary investigation and have not been validated in the field. The results are only representative of the dates analyzed and the classification scheme utilized. Remote sensing techniques such as this are inherently limited by a variety of factors, in particular the spatial resolution of the data analyzed.
