# Maiduguri Camp WASH Infrastructure Mapping

Maiduguri/Jere LGA, Borno State, Nigeria

March 2021

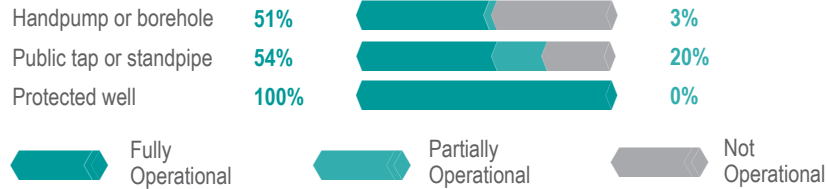
### Improved waterpoints functionality by type

45% of assessed waterpoints were reported to be damaged or in need of repair.
