Residential Building Damage Assessment
Chernihiv, February-April 2022

UKRAINE – Chernihiv residential damage assessment

Chernihiv, February-April 2022

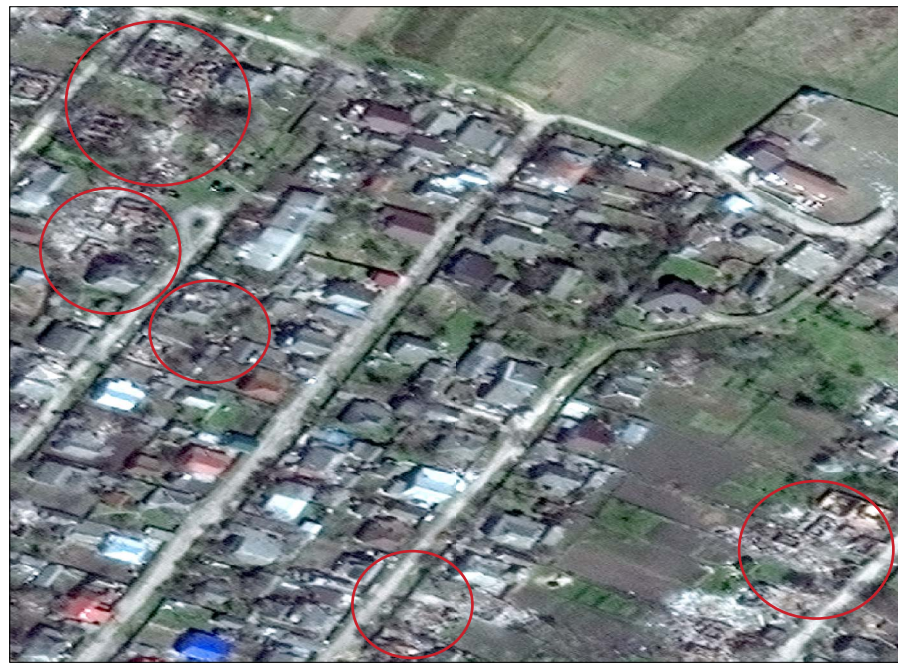
Image 1 and 2: Examples of detected damage to residential buildings in Chernihiv based on satellite imagery. Red circles depict buildings with clearly visible damage while the orange circle depicts a building likely to be damaged (based on visual inspection)
