Kakhovska dam damage and flood event monitoring using satellite data, 7 June 2023

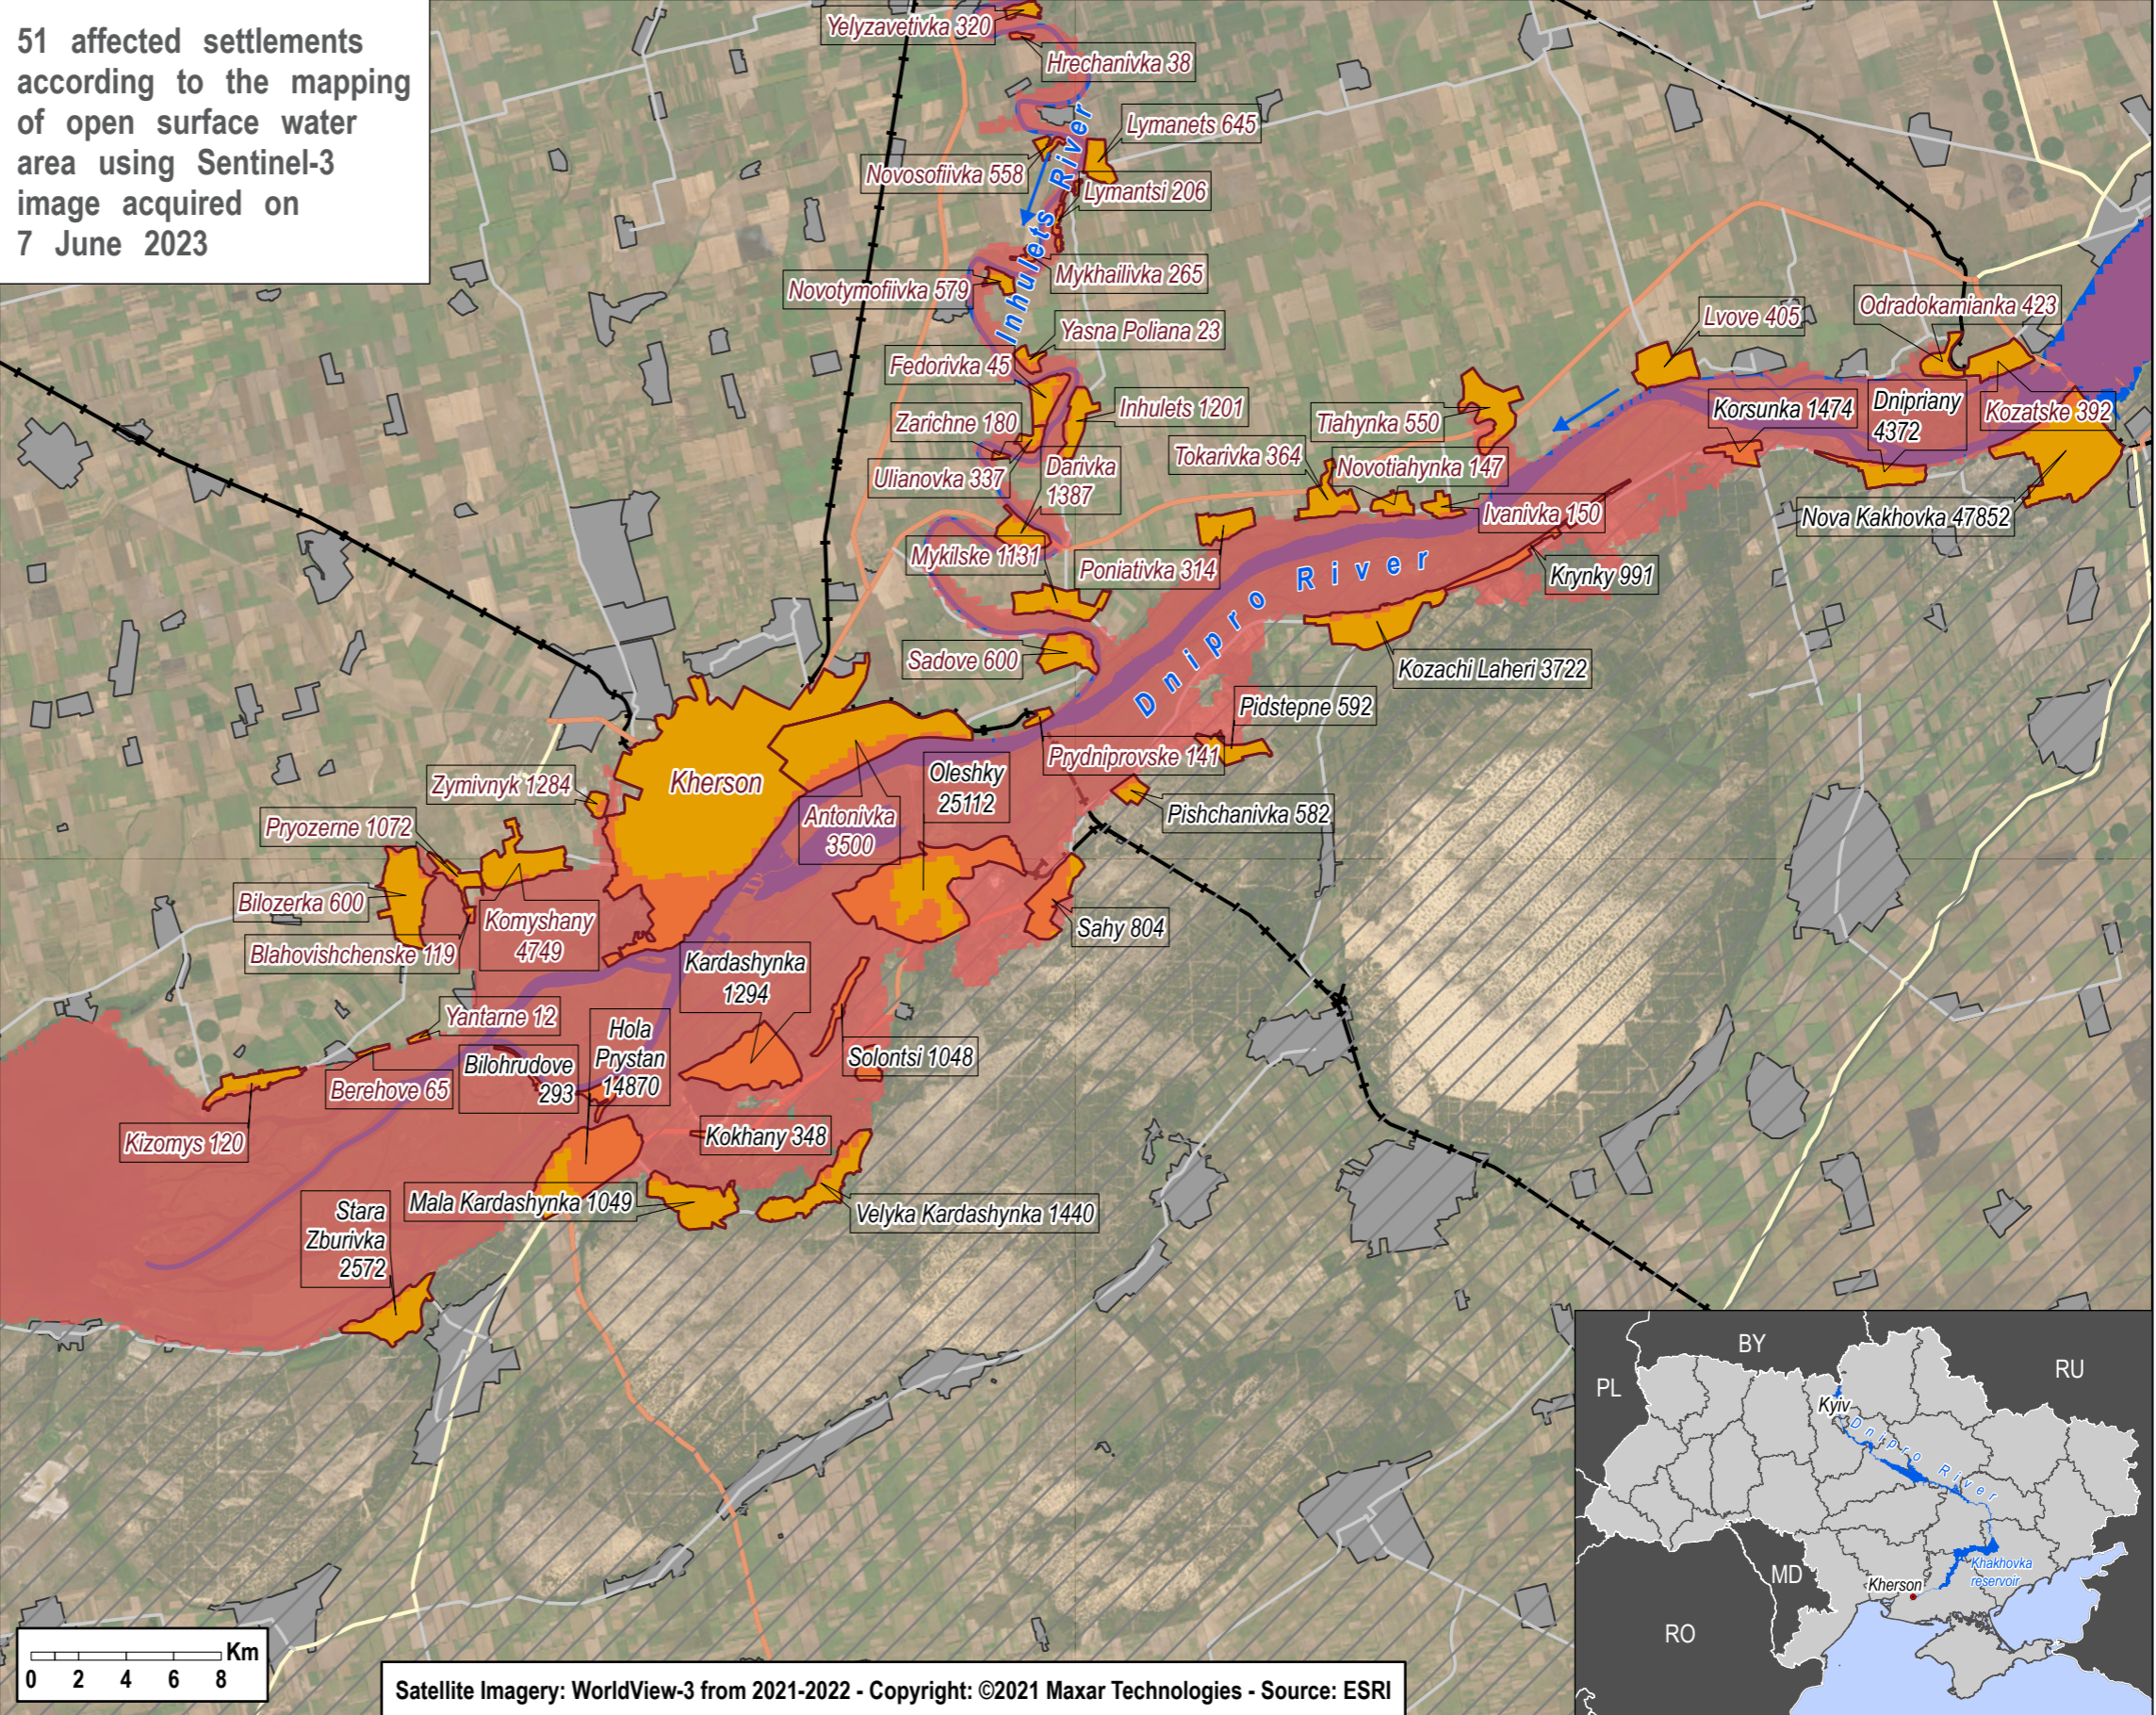
At approximately 3 a.m. on 6 June 2023, the dam of the Kakhovska Hydroelectric Power Plant (HPP) was breached and subsequently destroyed. This resulted in uncontrolled water release from the Kakhovka Reservoir and flooding of riverside areas downstream towards the Dnipro River Delta. The Head of the Kherson Regional Military Administration reported that an estimated 16,000 persons in 17 settlements on the right bank of the Dnipro River are located in areas within the flooding zone [1].

REACH initiated the satellite-based situation monitoring, based on open-source satellite remote sensing. The map shows the open water area, mapped from Sentinel-3 imagery [2] captured on the morning of 07 June 2023 [3]. Sentinel-3 satellites enable a short revisit time of less than two days for the OLCI instrument capturing images with 300-m spatial resolution.
