MOZAMBIQUE - Beira City

Matacuane - Structural Damage by Construction Typology - As of 26 March

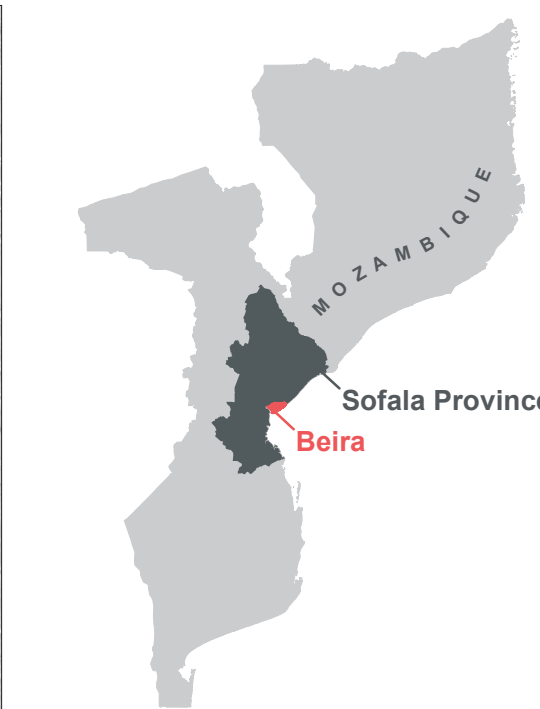
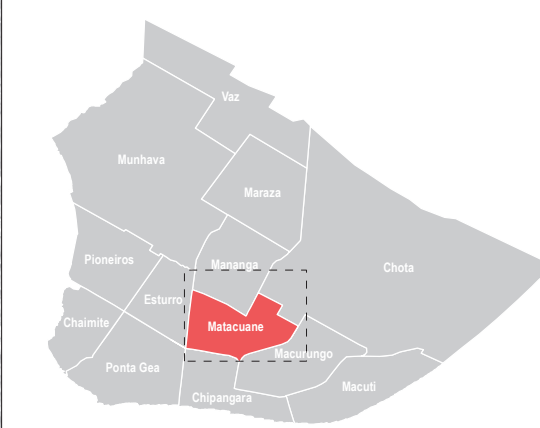
5,404 buildings total*

2,716 buildings damaged**

50% of neighbourhood damaged

***construction typologies by zone were gathered by REACH through participatory mapping with neighbourhood leaders. % of buildings in the area with each type of wall/roof were collected, and the remote sensing damage figures were used to estimate total damaged buildings by type. Damage numbers may not reach total numbers damaged due to some areas not being classified by neighbourhood leaders.
