# DAMAGE & REHABILITATION ASSESSMENT

Syria - Ar-Raqqa

April 2021

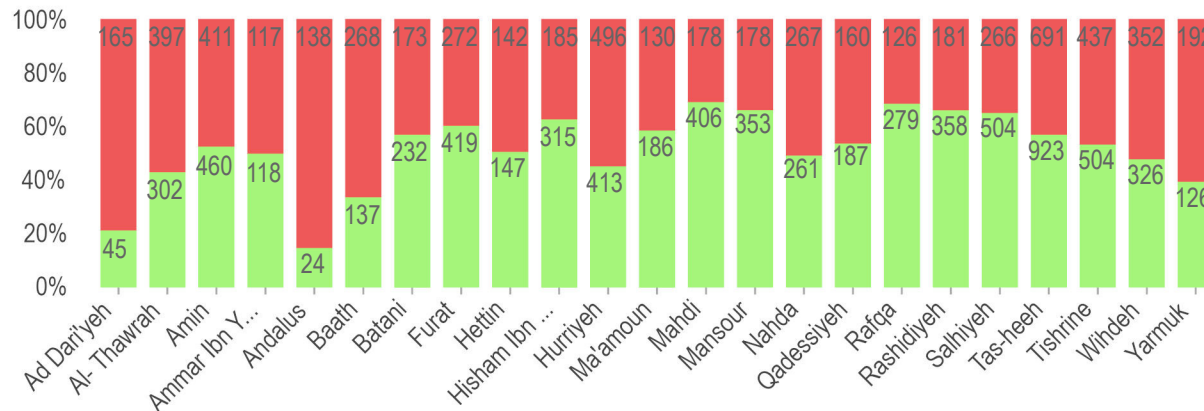
# and % of detected<sup>a</sup> affected structures in neighborhoods that were found to be destroyed, damaged, rehabilitated, reconstructed, or demolished since 2013.

\* Peri-urban area defined as the area outside of the city neighbourhood boundaries within the analysis extent.

- Rehabilitated/Reconstructed
- Damaged/Destroyed/Demolished
- Community
