# Damage Atlas Ar-Raqqa City

**Satellite-Detected Damage Severity  
Assessment**

**April 2021**

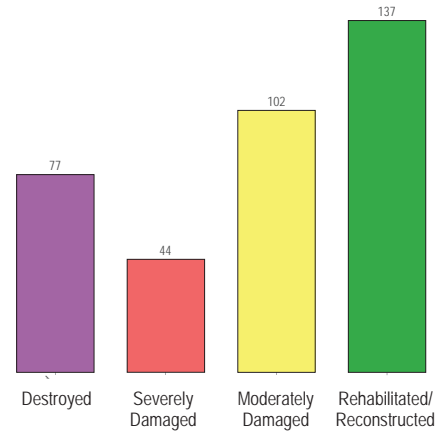
Baath Damage Counts,  
by # of identified structures

\*Severity calculated based on density of damaged infrastructure and weighted by scale of damage based on: destroyed, severely damaged or moderately damaged

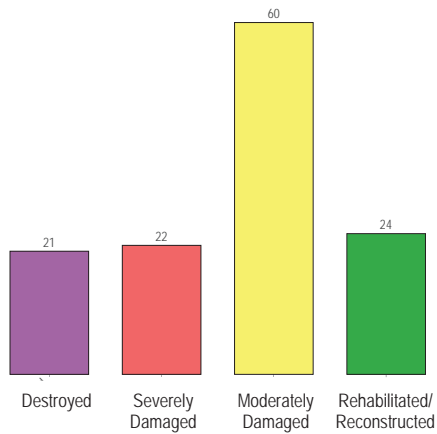
Andalus Damage Counts,  
by # of identified structures

\*Severity calculated based on density of damaged infrastructure and weighted by scale of damage based on: destroyed, severely damaged or moderately damaged

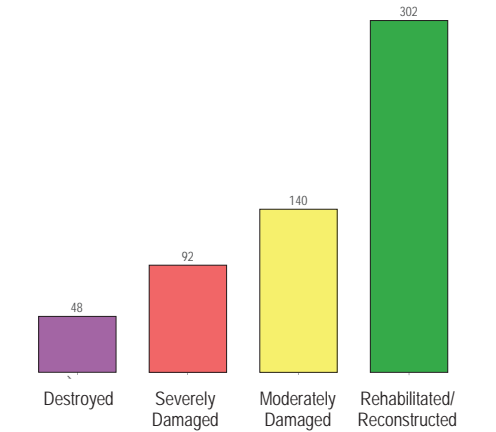
Al- Thawrah Damage Counts,  
by # of identified structures

\*Severity calculated based on density of damaged infrastructure and weighted by scale of damage based on: destroyed, severely damaged or moderately damaged

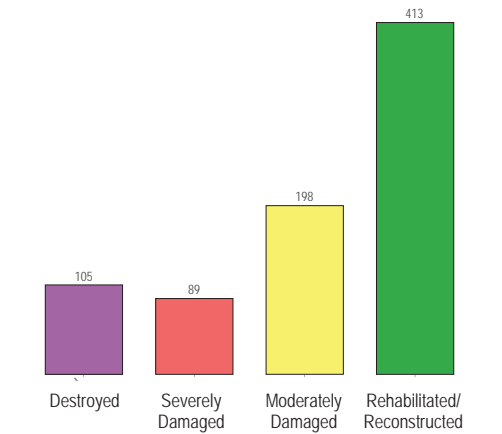
Hurriyeh Damage Counts,  
by # of identified structures

\*Severity calculated based on density of damaged infrastructure and weighted by scale of damage based on: destroyed, severely damaged or moderately damaged

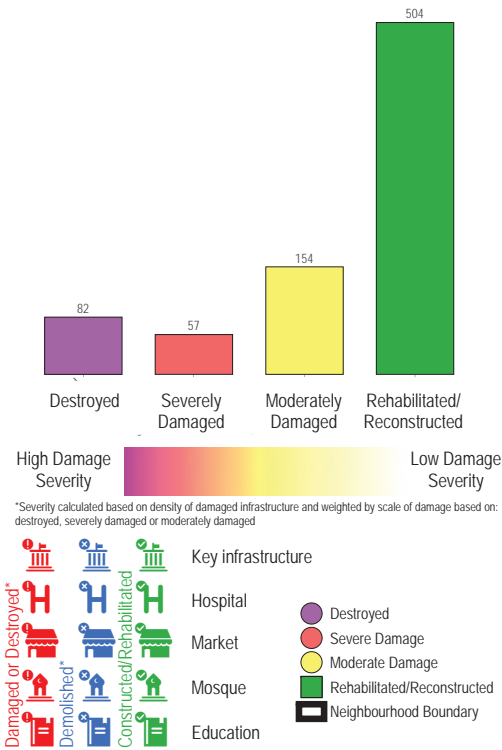
Tishrine Damage Counts,  
by # of identified structures

REHABILITATED/ RECONSTRUCTED	TOTAL NUMBER OF OBSERVED BUILDINGS	
504	/	941
% OF REHABILITATED/ RECONSTRUCTED:		53.56%

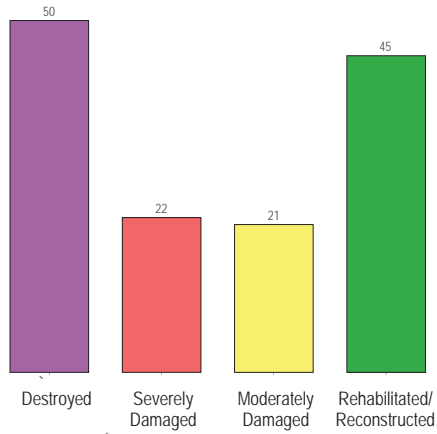
Ad Dari'yeh Damage Counts,  
by # of identified structures

\*Severity calculated based on density of damaged infrastructure and weighted by scale of damage based on: destroyed, severely damaged or moderately damaged

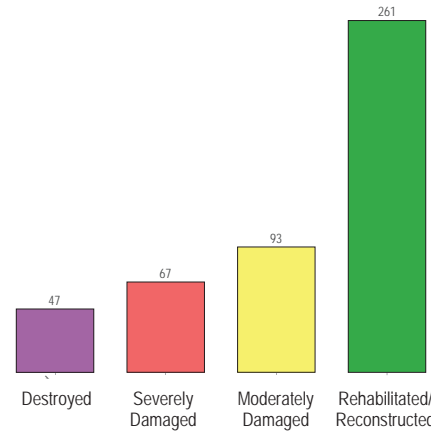
Nahda Damage Counts,  
by # of identified structures

\*Severity calculated based on density of damaged infrastructure and weighted by scale of damage based on: destroyed, severely damaged or moderately damaged

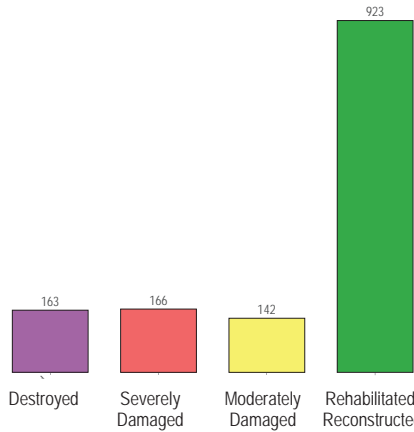
Tas-heeh Damage Counts,  
by # of identified structures

\*Severity calculated based on density of damaged infrastructure and weighted by scale of damage based on: destroyed, severely damaged or moderately damaged

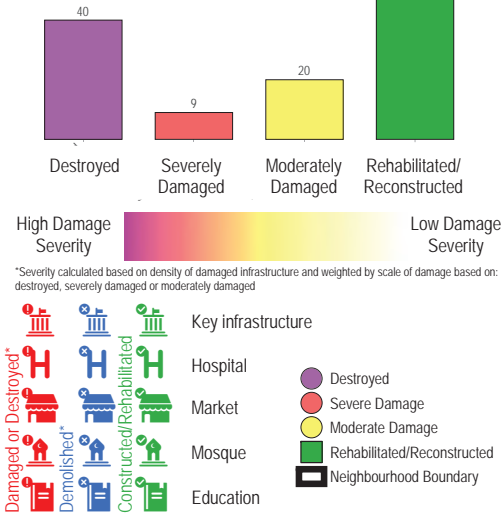
Ammar Ibn Yaser Damage Counts,  
by # of identified structures

REHABILITATED/ RECONSTRUCTED	TOTAL NUMBER OF OBSERVED BUILDINGS	
118	/	235
% OF REHABILITATED/ RECONSTRUCTED:		50.21%

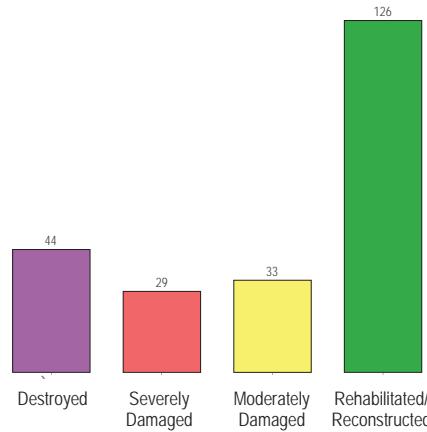
Yarmuk Damage Counts,  
by # of identified structures

\*Severity calculated based on density of damaged infrastructure and weighted by scale of damage based on: destroyed, severely damaged or moderately damaged
