### Jober Summary

**93%** of Structures Damaged or Destroyed

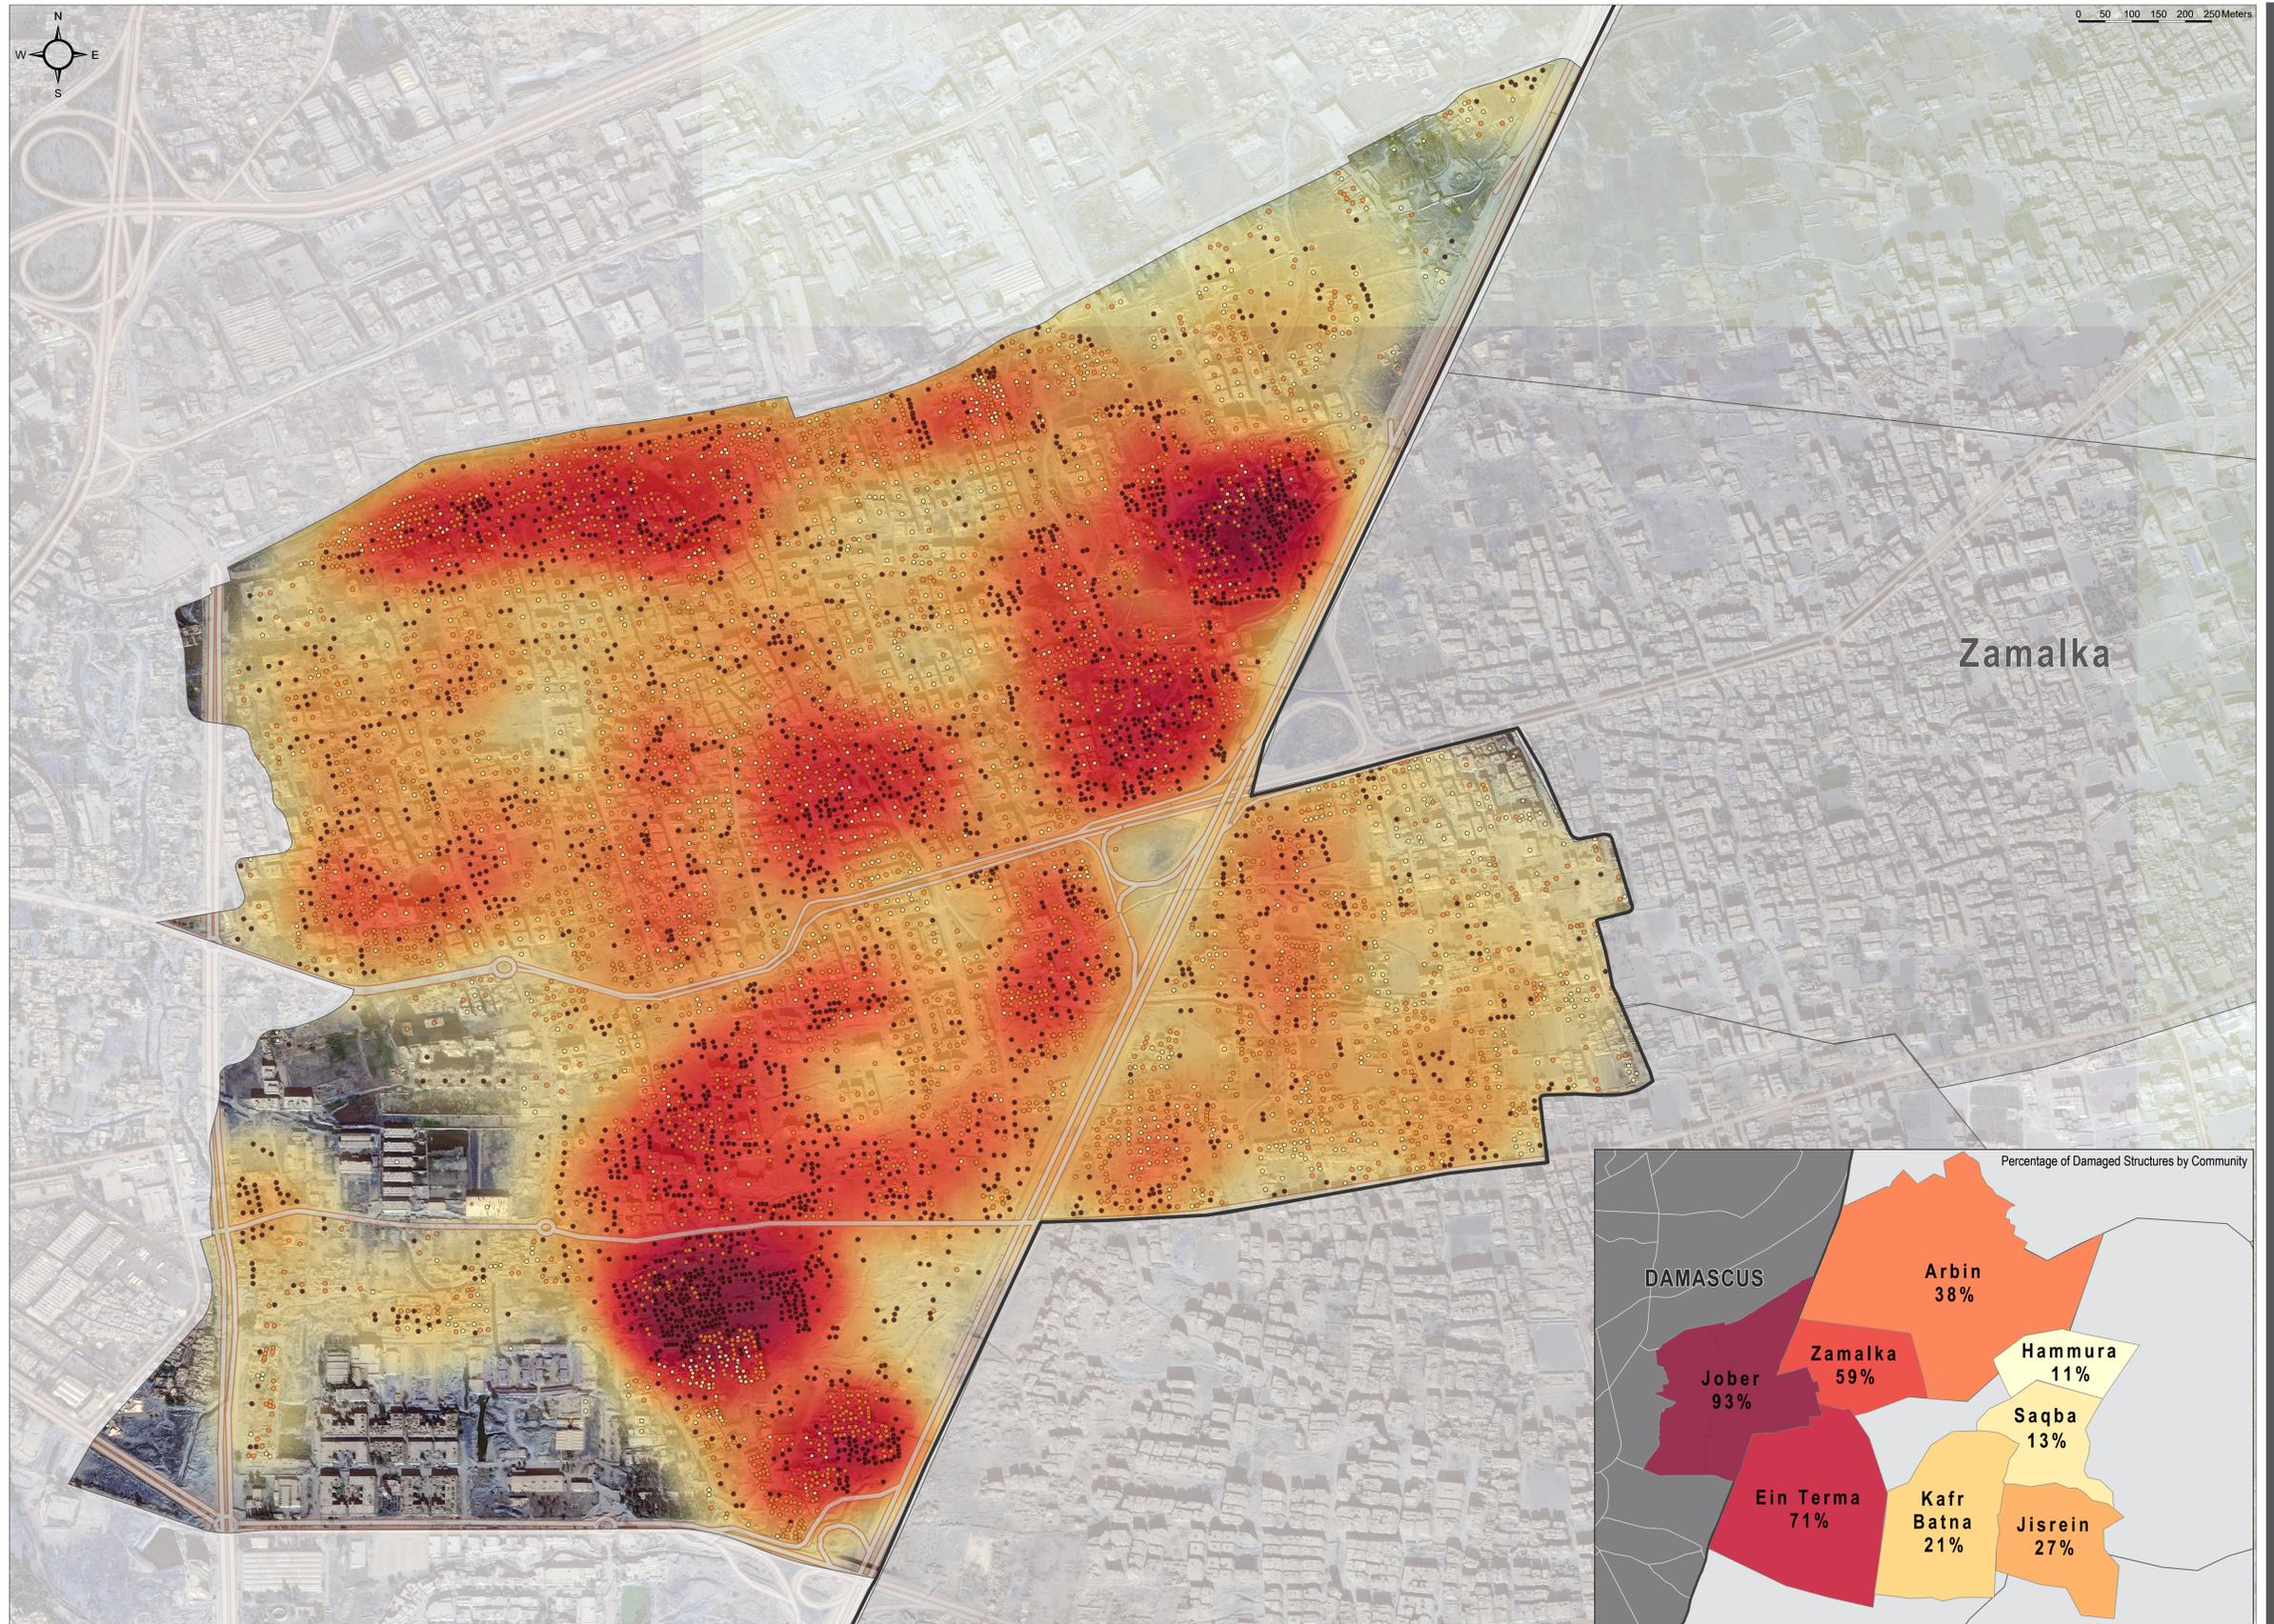
### Damage Severity Density

\* Severity calculated based on density of damaged infrastructure and weighted by scale of damaged based on; destroyed, severely damaged, or moderate damage.

- Destroyed
- Severe Damage
- Moderate Damage
