SHELTER DAMAGE ATLAS

Falluja City

Shelter Damage Reference Maps

Iraq Shelter Damage Atlas: Satellite Detected Damage, Falluja City

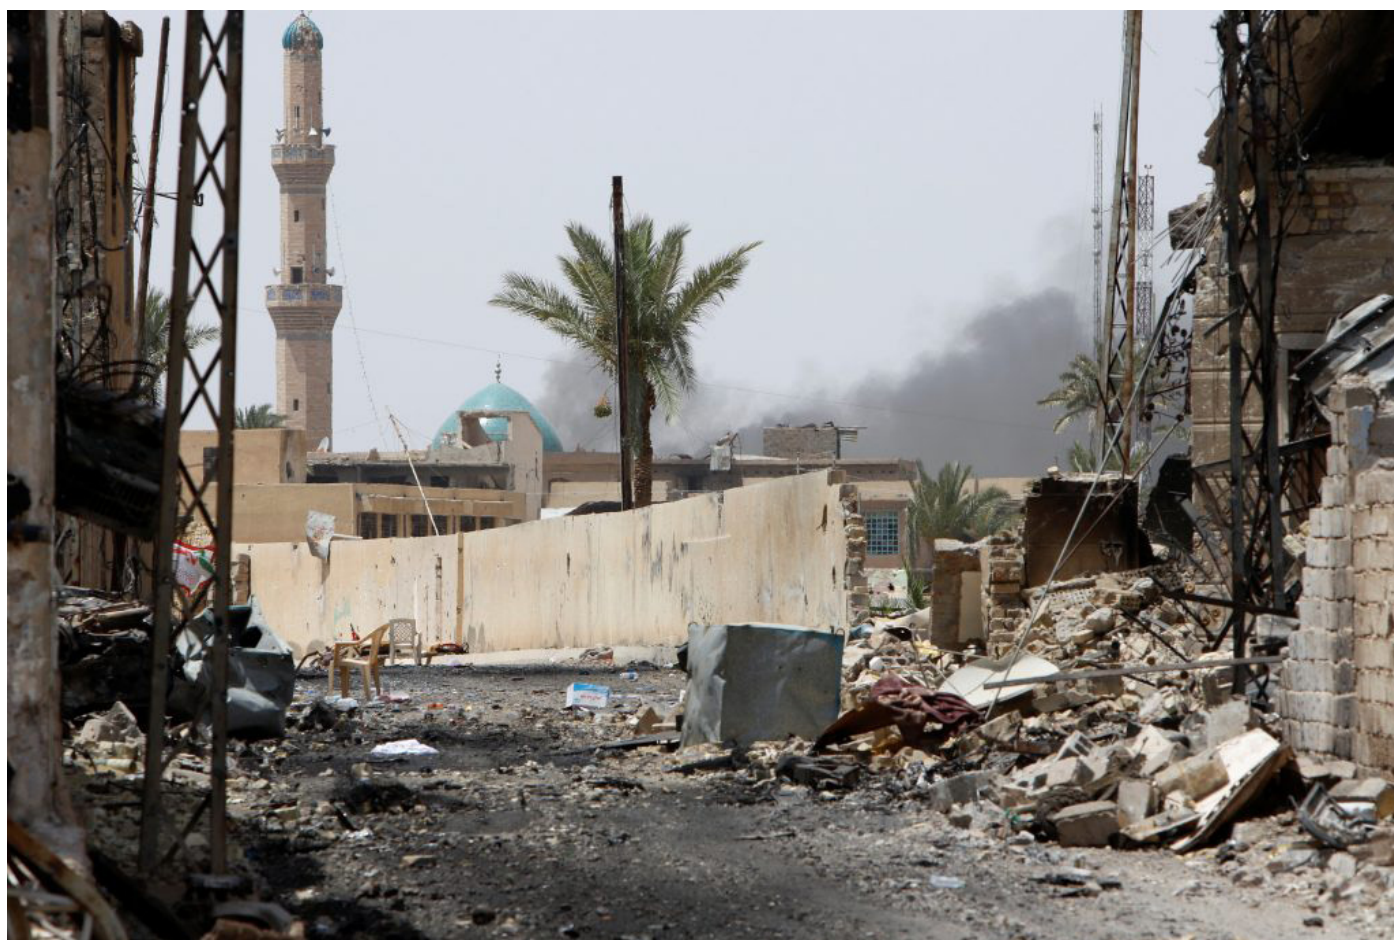
Falluja city, the capital of Falluja district is located in Anbar governorate, 69 kilometers west of Baghdad. It was the first city to fall under the control of the so-called Islamic State of Iraq and the Levant (ISIL) in 2014¹. Over the course of the conflict, the city sustained significant damage, including to shelter and basic infrastructure. After the city was recaptured in mid-2016, REACH Initiative, in partnership with the United Nations Institute for Training and Research's (UNITAR's) satellite application's programme, detected and classified 2,648 structures into three damage levels (destroyed, severely damaged, moderately damaged) for all 19 neighborhoods of Falluja city. Using imagery from November 2019, REACH and UNITAR sought to assess levels of rehabilitation and identified around 4,278 impacted sites being rehabilitated, reconstructed or constructed.

This atlas therefore presents the scale of damage immediately following the end of military interventions in Falluja with comparisons based on levels of reconstruction/rehabilitation from 2019.

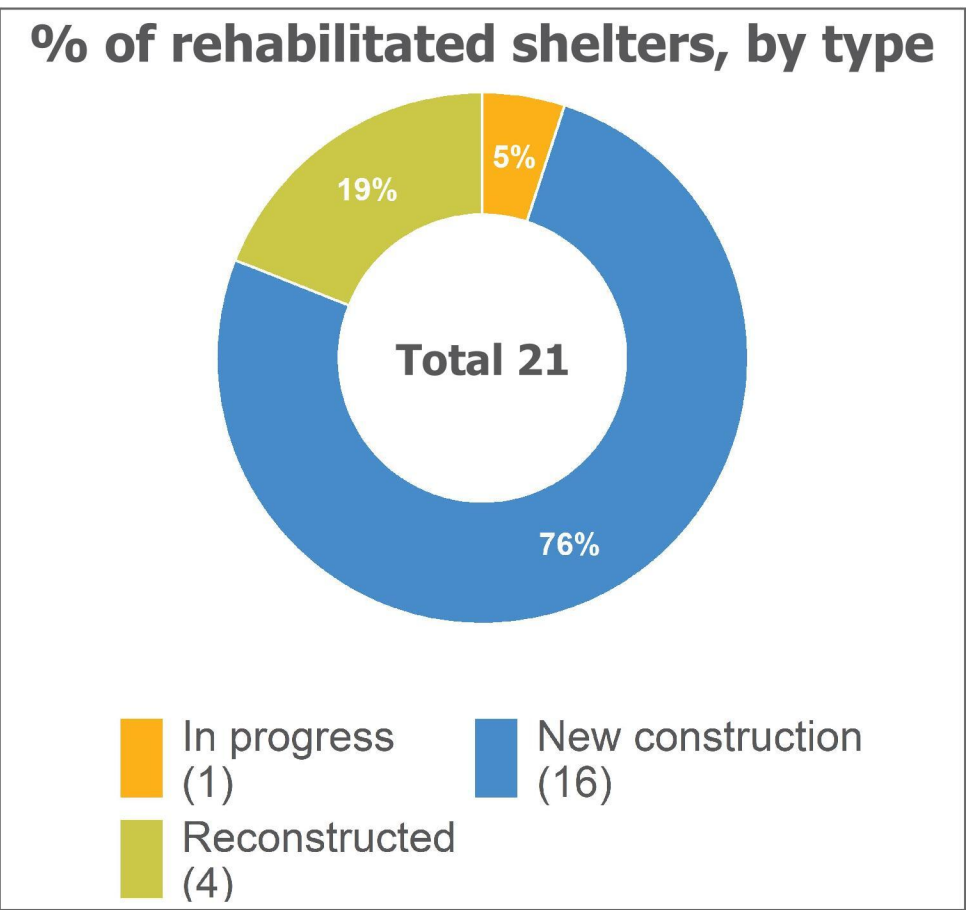
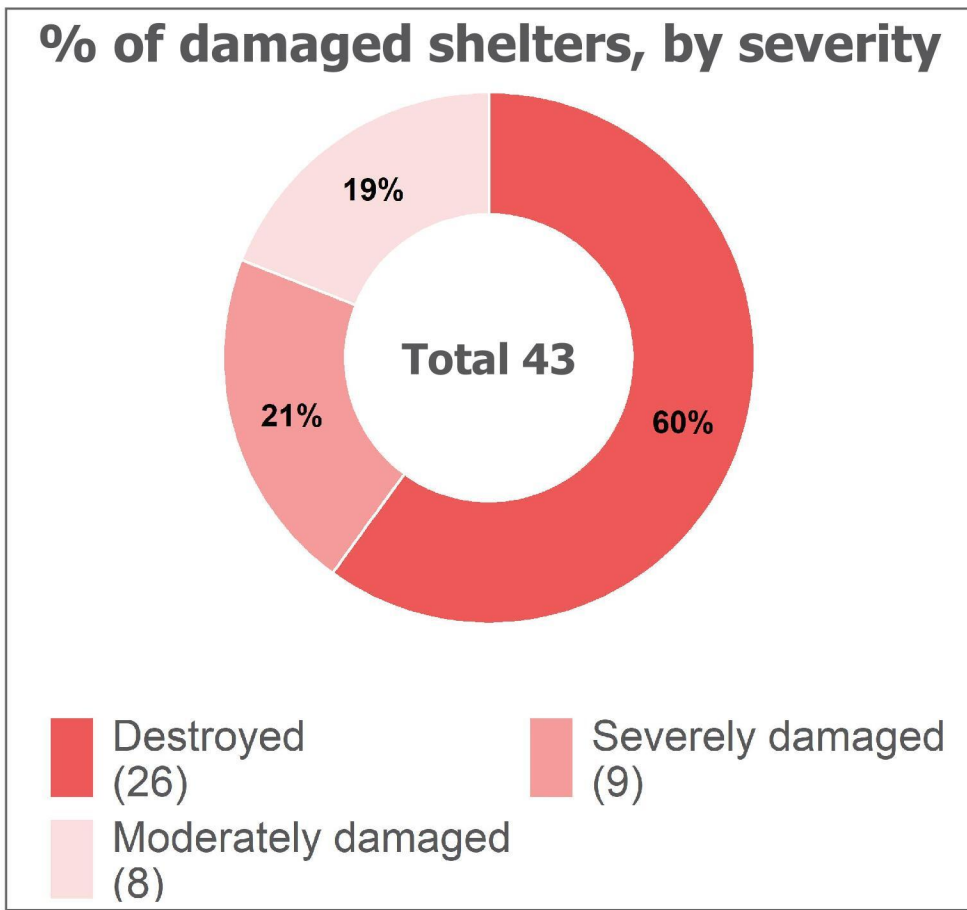
File: Al Jughaify
Map Size: A1

This map shows the percentage of damaged and rehabilitated shelters along with the damage intensity of Al Jughaify neighborhood of Falluja city. Falluja was the first city to fall under the control of the so-called Islamic State of Iraq and the Levant (ISIL) in 2014 and sustained significant damage during the presence of ISIL. After the city was recaptured in mid-2016, REACH Initiative, in partnership with the United Nations Institute for Training and Research's (UNITAR's) satellite application's programme, detected and classified 43 damage structures into three damage levels (destroyed, severely damaged, moderately damaged) of Al Jughaify neighbourhood. Using imagery from November 2019, REACH and UNITAR sought to assess levels of rehabilitation and identified around 21 impacted sites being rehabilitated, reconstructed or constructed within the Al Jughaify neighbourhood of Falluja city.

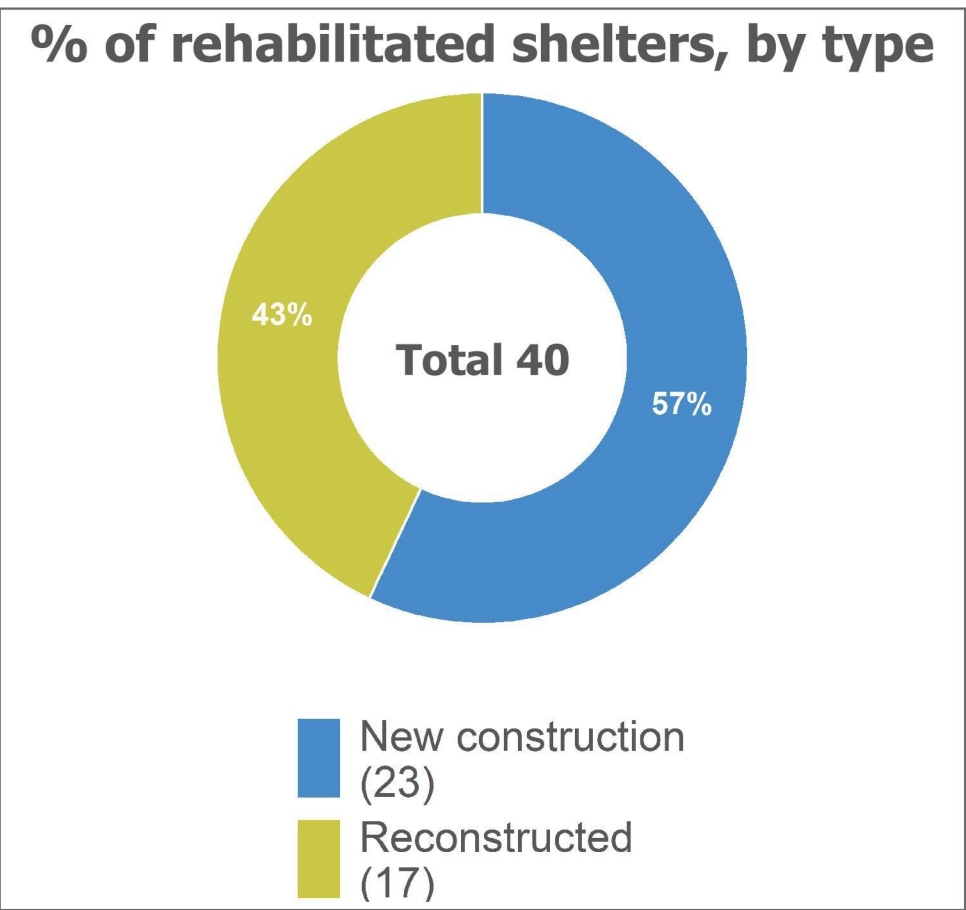
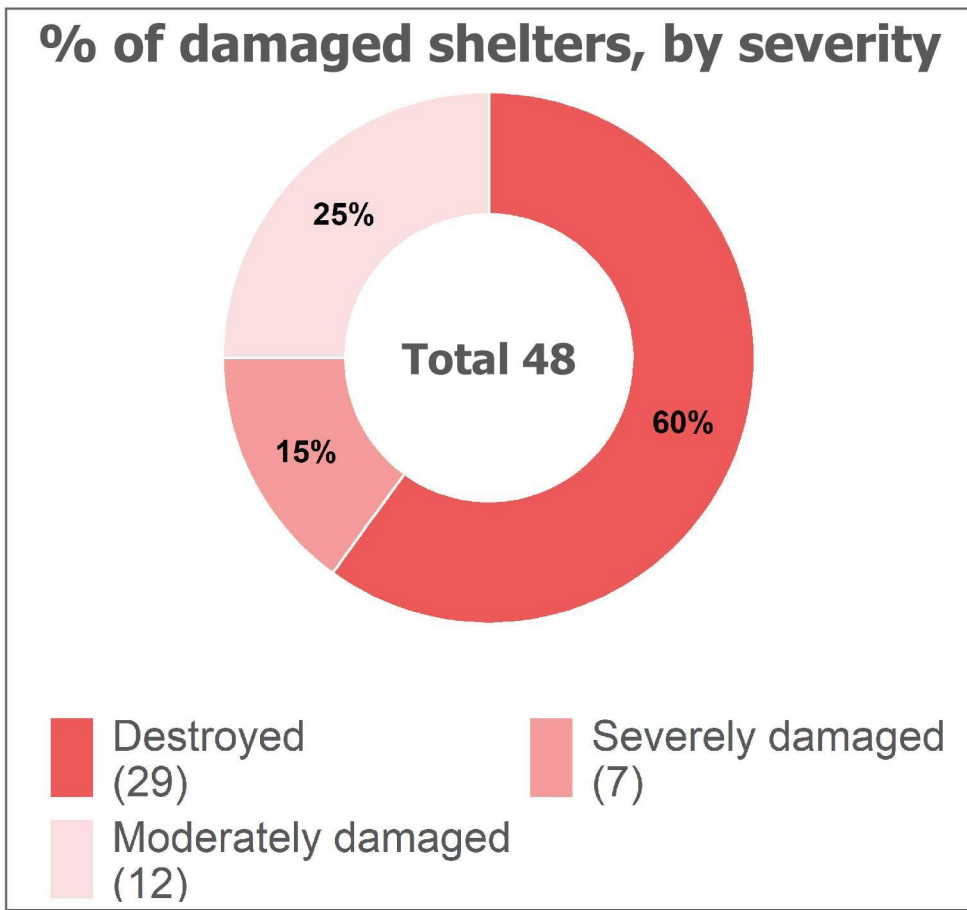
File: Al Shurta
Map Size: A1

This map shows the percentage of damaged and rehabilitated shelters along with the damage intensity of Al Shurta neighborhood of Falluja city. Falluja was the first city to fall under the control of the so-called Islamic State of Iraq and the Levant (ISIL) in 2014 and sustained significant damage during the presence of ISIL. After the city was recaptured in mid-2016, REACH Initiative, in partnership with the United Nations Institute for Training and Research's (UNITAR's) satellite application's programme, detected and classified 48 damage structures into three damage levels (destroyed, severely damaged, moderately damaged) of Al Shurta neighbourhood. Using imagery from November 2019, REACH and UNITAR sought to assess levels of rehabilitation and identified around 40 impacted sites being rehabilitated, reconstructed or constructed within the Al Shurta neighbourhood of Falluja city.

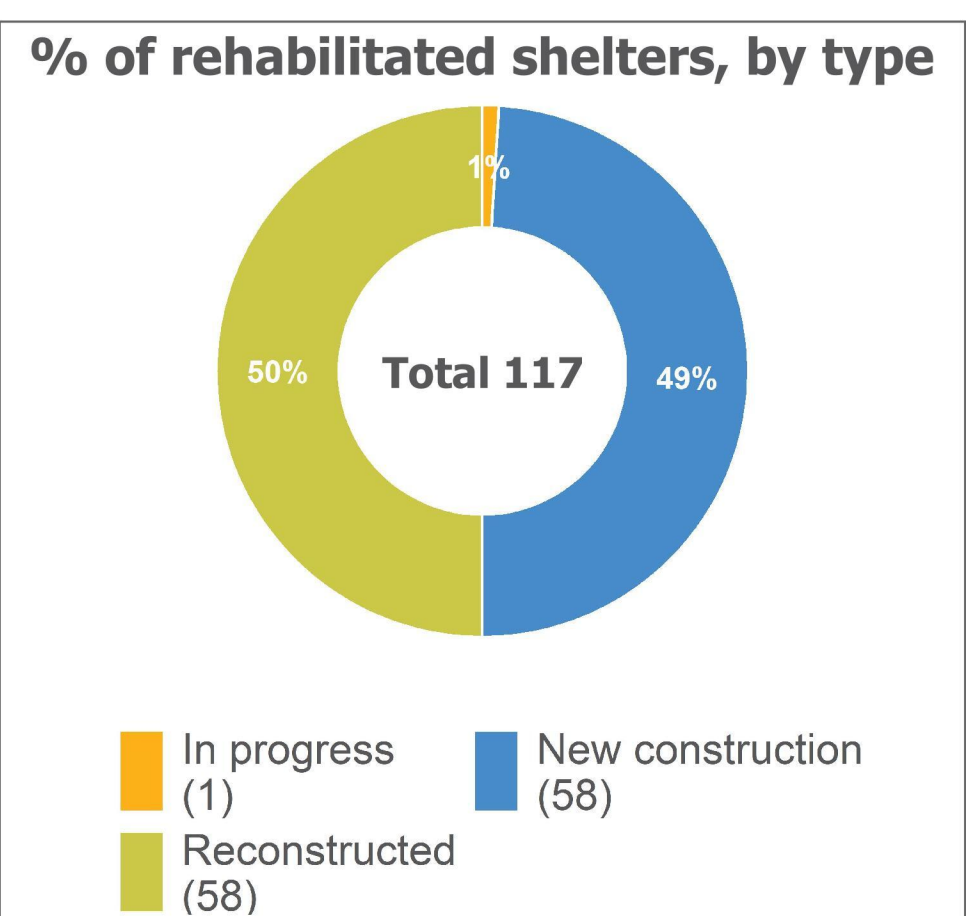
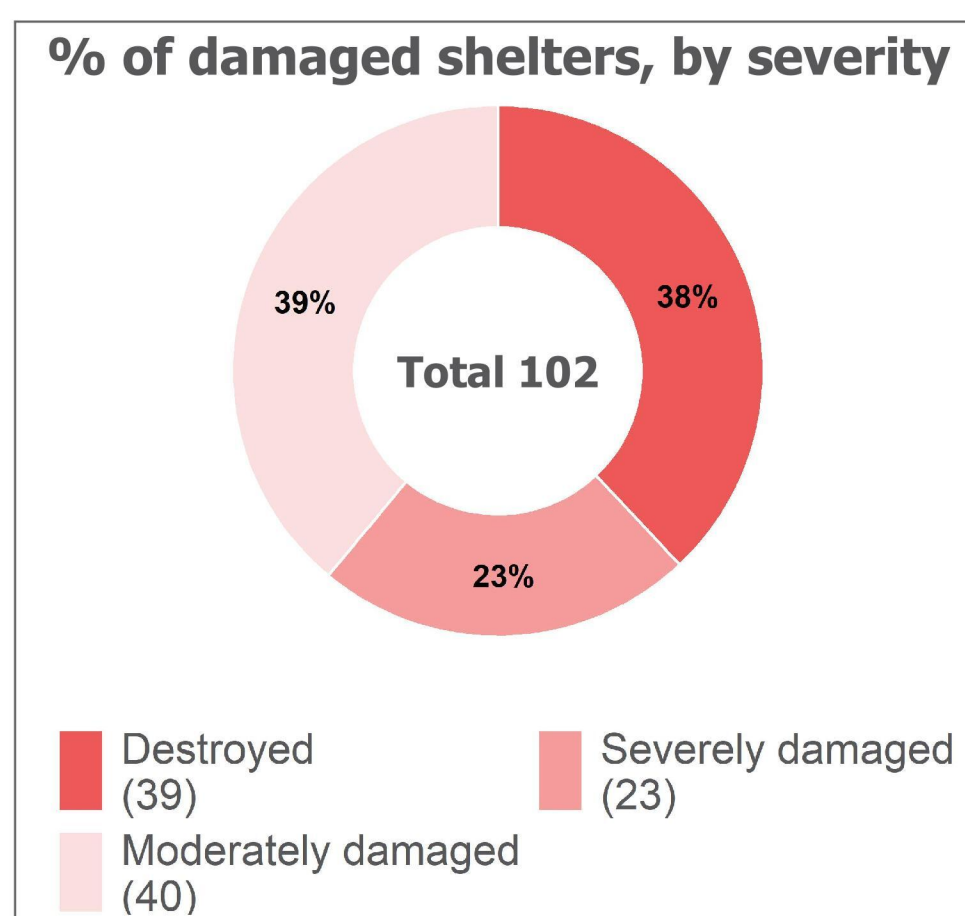
This map shows the percentage of damaged and rehabilitated shelters along with the damage intensity of Al Andalus neighbourhood of Falluja city. Falluja was the first city to fall under the control of the so-called Islamic State of Iraq and the Levant (ISIL) in 2014 and sustained significant damage during the presence of ISIL. After the city was recaptured in mid-2016, REACH Initiative, in partnership with the United Nations Institute for Training and Research's (UNITAR's) satellite application's programme, detected and classified 102 damage structures into three damage levels (destroyed, severely damaged, moderately damaged) of Al Andalus neighbourhood. Using imagery from November 2019, REACH and UNITAR sought to assess levels of rehabilitation and identified around 117 impacted sites being rehabilitated, reconstructed or constructed within the Al Andalus neighbourhood of Falluja city.

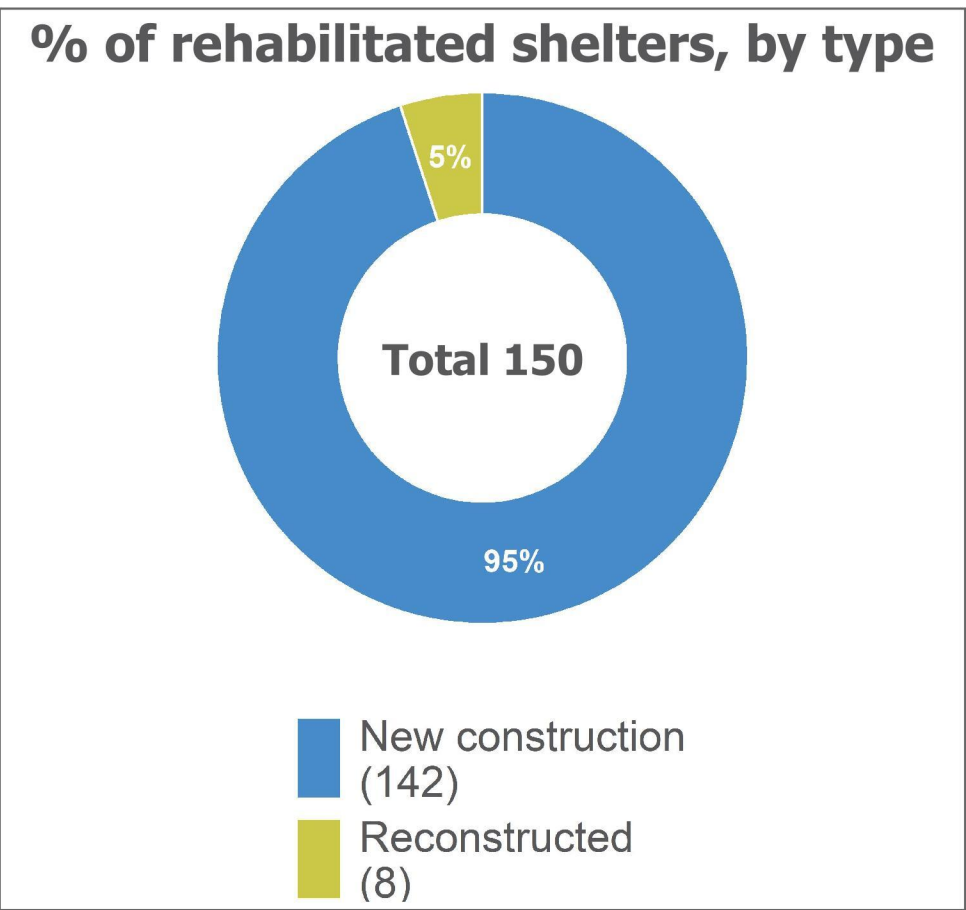
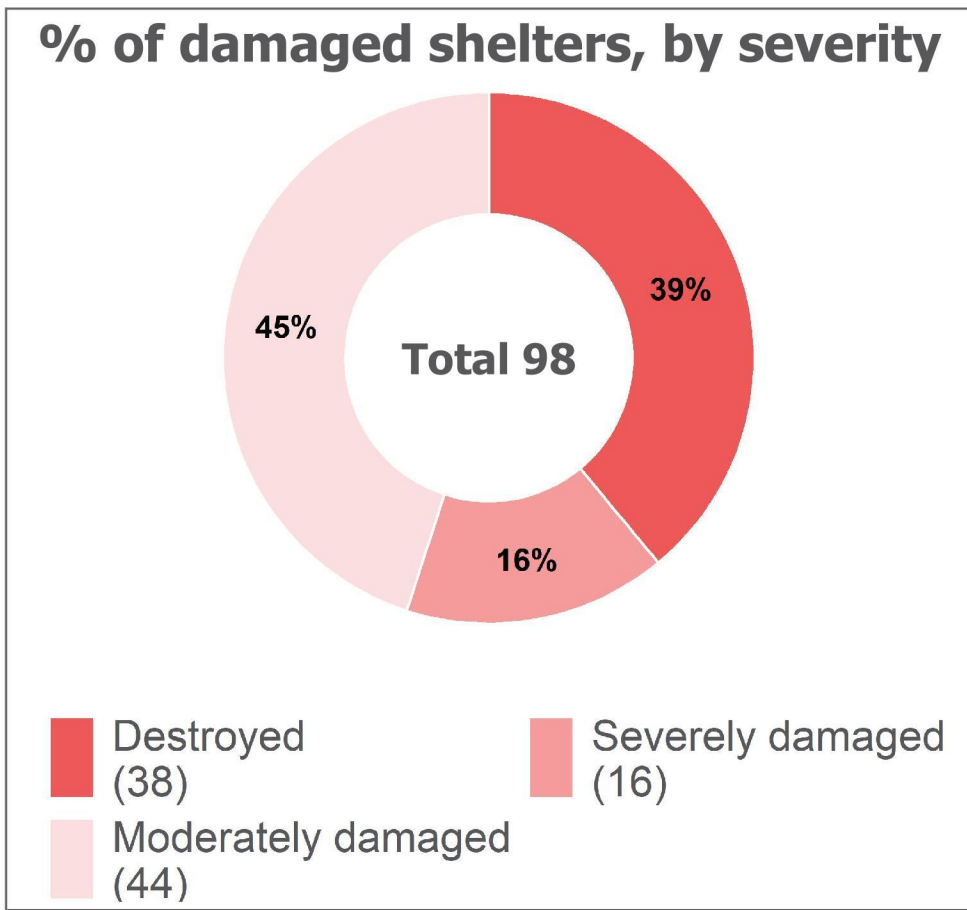
File: Al Sakaniya
Map Size: A1

This map shows the percentage of damaged and rehabilitated shelters along with the damage intensity of Al Sakaniya neighborhood of Falluja city. Falluja was the first city to fall under the control of the so-called Islamic State of Iraq and the Levant (ISIL) in 2014 and sustained significant damage during the presence of ISIL. After the city was recaptured in mid-2016, REACH Initiative, in partnership with the United Nations Institute for Training and Research's (UNITAR's) satellite application's programme, detected and classified 98 damage structures into three damage levels (destroyed, severely damaged, moderately damaged) of Al Sakaniya neighbourhood. Using imagery from November 2019, REACH and UNITAR sought to assess levels of rehabilitation and identified around 150 impacted sites being rehabilitated, reconstructed or constructed within the Al Sakaniya neighbourhood of Falluja city.

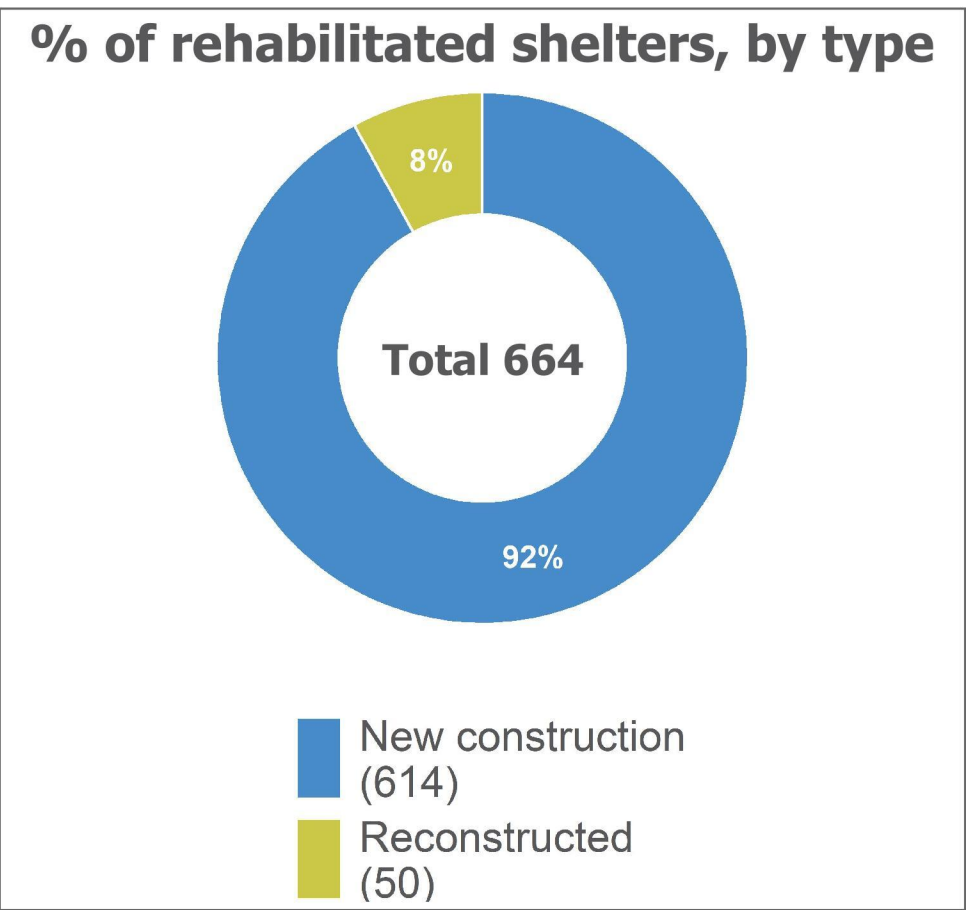
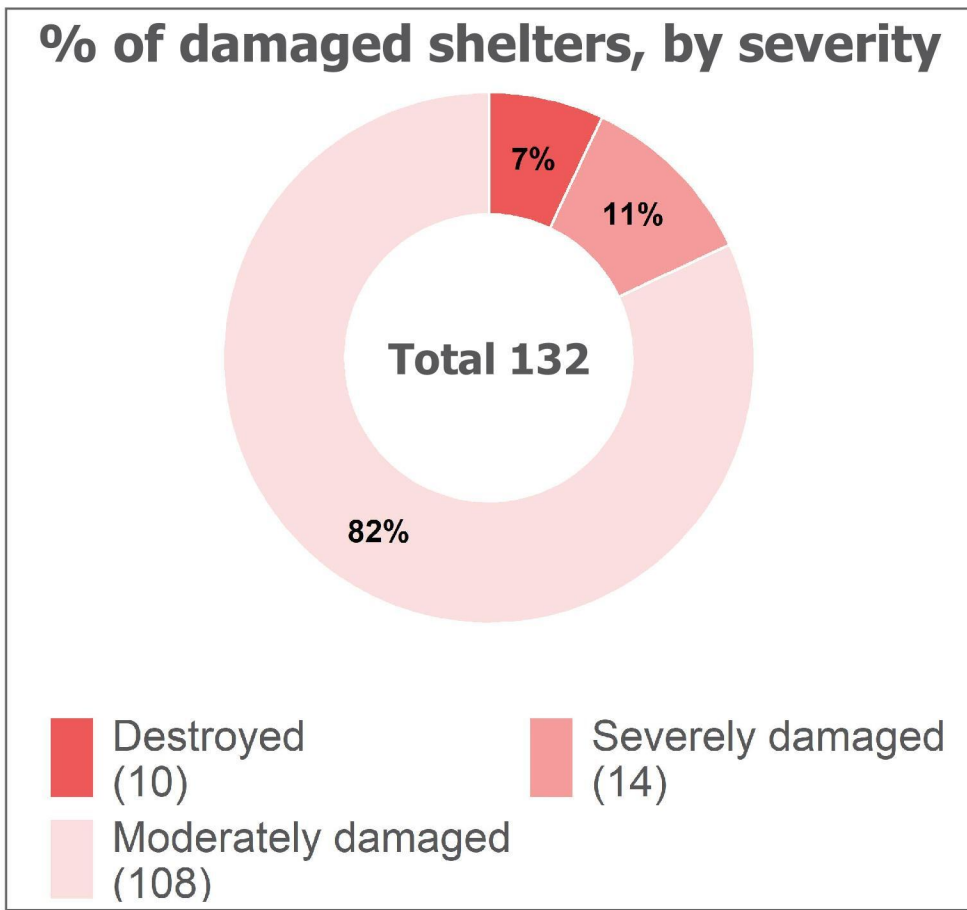
File: Al Jughaify 2
Map Size: A1

This map shows the percentage of damaged and rehabilitated shelters along with the damage intensity of Al Jughaify 2 neighborhood of Falluja city. Falluja was the first city to fall under the control of the so-called Islamic State of Iraq and the Levant (ISIL) in 2014 and sustained significant damage during the presence of ISIL. After the city was recaptured in mid-2016, REACH Initiative, in partnership with the United Nations Institute for Training and Research's (UNITAR's) satellite application's programme, detected and classified 132 damage structures into three damage levels (destroyed, severely damaged, moderately damaged) of Al Jughaify 2 neighbourhood. Using imagery from November 2019, REACH and UNITAR sought to assess levels of rehabilitation and identified around 664 impacted sites being rehabilitated, reconstructed or constructed within the Al Jughaify 2 neighbourhood of Falluja city.

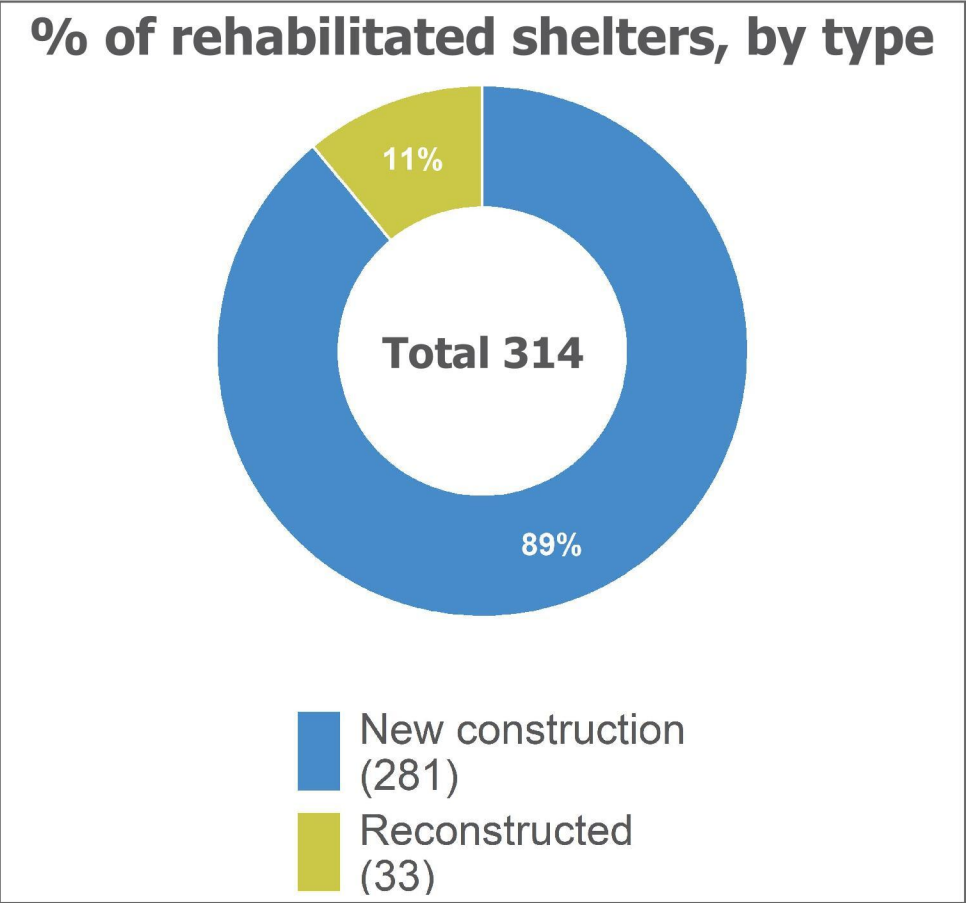
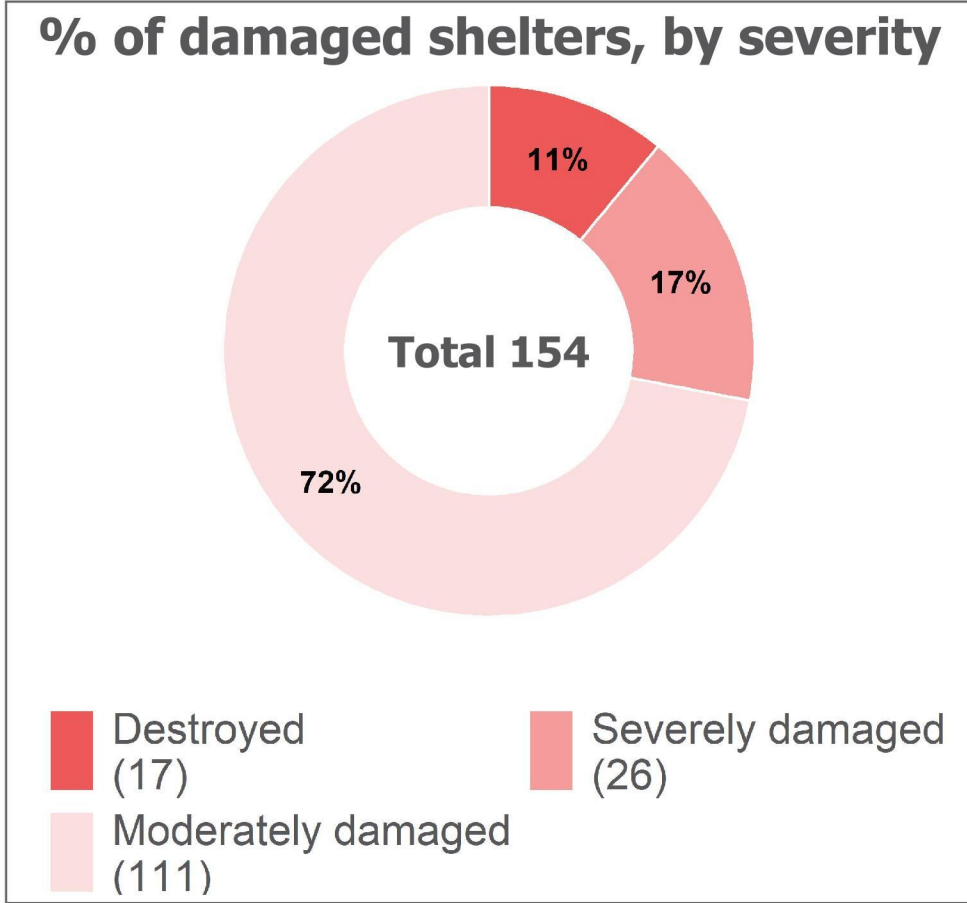
File: Al Mukhtar
Map Size: A1

This map shows the percentage of damaged and rehabilitated shelters along with the damage intensity of Al Mukhtar neighborhood of Falluja city. Falluja was the first city to fall under the control of the so-called Islamic State of Iraq and the Levant (ISIL) in 2014 and sustained significant damage during the presence of ISIL. After the city was recaptured in mid-2016, REACH Initiative, in partnership with the United Nations Institute for Training and Research's (UNITAR's) satellite application's programme, detected and classified 154 damage structures into three damage levels (destroyed, severely damaged, moderately damaged) of Al Mukhtar neighbourhood. Using imagery from November 2019, REACH and UNITAR sought to assess levels of rehabilitation and identified around 314 impacted sites being rehabilitated, reconstructed or constructed within the Al Mukhtar neighbourhood of Falluja city.

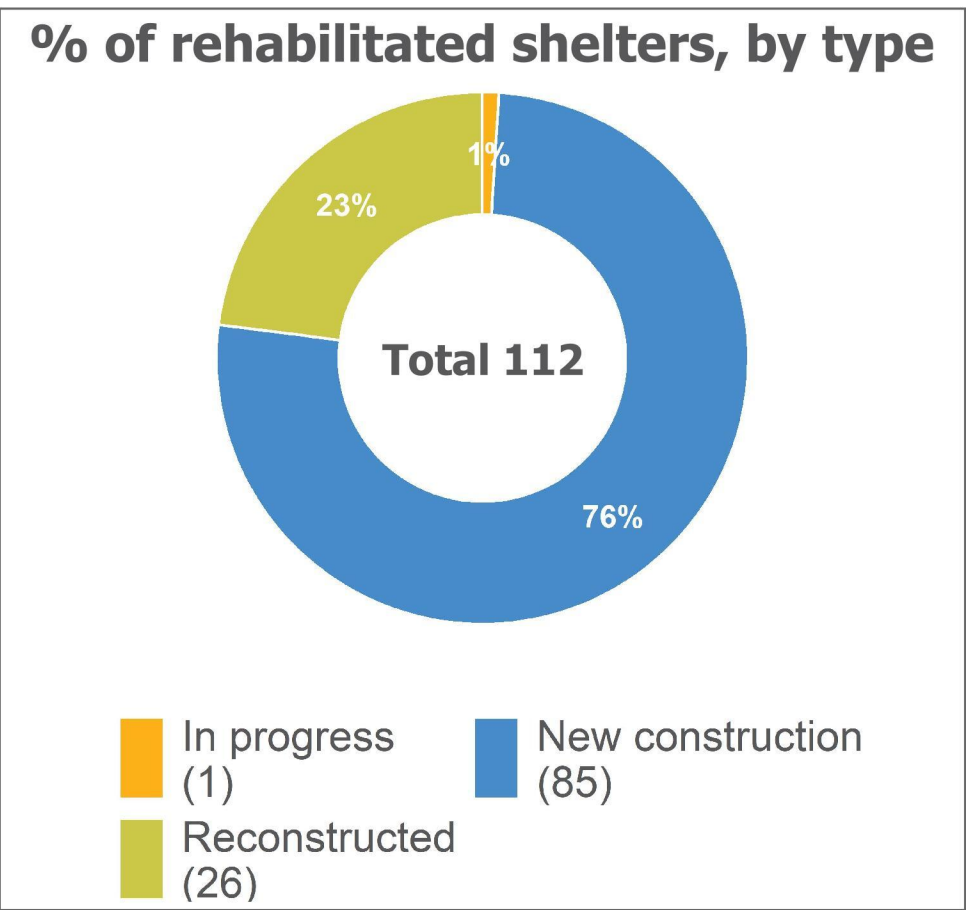
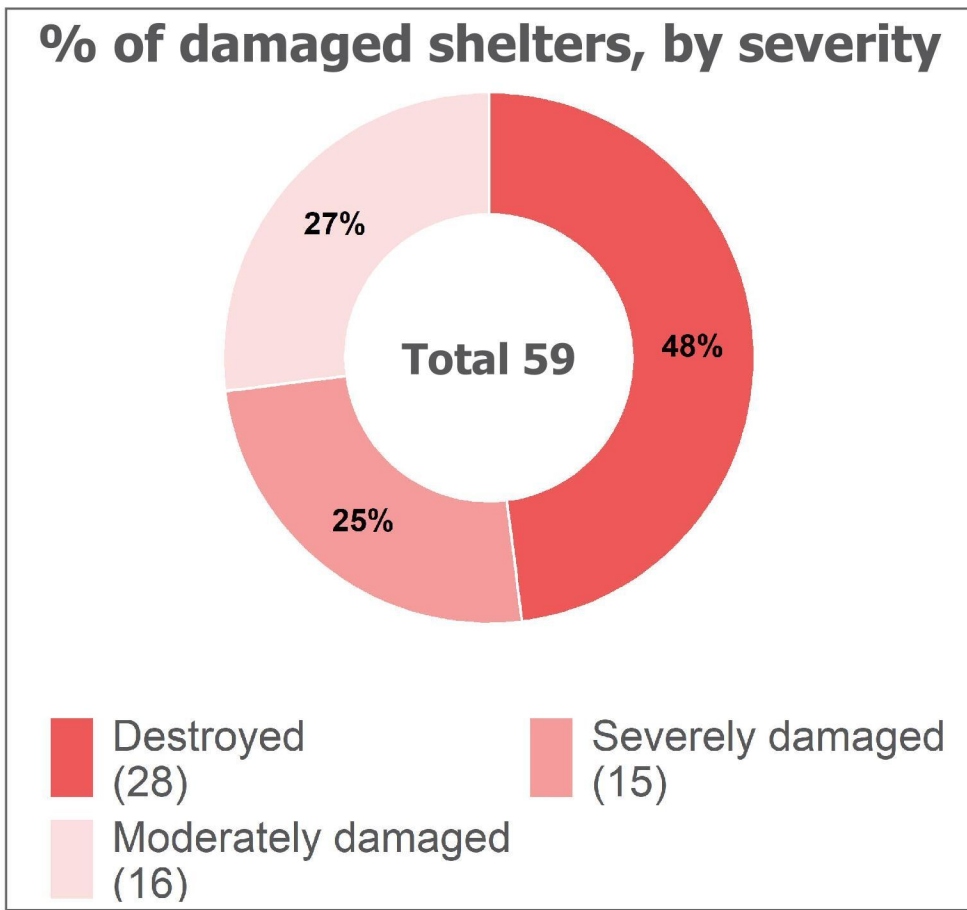
File: Al Askary
Map Size: A1

This map shows the percentage of damaged and rehabilitated shelters along with the damage intensity of Al Askary neighborhood of Falluja city. Falluja was the first city to fall under the control of the so-called Islamic State of Iraq and the Levant (ISIL) in 2014 and sustained significant damage during the presence of ISIL. After the city was recaptured in mid-2016, REACH Initiative, in partnership with the United Nations Institute for Training and Research's (UNITAR's) satellite application's programme, detected and classified 59 damage structures into three damage levels (destroyed, severely damaged, moderately damaged) of Al Askary neighbourhood. Using imagery from November 2019, REACH and UNITAR sought to assess levels of rehabilitation and identified around 112 impacted sites being rehabilitated, reconstructed or constructed within the Al Askary neighbourhood of Falluja city.

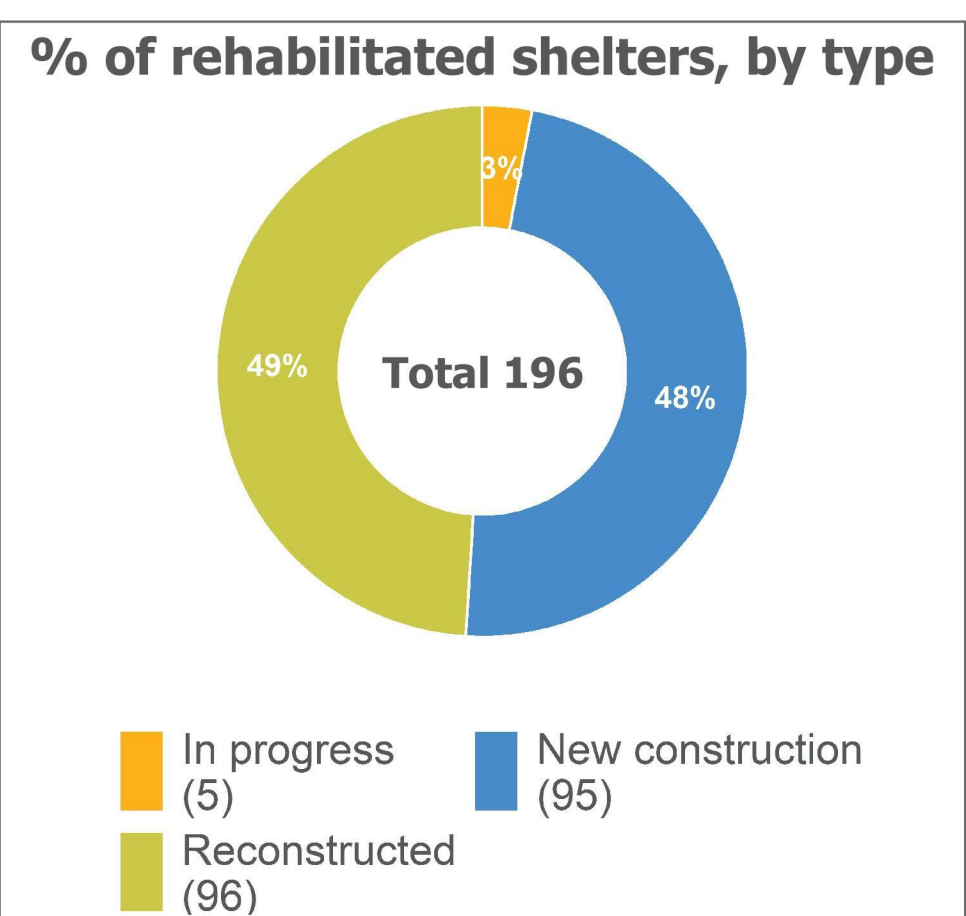
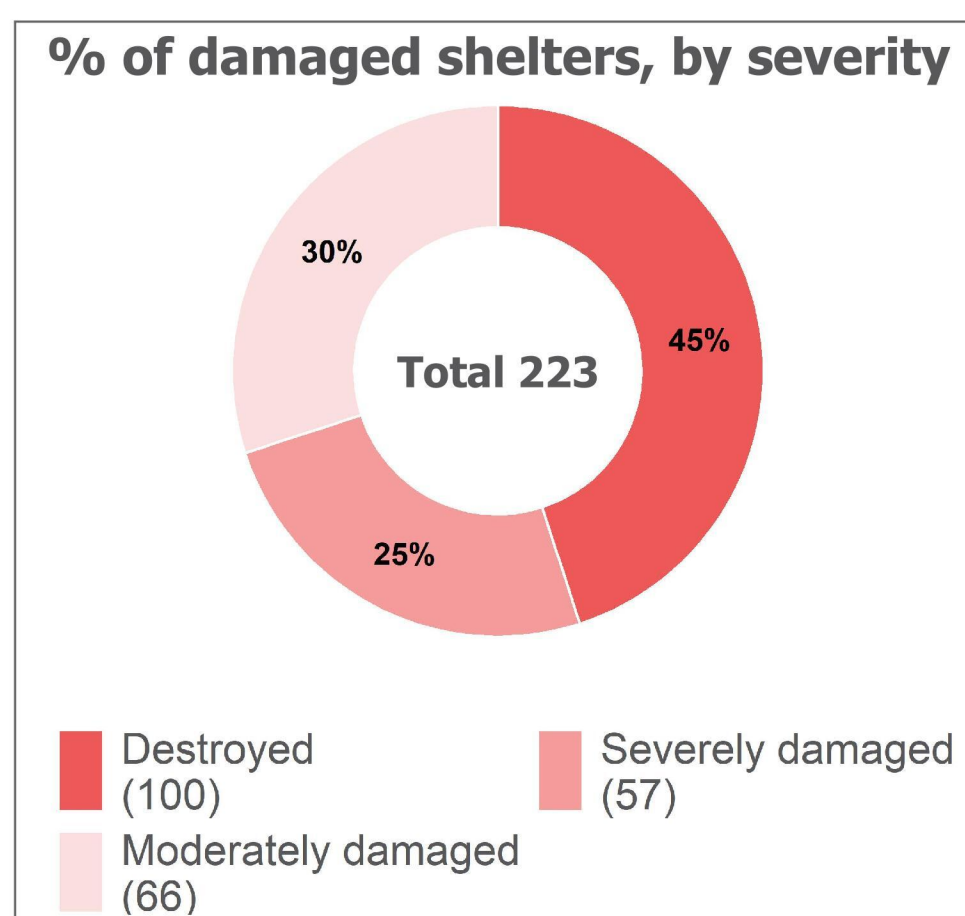
Al Dhubat

This map shows the percentage of damaged and rehabilitated shelters along with the damage intensity of Al Dhuhair neighbourhood of Falluja city. Falluja was the first city to fall under the control of the so-called Islamic State of Iraq and the Levant (ISIL) in 2014 and sustained significant damage during the presence of ISIL. After the city was recaptured in mid-2016, REACH Initiative, in partnership with the United Nations Institute for Training and Research's (UNITAR's) satellite application programme, detected and classified 223 damage structures into three damage levels (destroyed, severely damaged, moderately damaged) of Al Dhuhair neighbourhood. Using imagery from November 2019, REACH and UNITAR sought to assess levels of rehabilitation and identified around 196 impacted sites being rehabilitated, reconstructed or constructed within the Al Dhuhair neighbourhood of Falluja city.

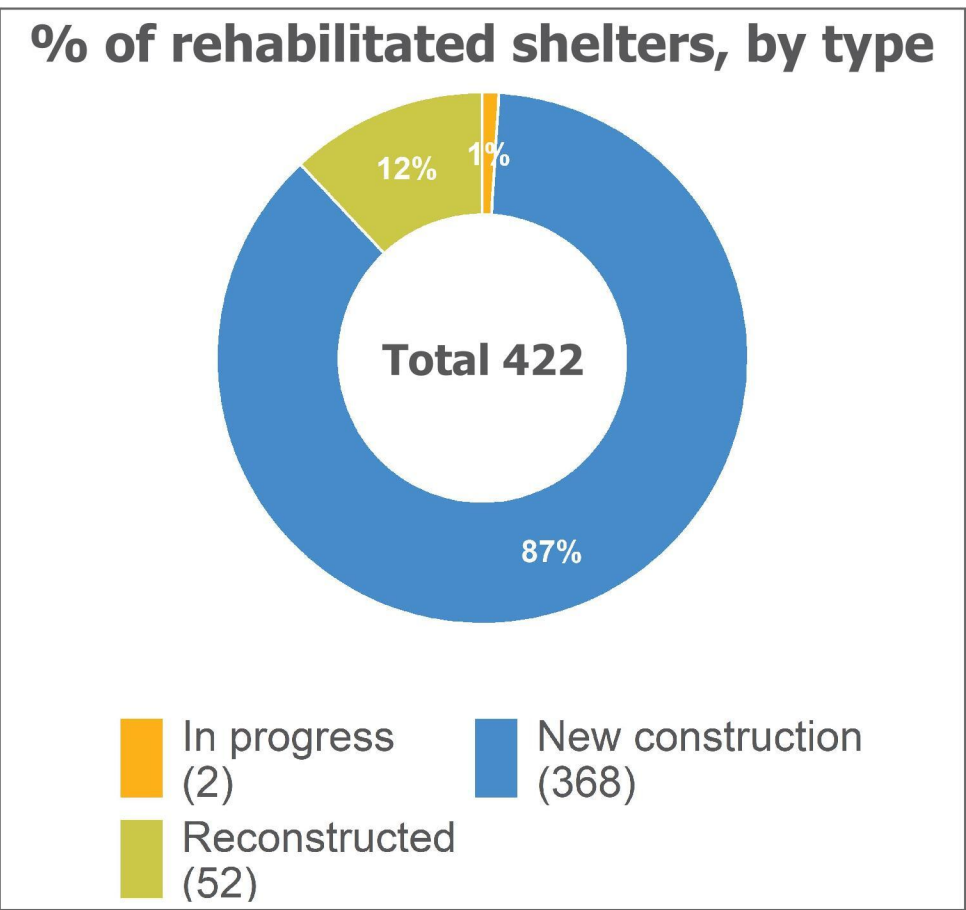
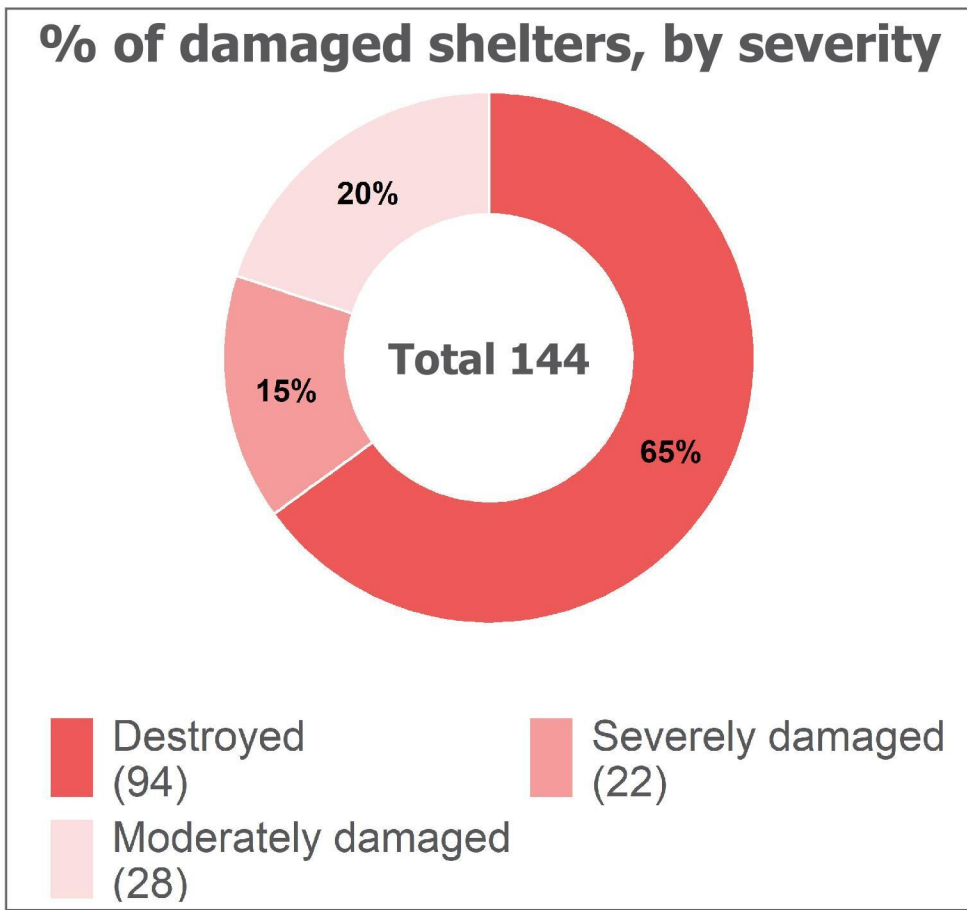
This map shows the percentage of damaged and rehabilitated shelters along with the damage intensity of Shuhada Dhubat neighborhood of Falluja city. Falluja was the first city to fall under the control of the so-called Islamic State of Iraq and the Levant (ISIL) in 2014 and sustained significant damage during the presence of ISIL. After the city was recaptured in mid-2016, REACH Initiative, in partnership with the United Nations Institute for Training and Research's (UNITAR's) satellite application's programme, detected and classified 144 damage structures into three damage levels (destroyed, severely damaged, moderately damaged) of Shuhada Dhubat neighbourhood. Using imagery from November 2019, REACH and UNITAR sought to assess levels of rehabilitation and identified around 422 impacted sites being rehabilitated, reconstructed or constructed within the Shuhada Dhubat neighbourhood of Falluja city.

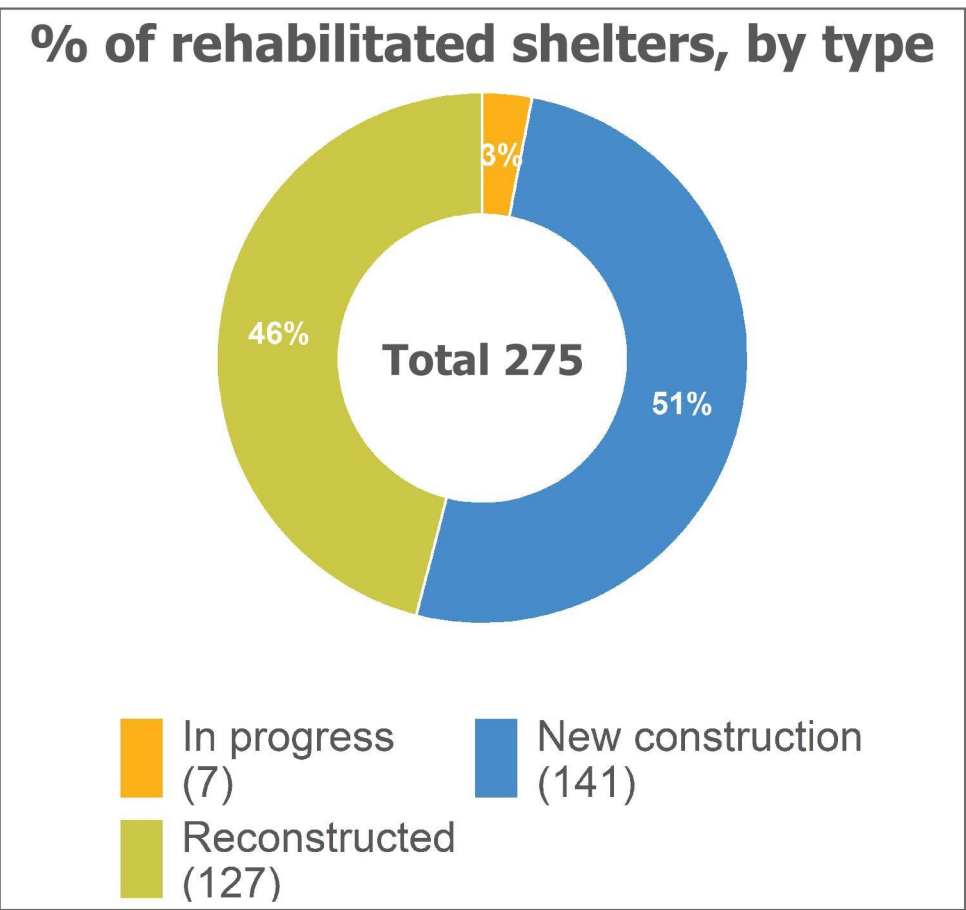
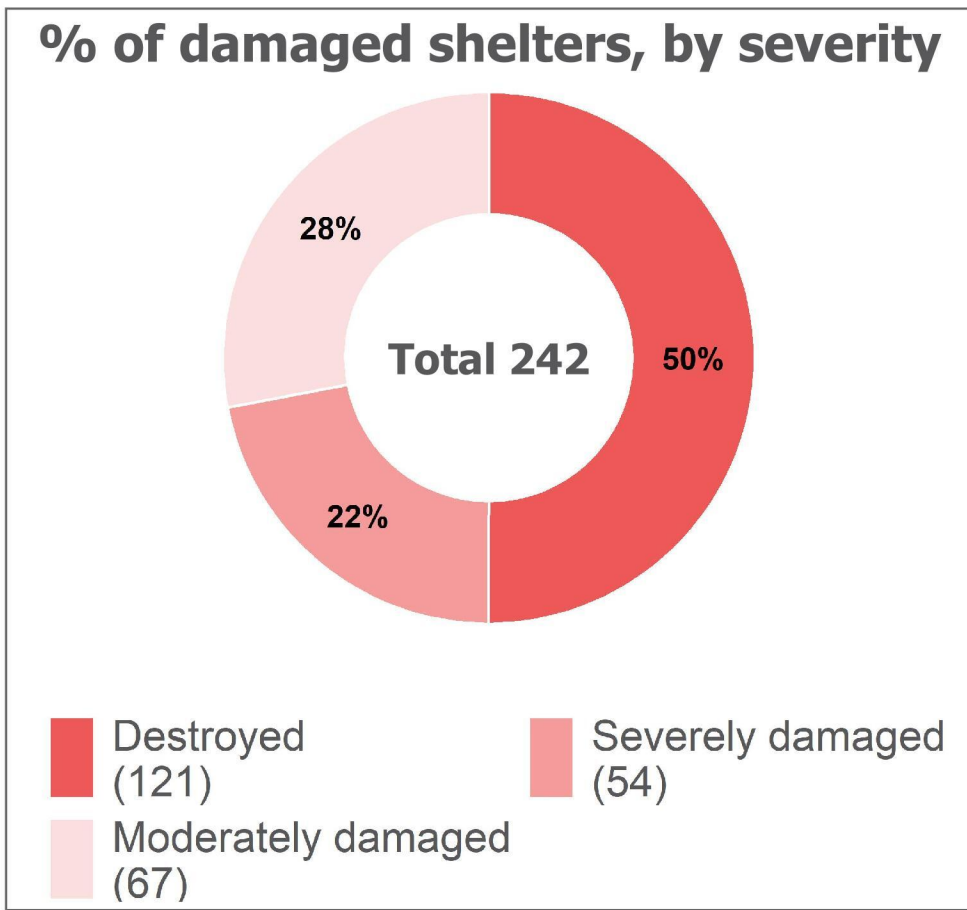
This map shows the percentage of damaged and rehabilitated shelters along with the damage intensity of Al Shuhada neighborhood of Falluja city. Falluja was the first city to fall under the control of the so-called Islamic State of Iraq and the Levant (ISIL) in 2014 and sustained significant damage during the presence of ISIL. After the city was recaptured in mid-2016, REACH Initiative, in partnership with the United Nations Institute for Training and Research's (UNITAR's) satellite application's programme, detected and classified 242 damage structures into three damage levels (destroyed, severely damaged, moderately damaged) of Al Shuhada neighbourhood. Using imagery from November 2019, REACH and UNITAR sought to assess levels of rehabilitation and identified around 275 impacted sites being rehabilitated, reconstructed or constructed within the Al Shuhada neighbourhood of Falluja city.
