SHELTER DAMAGE ATLAS

Falluja City

Shelter Damage Reference Maps

Iraq Shelter Damage Atlas: Satellite Detected Damage, Falluja City

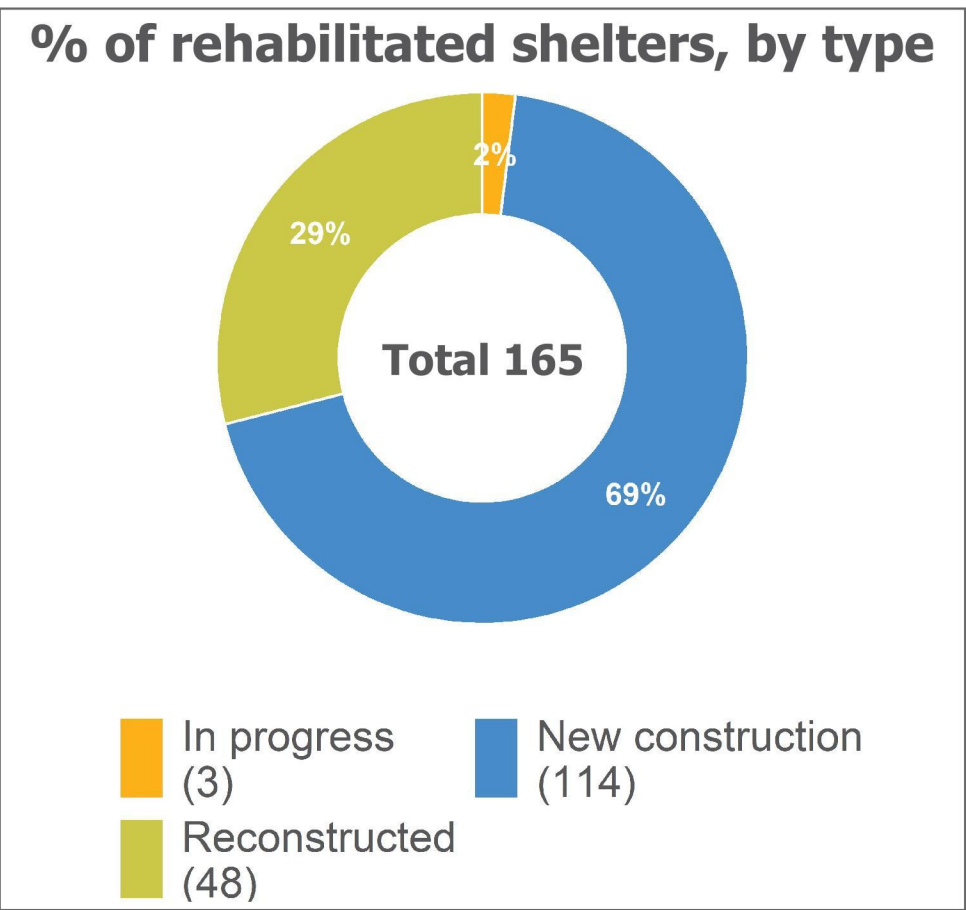
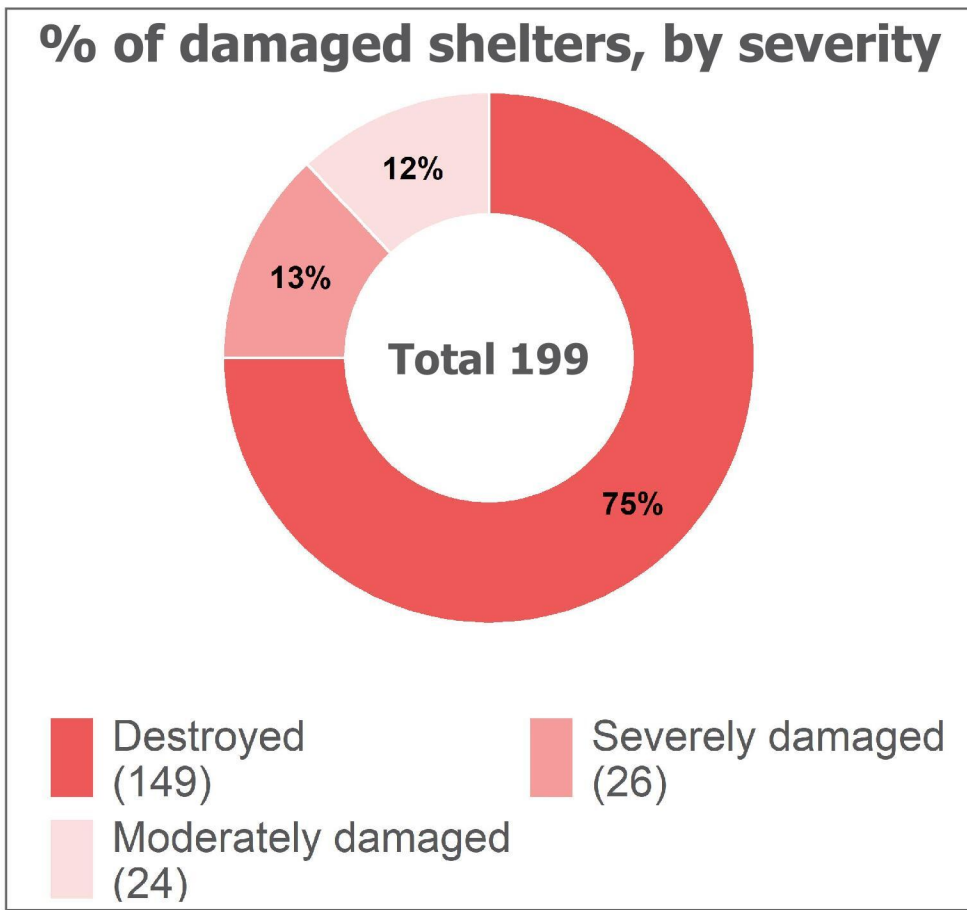
This map shows the percentage of damaged and rehabilitated shelters along with the damage intensity of Al Muhandeseen neighborhood of Falluja city. Falluja was the first city to fall under the control of the so-called Islamic State of Iraq and the Levant (ISIL) in 2014 and sustained significant damage during the presence of ISIL. After the city was recaptured in mid-2016, REACH Initiative, in partnership with the United Nations Institute for Training and Research's (UNITAR's) satellite application's programme, detected and classified 199 damage structures into three damage levels (destroyed, severely damaged, moderately damaged) of Al Muhandeseen neighbourhood. Using imagery from November 2019, REACH and UNITAR sought to assess levels of rehabilitation and identified around 165 impacted sites being rehabilitated, reconstructed or constructed within the Al Muhandeseen neighbourhood of Falluja city.

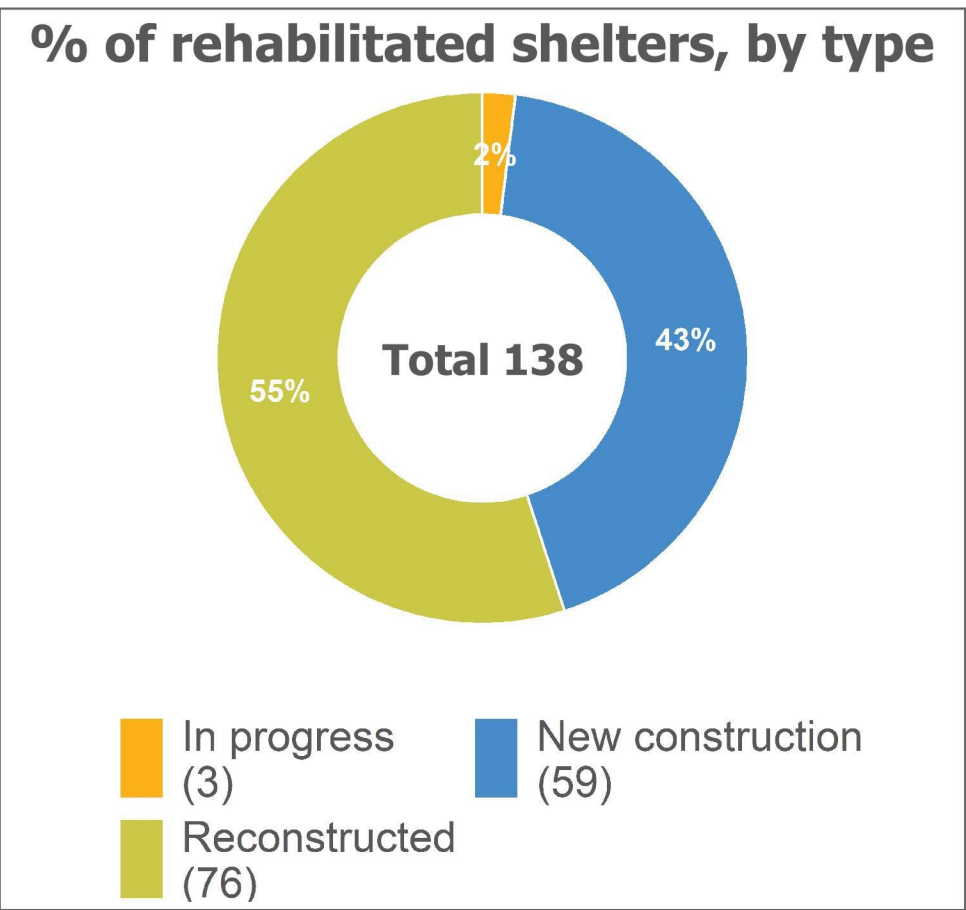
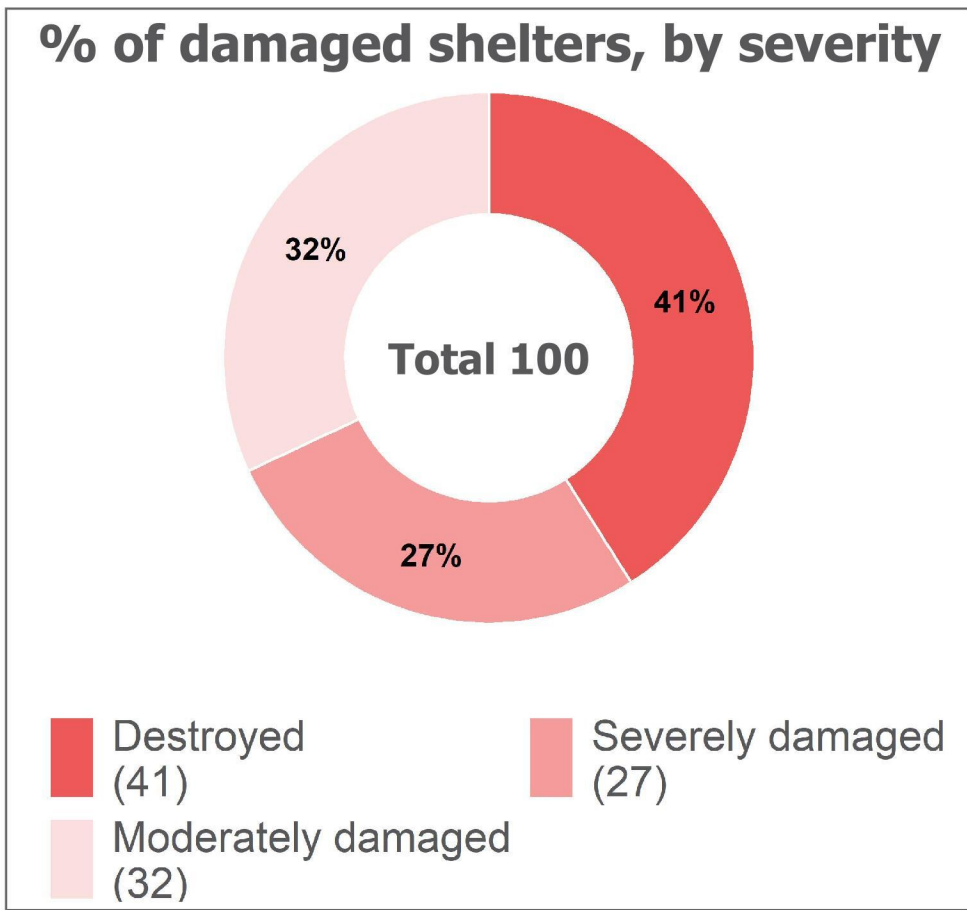
This map shows the percentage of damaged and rehabilitated shelters along with the damage intensity of Al-Jamuriya, Rusafi & Muatasem neighborhood of Falluja city. Falluja was the first city to fall under the control of the so-called Islamic State of Iraq and the Levant (ISIL) in 2014 and sustained significant damage during the presence of ISIL. After the city was recaptured in mid-2016, REACH Initiative, in partnership with the United Nations Institute for Training and Research's (UNITAR's) satellite application's programme, detected and classified 100 damage structures into three damage levels (destroyed, severely damaged, moderately damaged) of Al-Jamuriya, Rusafi & Muatasem neighbourhood. Using imagery from November 2019, REACH and UNITAR sought to assess levels of rehabilitation and identified around 138 impacted sites being rehabilitated, reconstructed or constructed within the Al-Jamuriya, Rusafi & Muatasem neighbourhood of Falluja city.

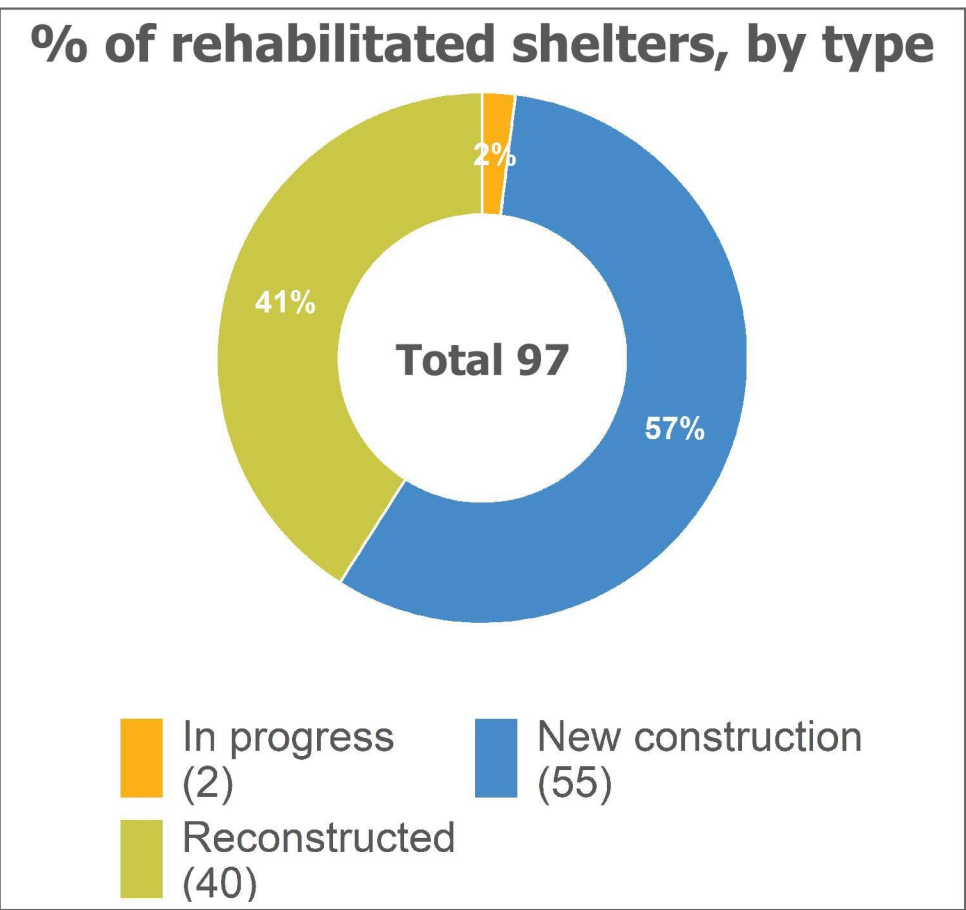
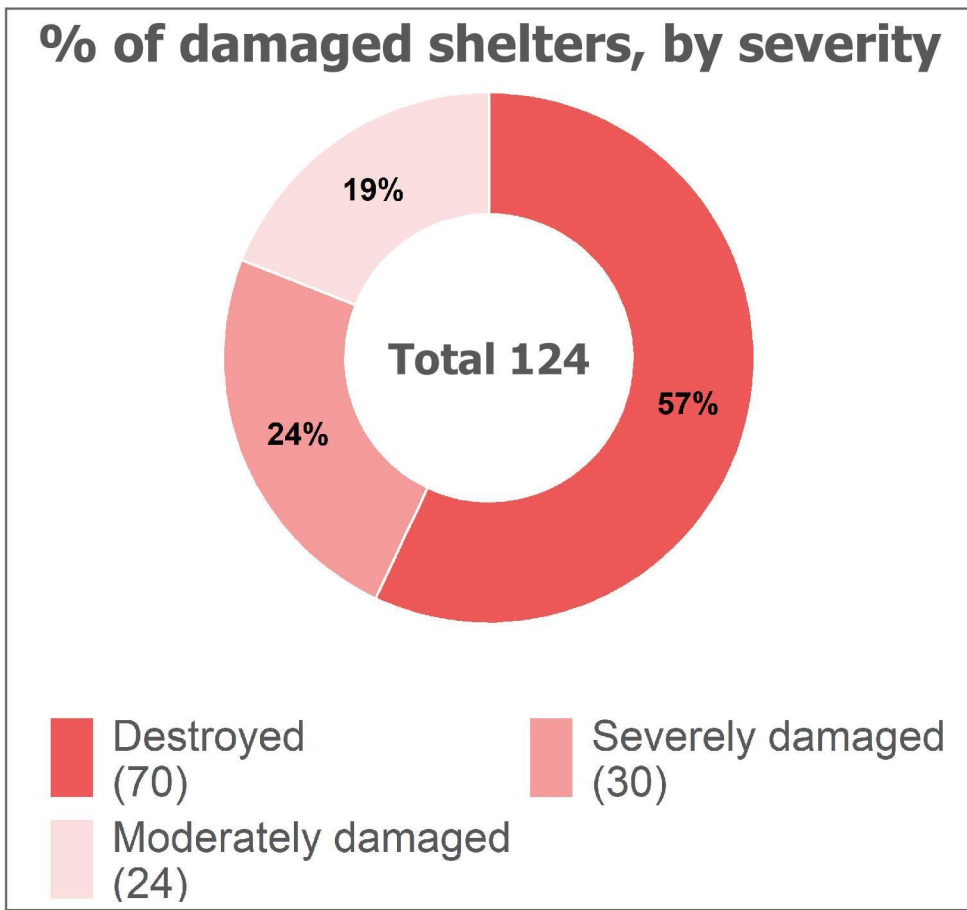
This map shows the percentage of damaged and rehabilitated shelters along with the damage intensity of Al Mualmeen neighborhood of Falluja city. Falluja was the first city to fall under the control of the so-called Islamic State of Iraq and the Levant (ISIL) in 2014 and sustained significant damage during the presence of ISIL. After the city was recaptured in mid-2016, REACH Initiative, in partnership with the United Nations Institute for Training and Research's (UNITAR's) satellite application's programme, detected and classified 124 damage structures into three damage levels (destroyed, severely damaged, moderately damaged) of Al Mualmeen neighbourhood. Using imagery from November 2019, REACH and UNITAR sought to assess levels of rehabilitation and identified around 97 impacted sites being rehabilitated, reconstructed or constructed within the Al Mualmeen neighbourhood of Falluja city.

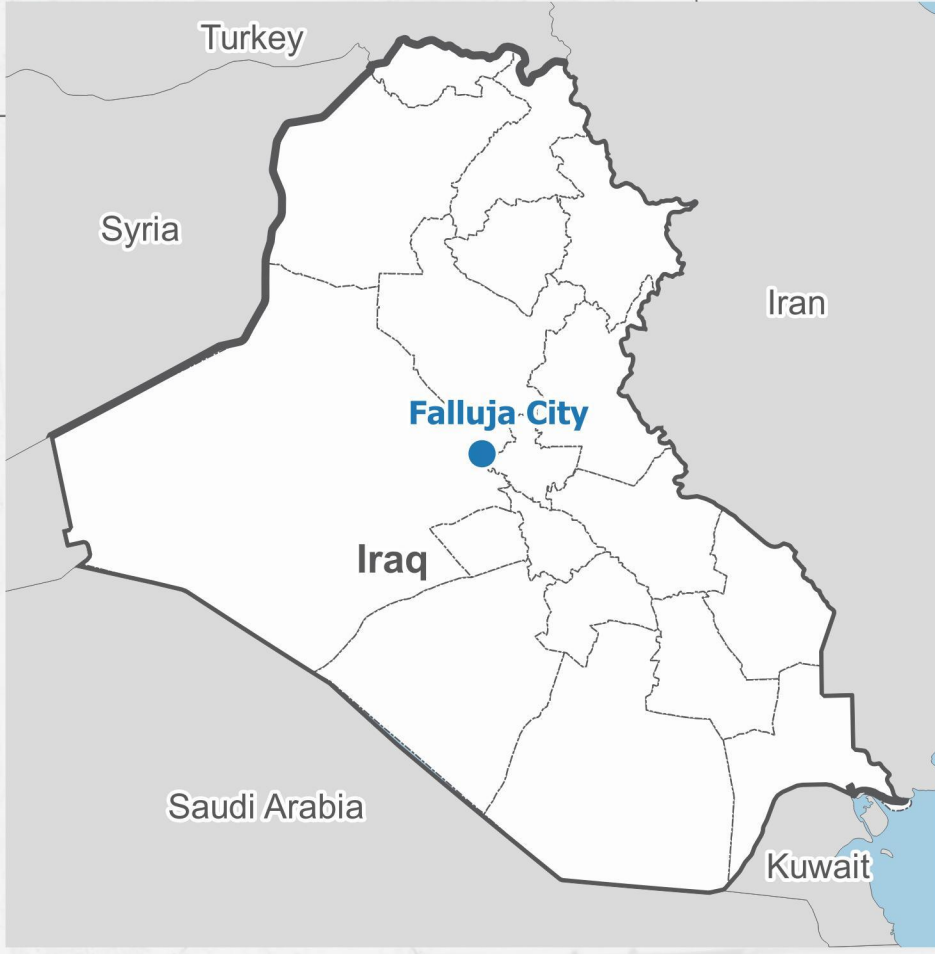
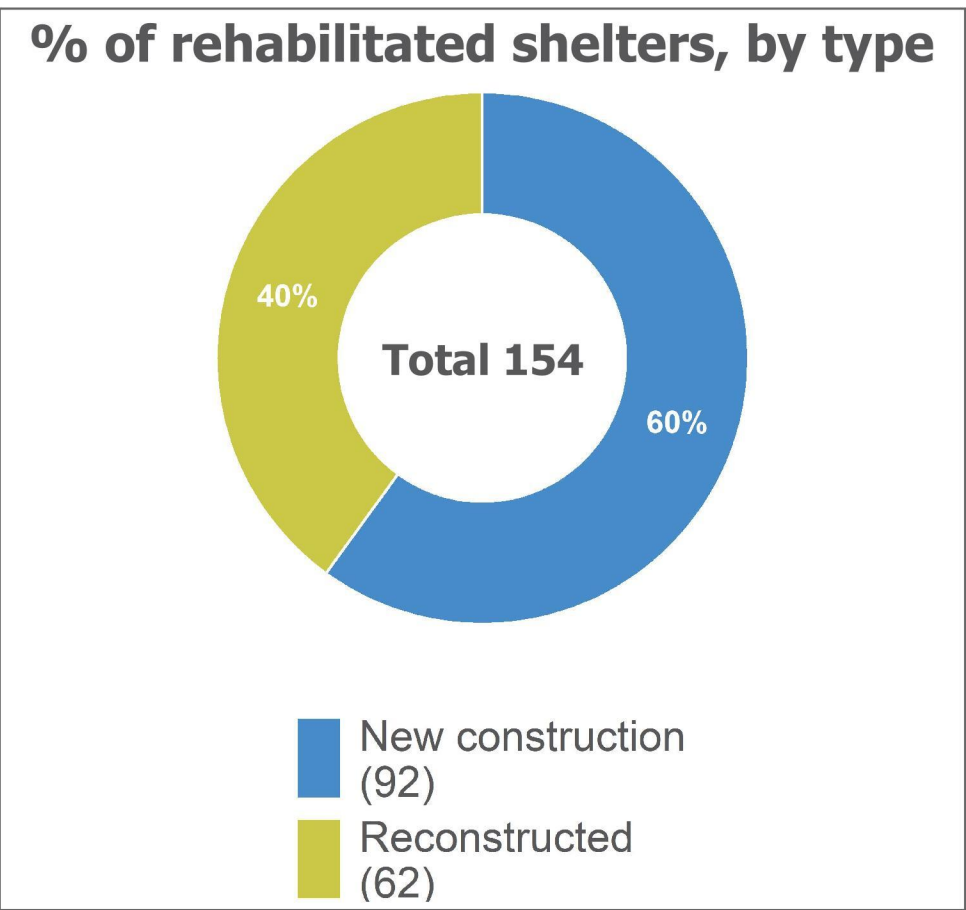
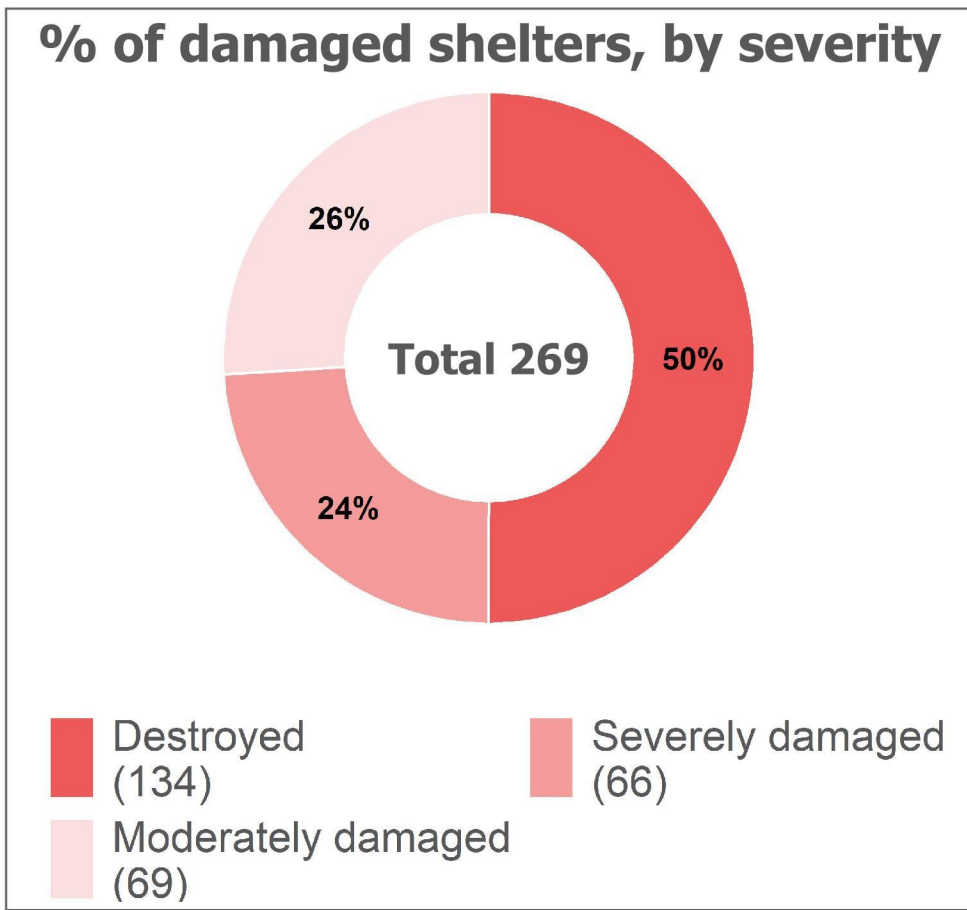
This map shows the percentage of damaged and rehabilitated shelters along with the damage intensity of Industrial area neighborhood of Falluja city. Falluja was the first city to fall under the control of the so-called Islamic State of Iraq and the Levant (ISIL) in 2014 and sustained significant damage during the presence of ISIL. After the city was recaptured in mid-2016, REACH Initiative, in partnership with the United Nations Institute for Training and Research's (UNITAR's) satellite application's programme, detected and classified 269 damage structures into three damage levels (destroyed, severely damaged, moderately damaged) of Industrial area neighbourhood. Using imagery from November 2019, REACH and UNITAR sought to assess levels of rehabilitation and identified around 154 impacted sites being rehabilitated, reconstructed or constructed within the Industrial area neighbourhood of Falluja city.
