BANGLADESH - Rohingya Refugee Crisis - Cox's Bazar District

Camp 1E - Handpump and Tubewell Proximity to Latrines

For Humanitarian Purposes Only
Production date: 14 March 2018

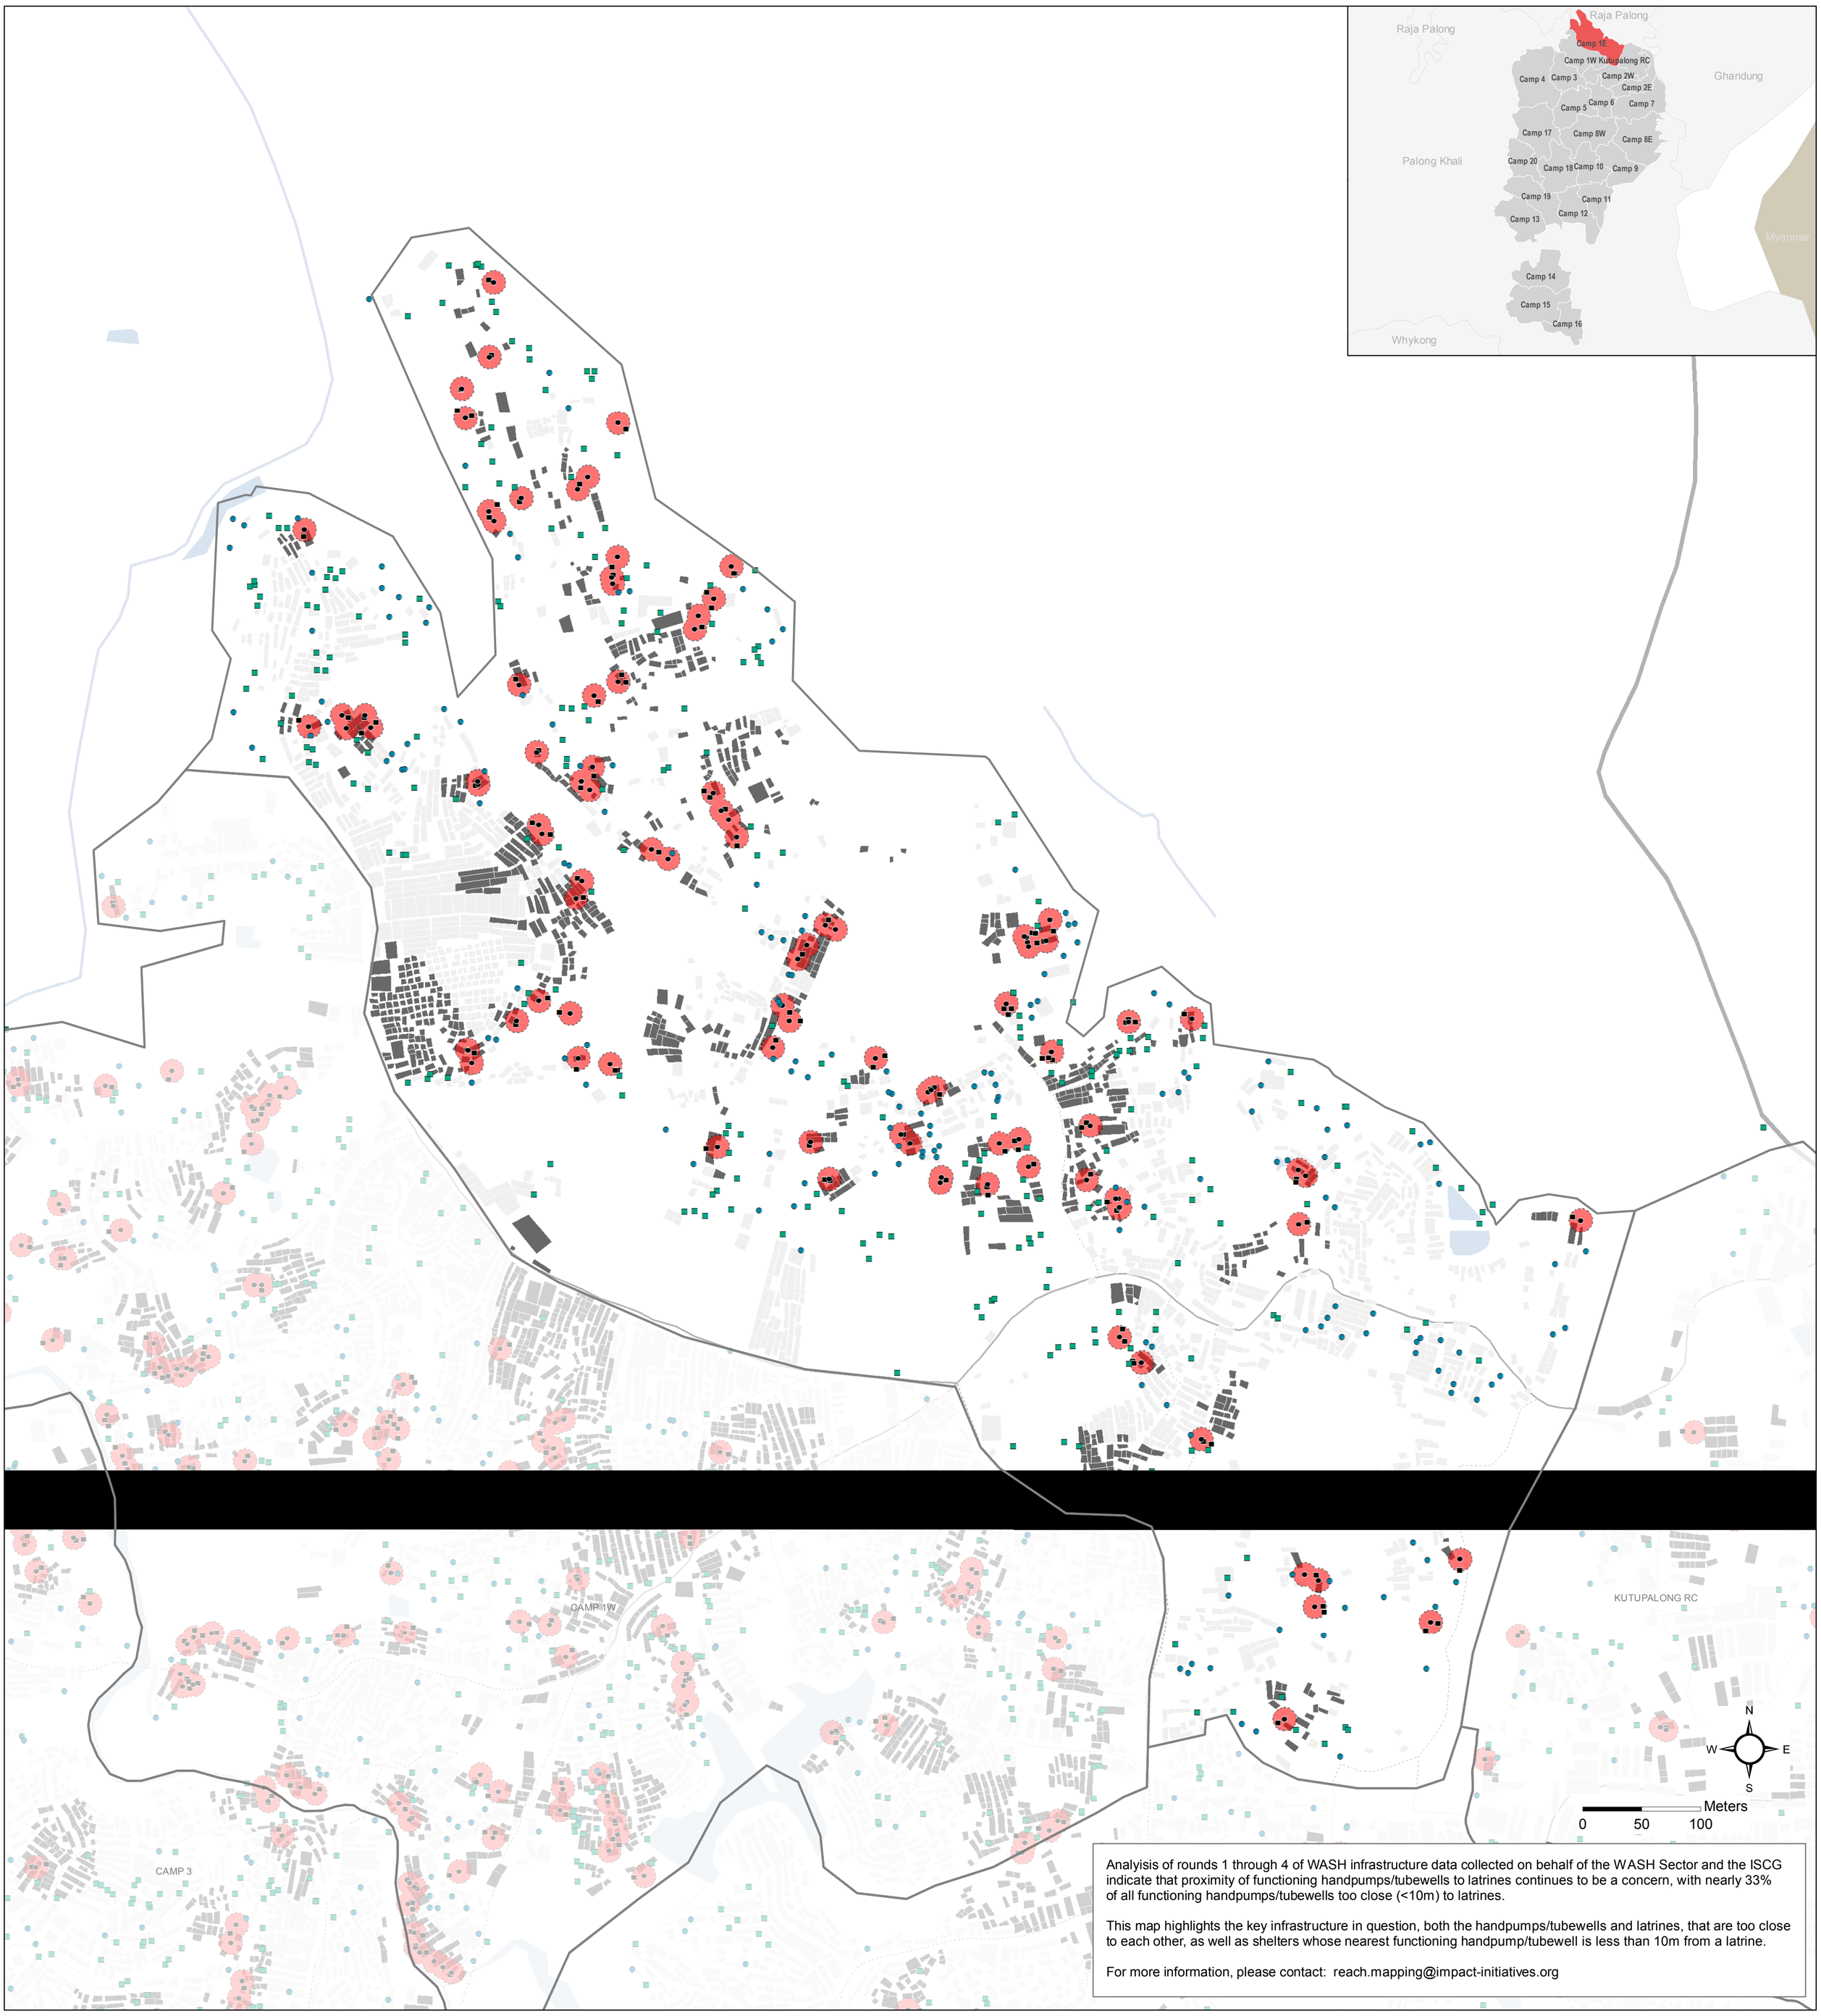
Analyisis of rounds 1 through 4 of WASH infrastructure data collected on behalf of the WASH Sector and the ISCG indicate that proximity of functioning handpumps/tubewells to latrines continues to be a concern, with nearly 33% of all functioning handpumps/tubewells too close (<10m) to latrines.

This map highlights the key infrastructure in question, both the handpumps/tubewells and latrines, that are too close to each other, as well as shelters whose nearest functioning handpump/tubewell is less than 10m from a latrine.
