JORDAN - Al Za'atari Refugee Camp

Damaged Ventilation Pipes on Septic Tanks - March 2017

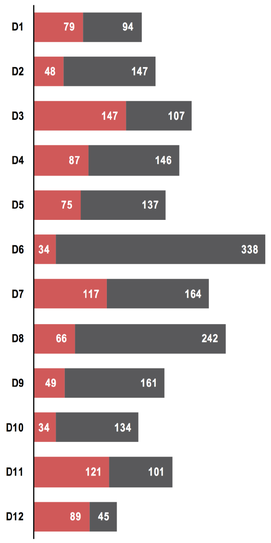
Number of Ventilation Pipes with Observed Damaged per District

In March 2017, REACH undertook a damage assessment of all septic tanks in Za'atari. Since the completion of the wastewater network in June 2016, a common source of damage observed is the removal of ventilation pipe caps, replaced with either nothing, rocks, or other material. This map shows the extent to which septic tank ventilation pipes have been damaged in one form or another.

Damaged Ventilation Pipes: 946
Percent of Pipes Damaged: 34%
