# IRAQ - Khazer M1 Camp

## Tent Condition - Updated 19 January 2017

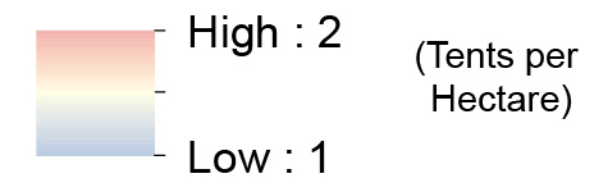
### Density of Sample Tents Experiencing Flooding

52% do not utilize secondary cover

62% experience flooding

100% do not have concrete base
