Damage & Rehabilitation Assessment:

Syria - Al-Thawrah (Tabqa)

September 2021

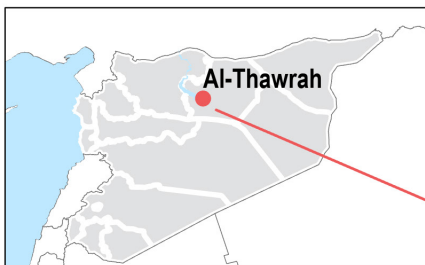
This map illustrates satellite-detected rehabilitated/reconstructed or damaged/demolished structures in the city of Al-Thawrah, Syria compared to previous damage analysis. Using imagery acquired on 11 September 2021, UNITAR-UNOSAT detected a total of 196 rehabilitated/reconstructed buildings.

In particular, efforts of reconstruction and rehabilitation have been undertaken in the area of Tabqa city, where 98 (33%) detected structures have been reconstructed or rehabilitated.

There have also been efforts of reconstruction and rehabilitation in the north of the city in Hurriyah with 24 (37%) detected structures rehabilitated or reconstructed.

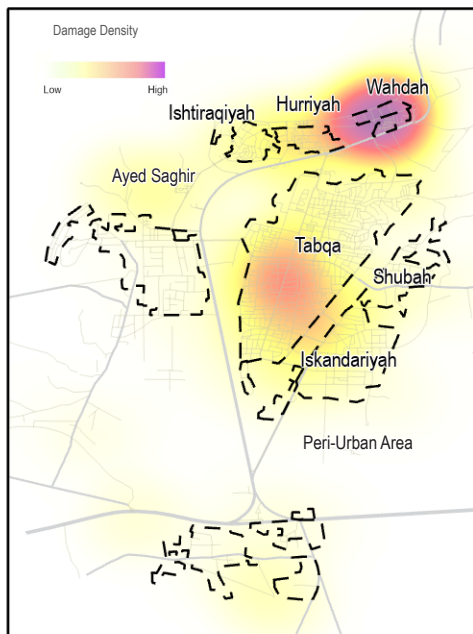
This map illustrates the damage severity of satellite-detected damaged/destroyed structures in the city of Al-Thawrah, and damage density, using imagery acquired on 11 September 2021.

Wahdah neighbourhood has the highest damage density, as a result of its proximity to the dam, where the 2017 clashes were most severe. In Wahdah, 96 (92%) detected structures were observed to be damaged, destroyed or demolished. In December 2019, Information Management Unit (IMU) KIs reported that the majority resident population in this neighbourhood was IDPs, who were residing in multi-story buildings, with poor to average living conditions.²⁵
