## **BANGLADESH - Rohingya Refugee Crisis - Cox's Bazar District** For Humanitarian Purposes Onl Production date: 11 January 2018 **Environmental Impact by NDVI Analysis - January 2017 to January 2018**

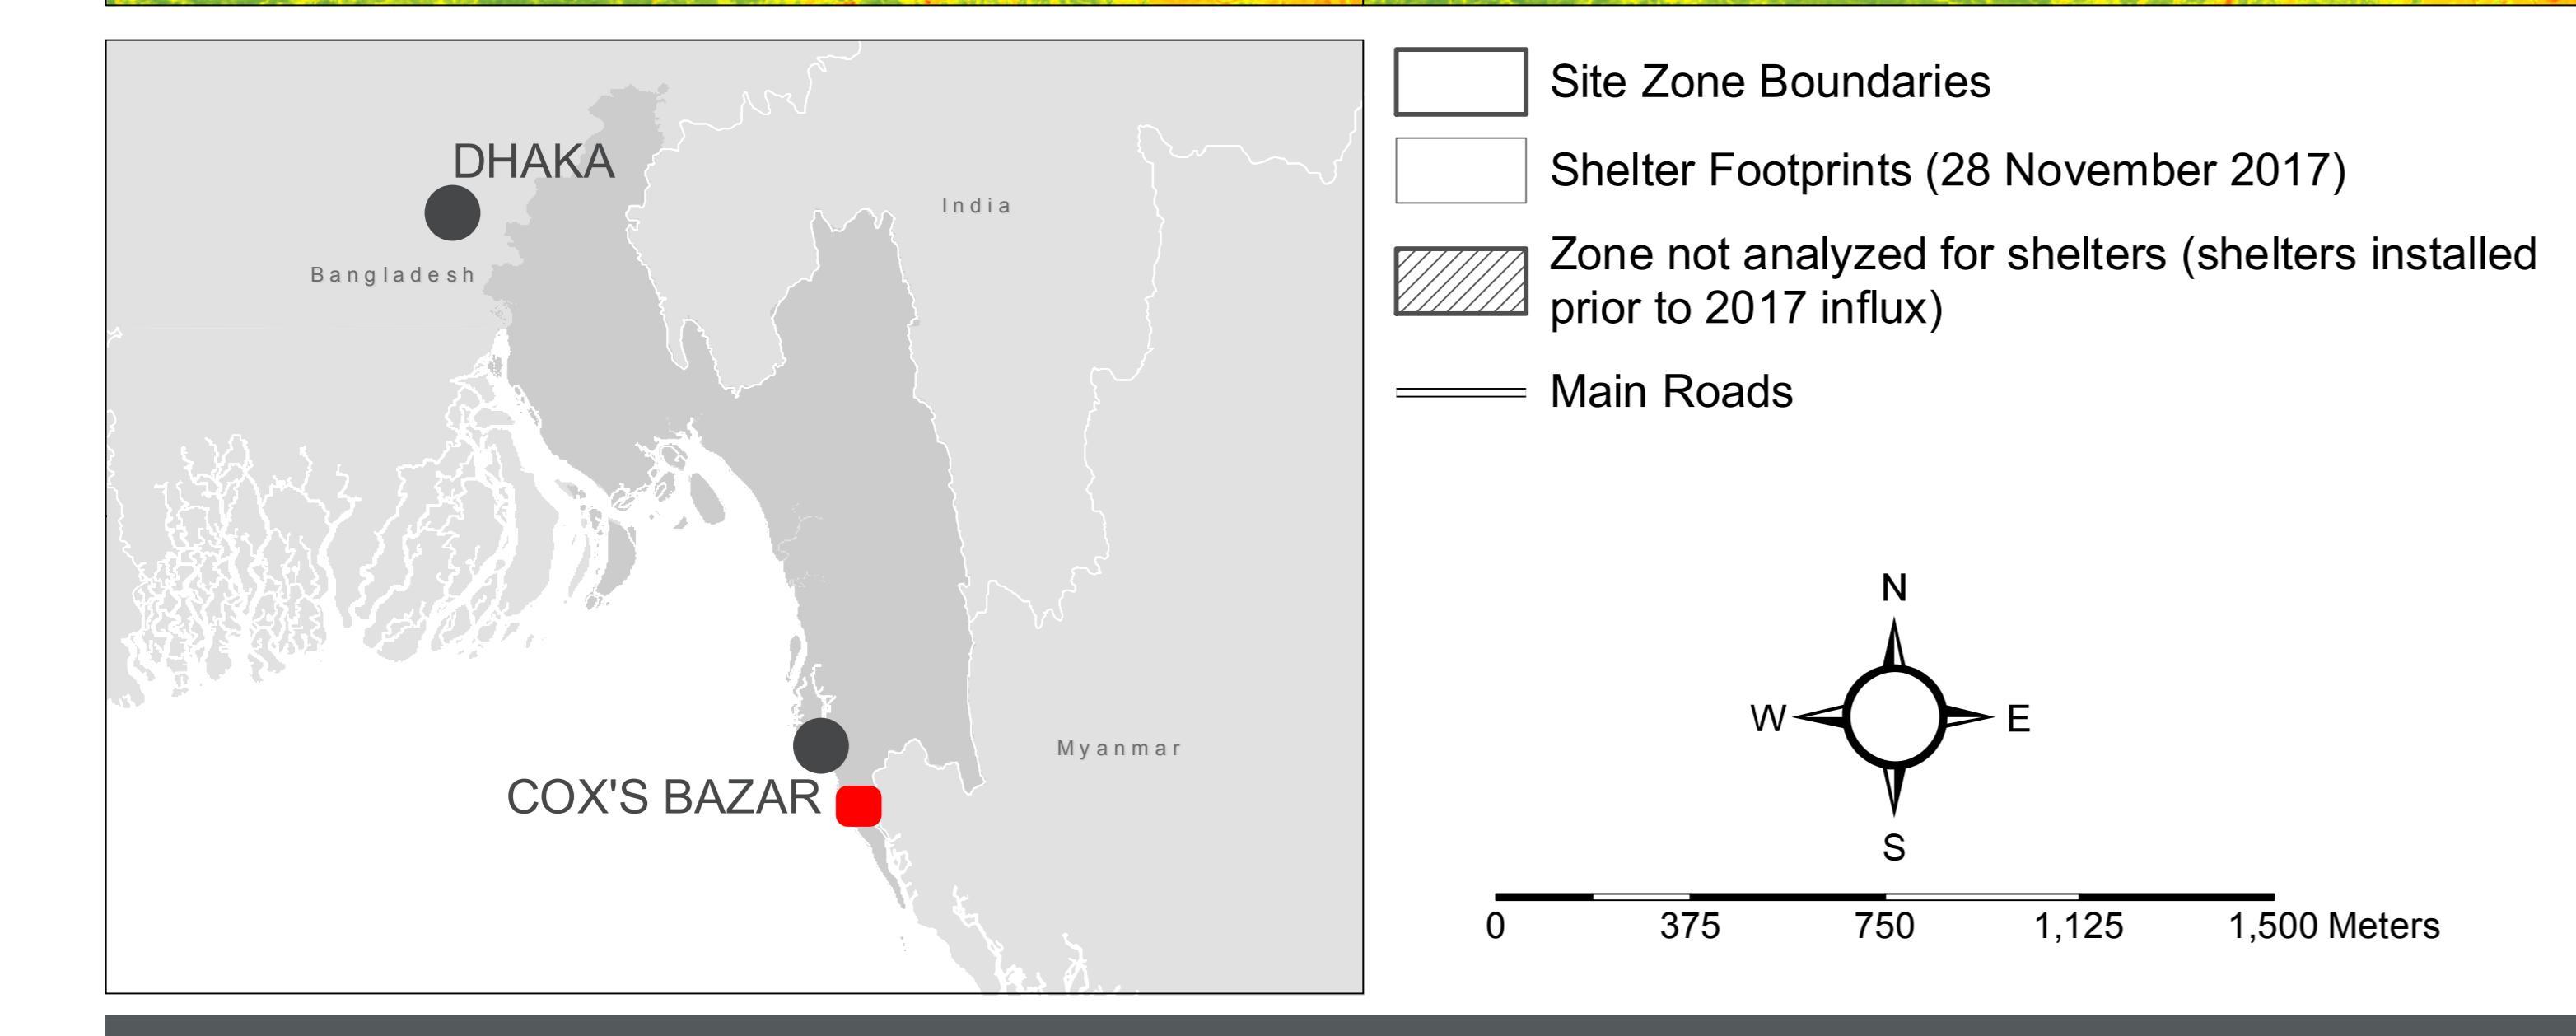
vegetation, low NDVI values (-1) generally indicate water due to its low reflectance, mid NDVI values (around 0) indicate lack of vegetation (urban areas, arid areas, etc.)
