# **Post-Earthquake Shelter Assessment**

# **Bohol Province, Region VII, Philippines**

# PROVISIONAL INTERIM REPORT 11 November 2013

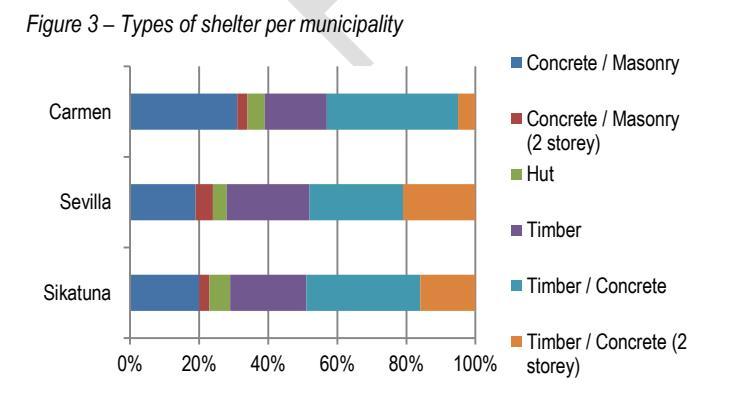
The three municipalities targeted for assessment have relatively similar shelter profiles, with huts or timber based shelters making up the majority, 66% in Carmen, 76% in Sevilla, and 77% in Sikatuna. While on the whole similar, Carmen has the highest proportion of concrete / masonry shelters, 34% of the total housing stock.

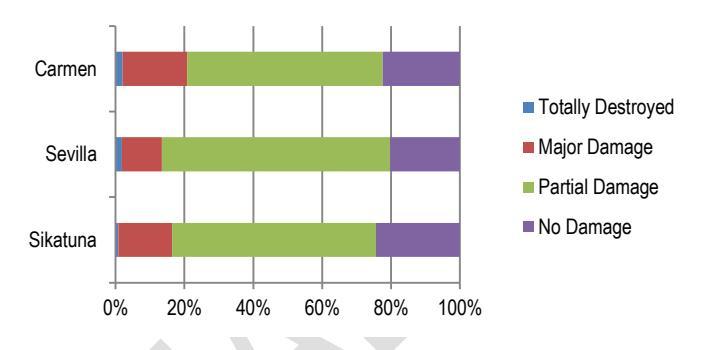
Figure 4 – Level of shelter damage per municipality

Overall, the predominant level of damage identified by enumerators (see Annex 2) is 'partial damage' (60%). Only a very small proportion of the housing stock (2%) was identified as being totally destroyed. Whilst relatively similar levels of damage were identified across the three municipalities, the highest proportion of shelters with major damage or totally destroyed were found in Carmen (21% of the total housing stock).

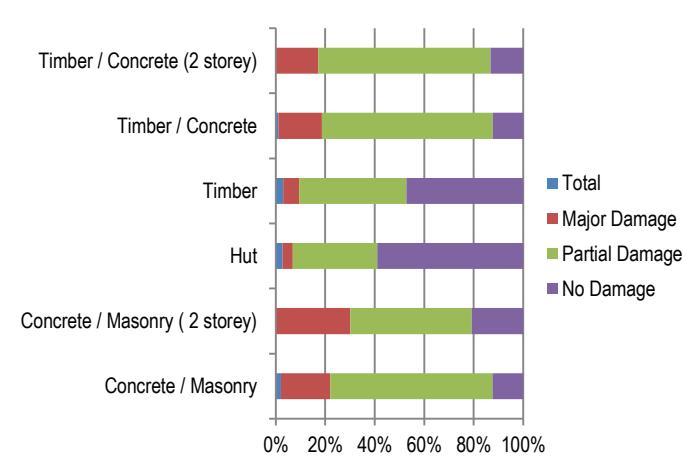
#### Figure 5 – Level of damage per shelter type

The higher level of major / total damaged identified in Carmen can be explained by the prevalence of masonry structures which were more severely affected by the earthquake than huts or timber-based structures. While 60% of assessed of huts were left undamaged, 23% of masonry structure sustained major or total damage.

The difference in levels of damage per shelter types can be explained by the inability for rigid masonry structures to absorb the increased lateral and vertical forces placed on them during earthquakes. This is confirmed by household level data indicating that 75% of shelter damage result from shaking during the earthquake.

Additionally the recent earthquake occurred as a result of a newly discovered fault line, thus housing in Bohol province was on the whole not built with earthquake resilience in mind.
