## Summary

This profile provides an overview of water, sanitation and hygiene (WASH) infrastructure within Camp 18 in Ukhia, Cox's Bazar. Primary data for this round was collected from 29<sup>th</sup> May to 22<sup>nd</sup> July 2018.<sup>1</sup> Findings should be considered indicative only. Full camp dataset is available on [HDX](#).

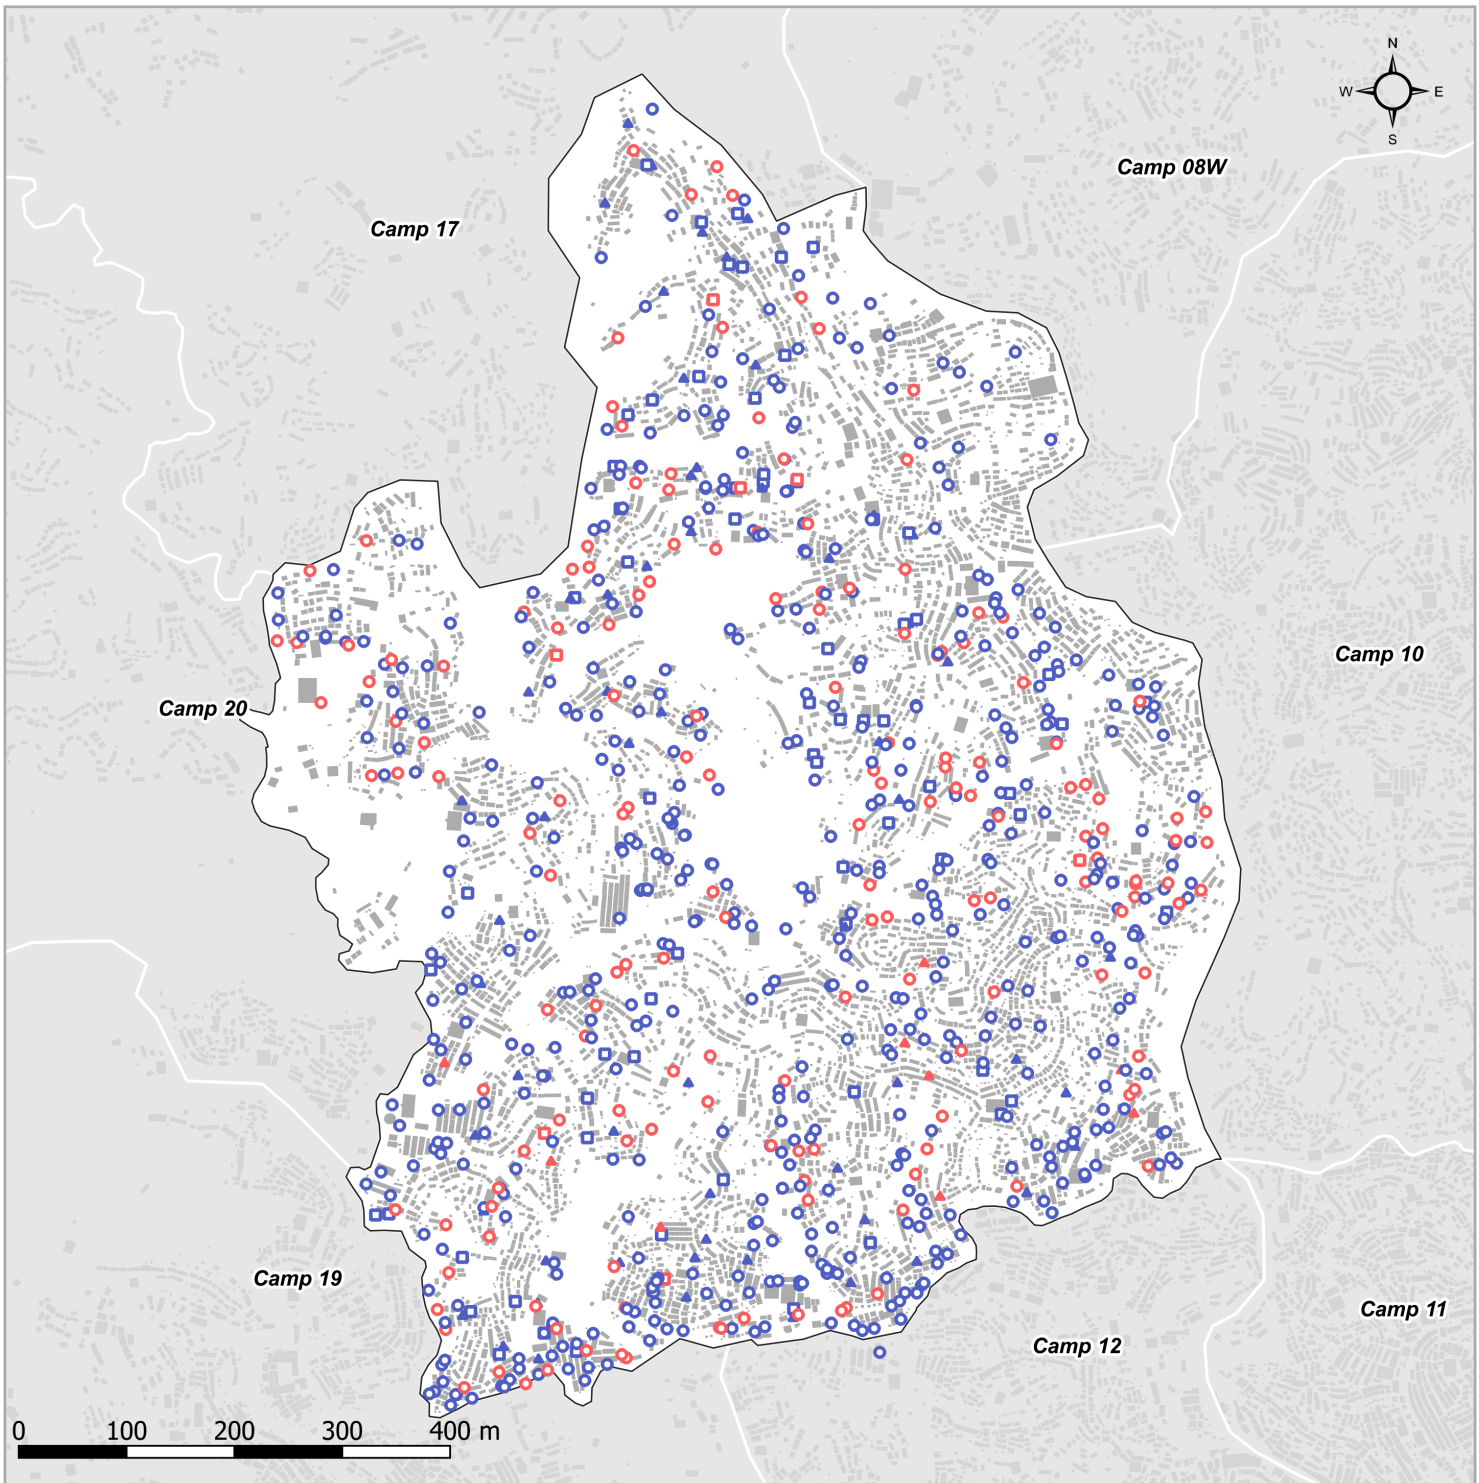
## Water Access

Functioning	Non-functioning	Boundaries
○ Tube Well	○ Tube Well	□ Camps
▲ Tapstand	▲ Tapstand	■ Shelters
□ Water Tank	□ Water Tank

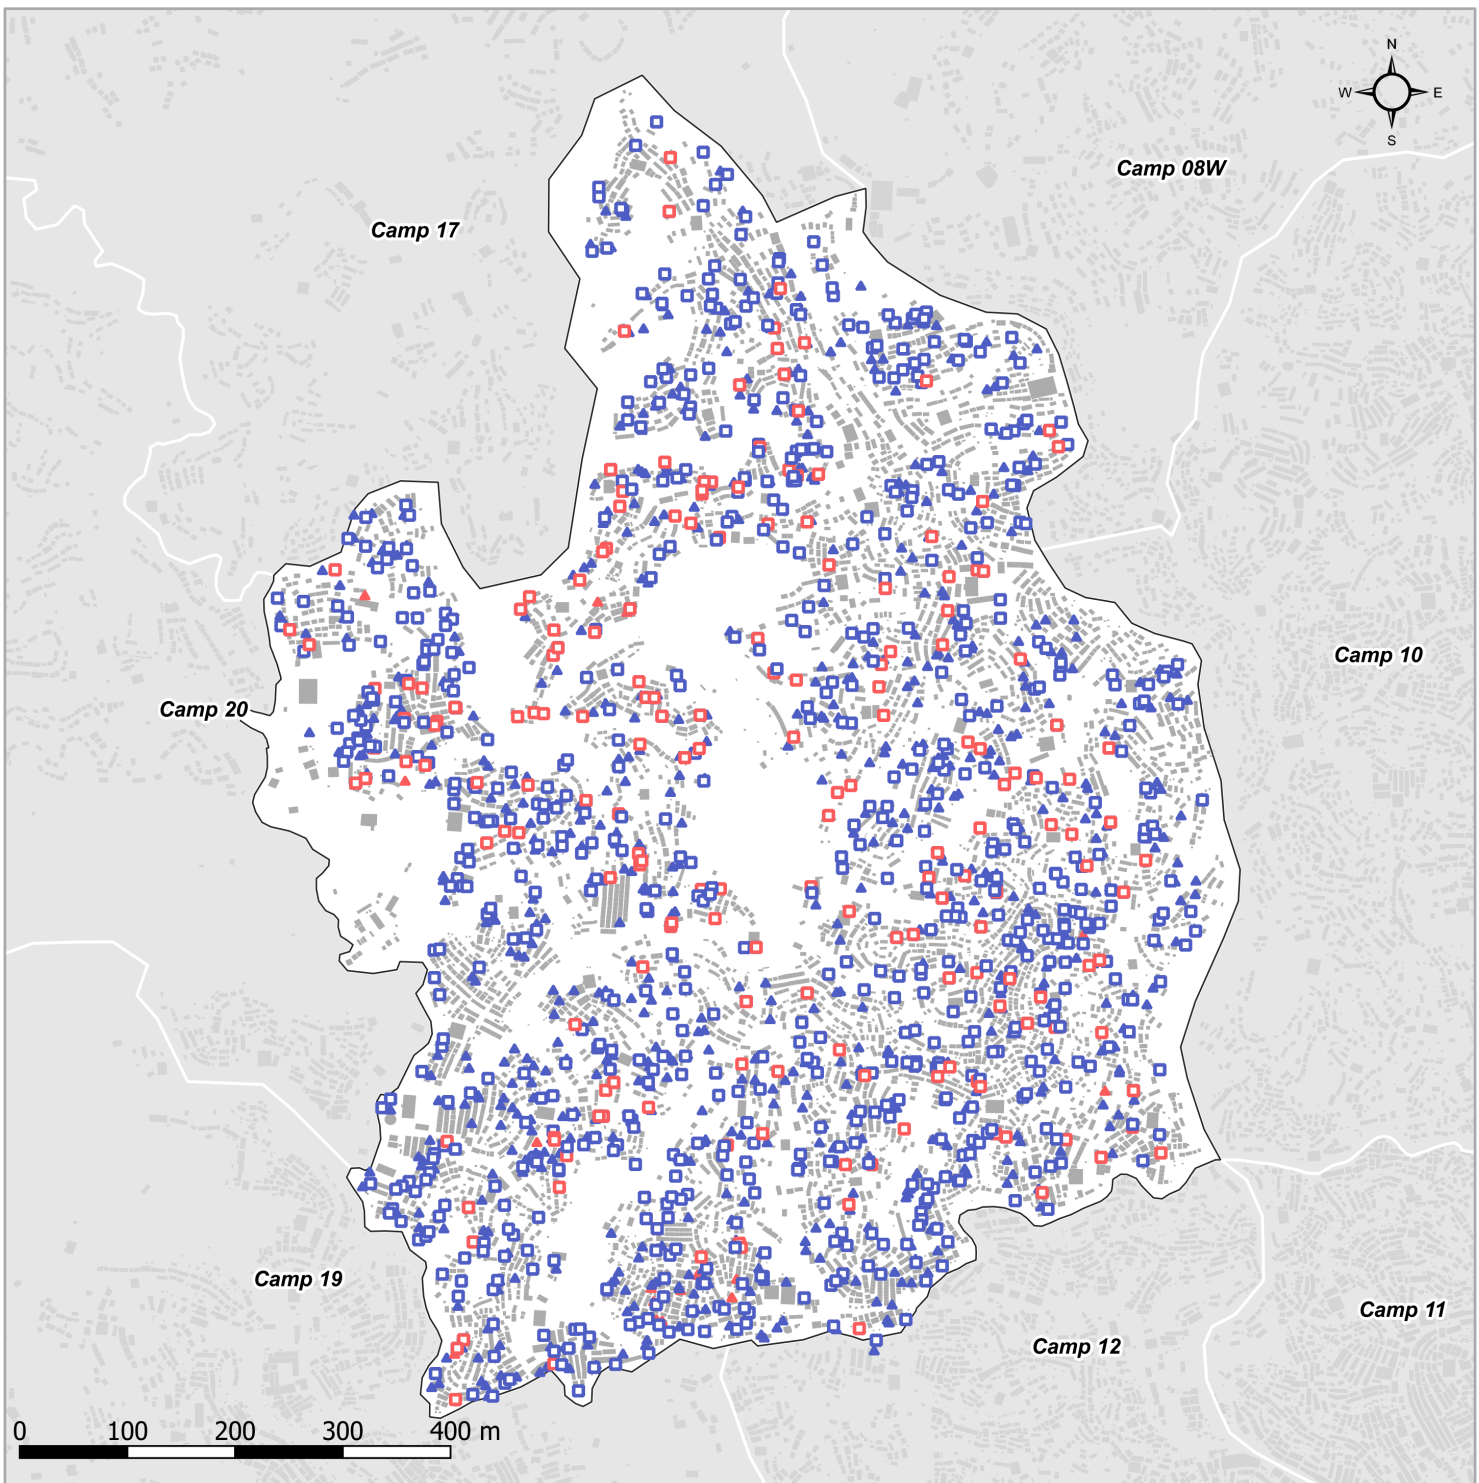
Sanitation

Functioning	Non-functioning	Boundaries
Latrines	Latrines	Camps
WASH Room	WASH Room	Shelters
