# **WASH Site Profile - Camp 11**

Ukhia, Cox's Bazar, Bangladesh (May 2018) GPS Coordinates: 21.1828, 92.1557

This profile provides an overview of water, sanitation and hygiene (WASH) infrastructure within Camp 11 in Ukhia, Cox's Bazar. Primary data for the sixth round was collected between 22 April -12 May 2018.1 Findings should be considered indicative only. The full camp dataset is available on HDX.

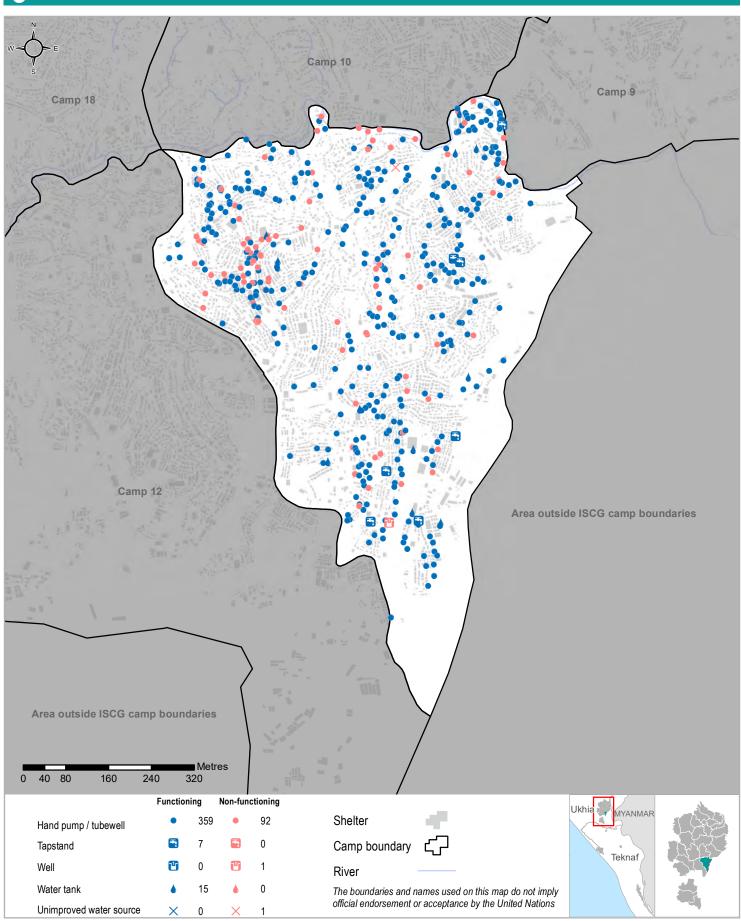
## **Water Access**

Three most commonly identified types of water points, by functionality:

95%	Handpump / tube well	78%	22%	
3%	Water tank	100%	0%	Functional
1%	Tapstand	100%	0%	Non-functional

Key sectoral standards:	Target	<b>Current Round</b>	Achievement
# of people per functional improved water source <sup>3</sup>	max. 250	90	
% of shelters with at least 1 functional improved water source <sup>3</sup> within 200m	100%	100%	
% of functional improved water source with no latrine within 10m	100%	53%

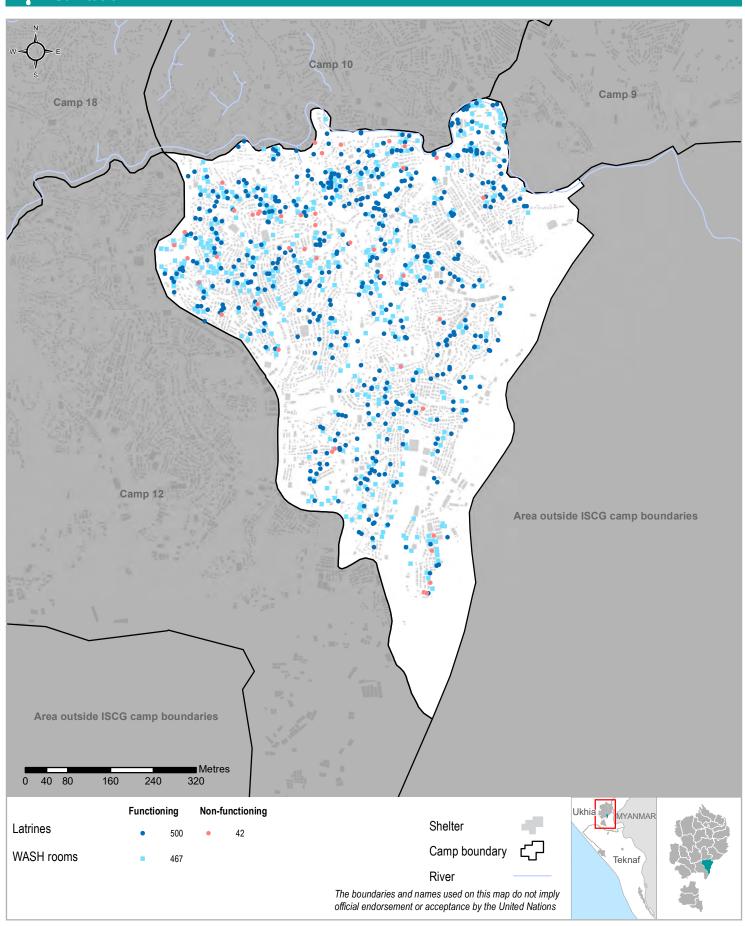
### **Sanitation**

## Latrine characteristics:

Key sectoral standards:	Target	Current Round	Achievement
# of people per functional (non-full) and safe latrine <sup>2</sup>	max. 20	46	
# of people per functional (non-full) latrine	max. 20	41	
# of people per safe latrine <sup>2</sup>	max. 20	44	
% of shelters with at least one functional and safe latrine <sup>2</sup> block within 50m	100%	98%
