WASH Site Profile - Camp 10

Ukhiya, Cox's Bazar, Bangladesh (February 2018) GPS Coordinates: 92.15425876 21.8974346

Summary

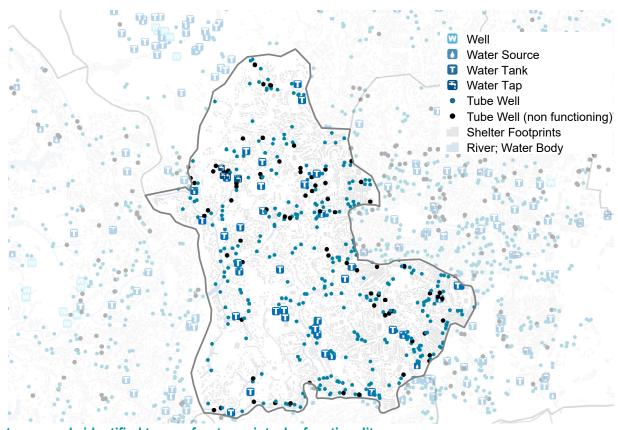
Access to Water

Three most commonly identified types of water points, by functionality

91% Handpump/tubewell	82%	18%	
7% Water tank	73%	27%	Functional Non-functional
1% Tapstand	100%	0%	Non-tunctional

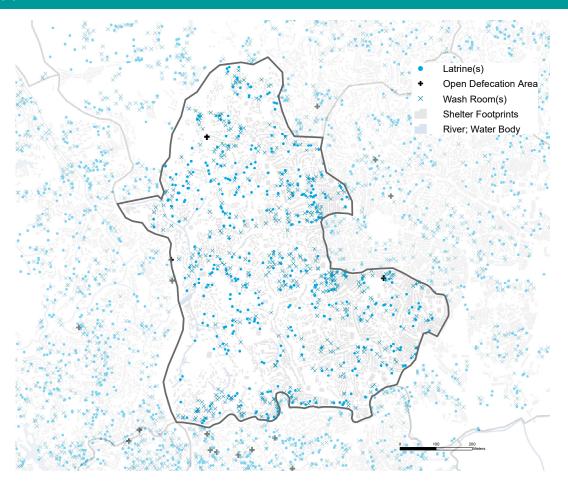
Sanitation

Latrine characteristics

% of functional/non-functional latrines

functional (non-full) latrines non-functional latrines
