3,742 buildings total*
1,087 buildings damaged**
29% of neighbourhood damaged

Coordinate System: GCS WGS 1984
File: MOZ_Map_CycloneIdai_Beira_DamageByType_PontaGea_30APR2019
Contact: reach.mapping@impact-initiatives.org

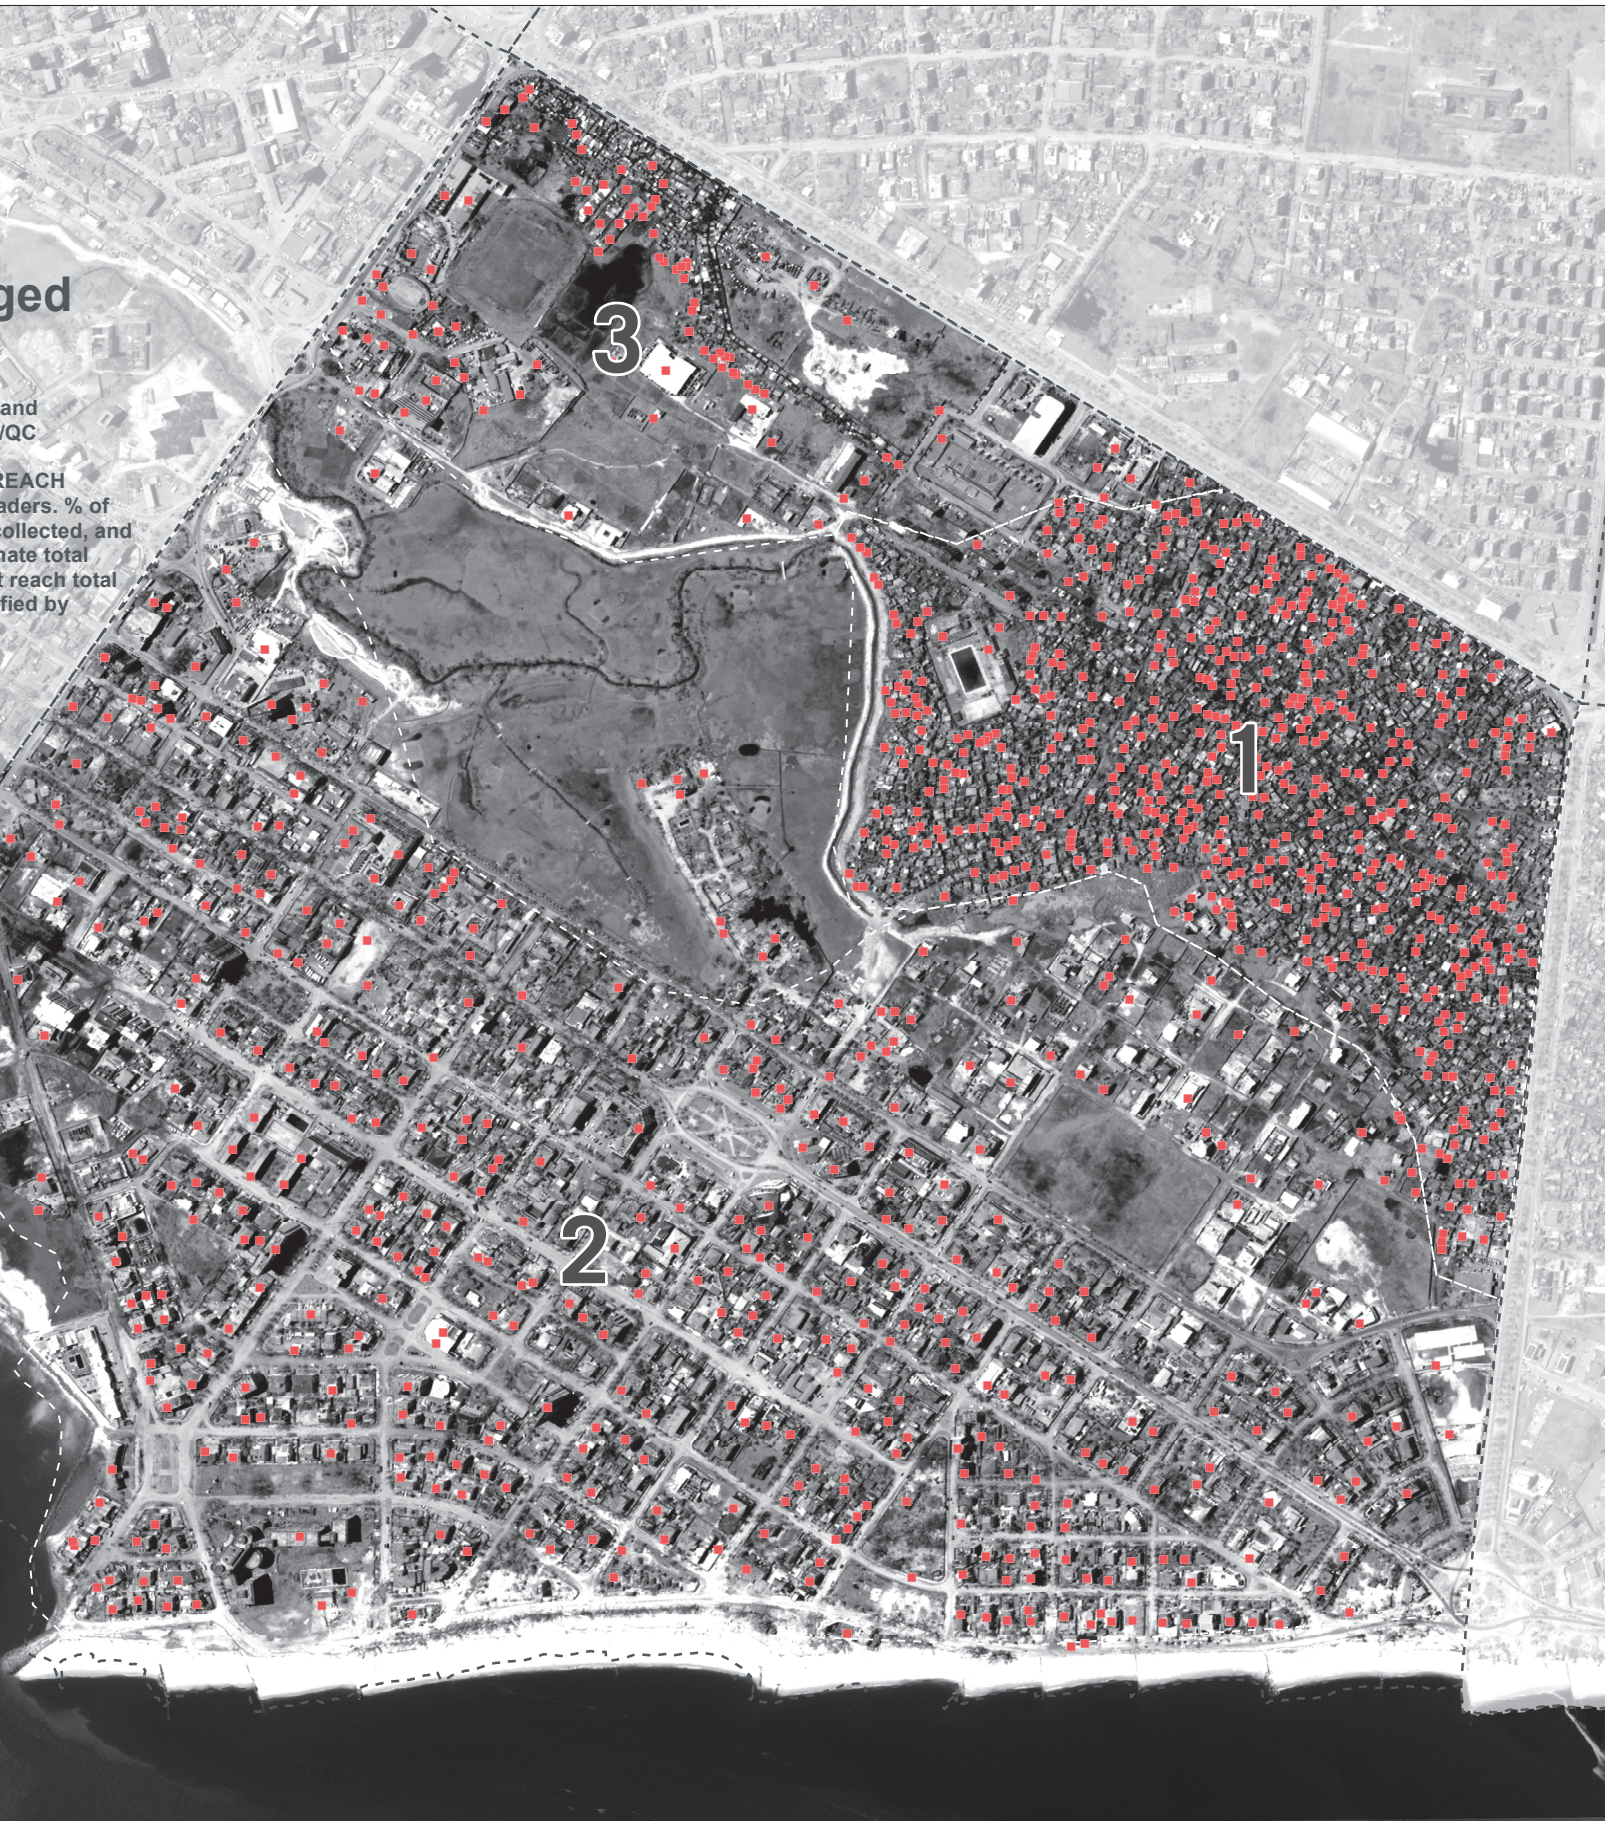
Damaged buildings by construction typology and zone***		Zone			Total
		1	2	3	
Structure	Blocks (precarious)	161	0	0	161
	Blocks (strong)	0	22	0	22
	Pau e pique/bamboo	350	0	61	411
	Mud	0	0	0	0
	Multi-story	27	420	33	480
	Warehouse	0	0	0	0
Roof	Asbestos	178	309	0	487
	Metal sheeting	350	31	71	451
	Tiles	0	88	5	93
	Cement	11	13	19	43
	Grass/plastic	0	0	0	0
