WASH Site Profile - Nayapara RC

Teknaf, Cox's Bazar, Bangladesh (October 2018) GPS Coordinates: 92.25, 20.9571

Summary

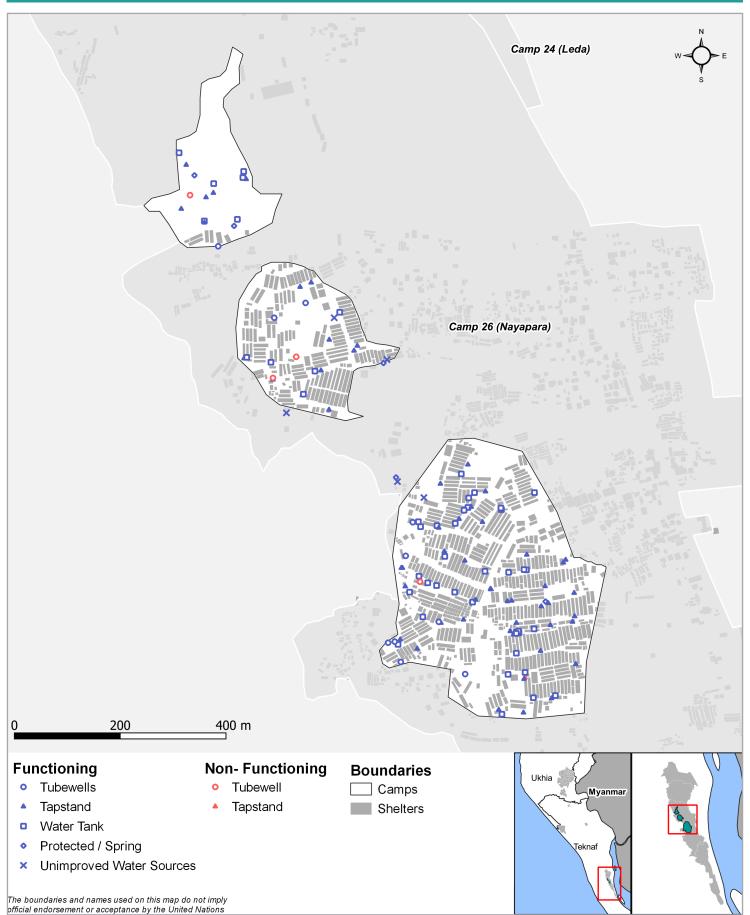
Water Access

Three most commonly identified types of water points, by functionality:

Key sectoral standards:	Target	Current Round	Achievement
# of people per functional improved water source	max. 250	229	
% of shelters with at least 1 functional improved water source³ within 200m	100%	100%	
% of functional improved water sources with no latrine within 10m	100%	41%

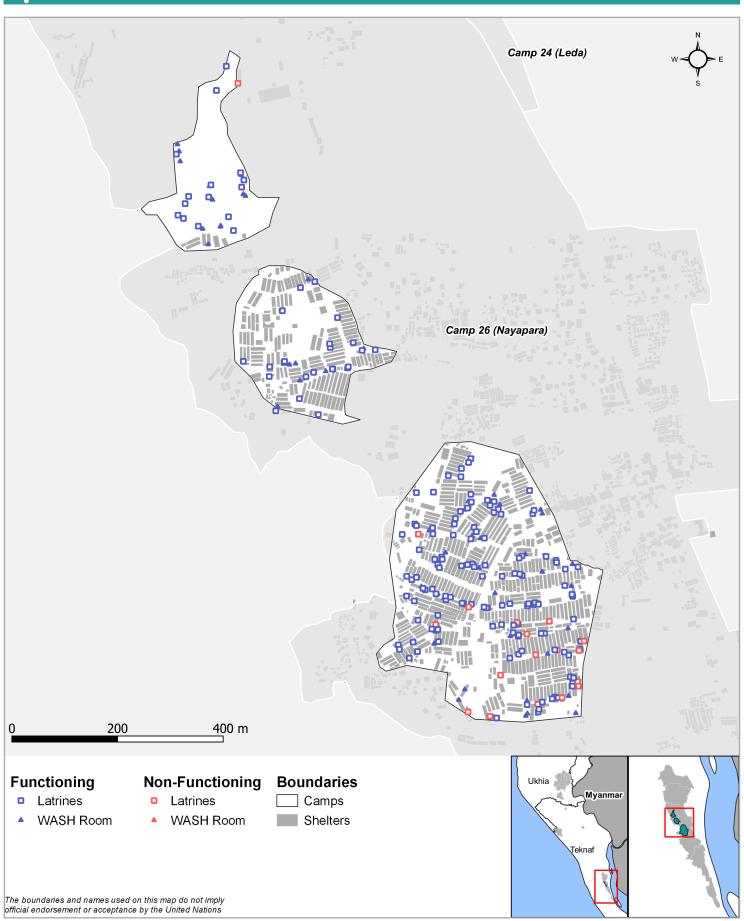
Sanitation

Latrine characteristics:

Key sectoral standards:	Target	Current Round	Achievement
# of people per functional (non-full) and safe latrine ²	max. 20	37	
# of people per functional (non-full) latrine	max. 20	34	
# of people per safe latrine ²	max. 20	36	
% of shelters with at least one functional and safe latrine ² block within 50m	100%	97%
