Inter Sector Coordination BANGLADESH - Rohingya Refugee Crisis - Cox's Bazar District Chakmarkul - Potential Flood Inundation and Slope Risk

For Humanitarian Purposes Only **Production date: 6 April 2018**

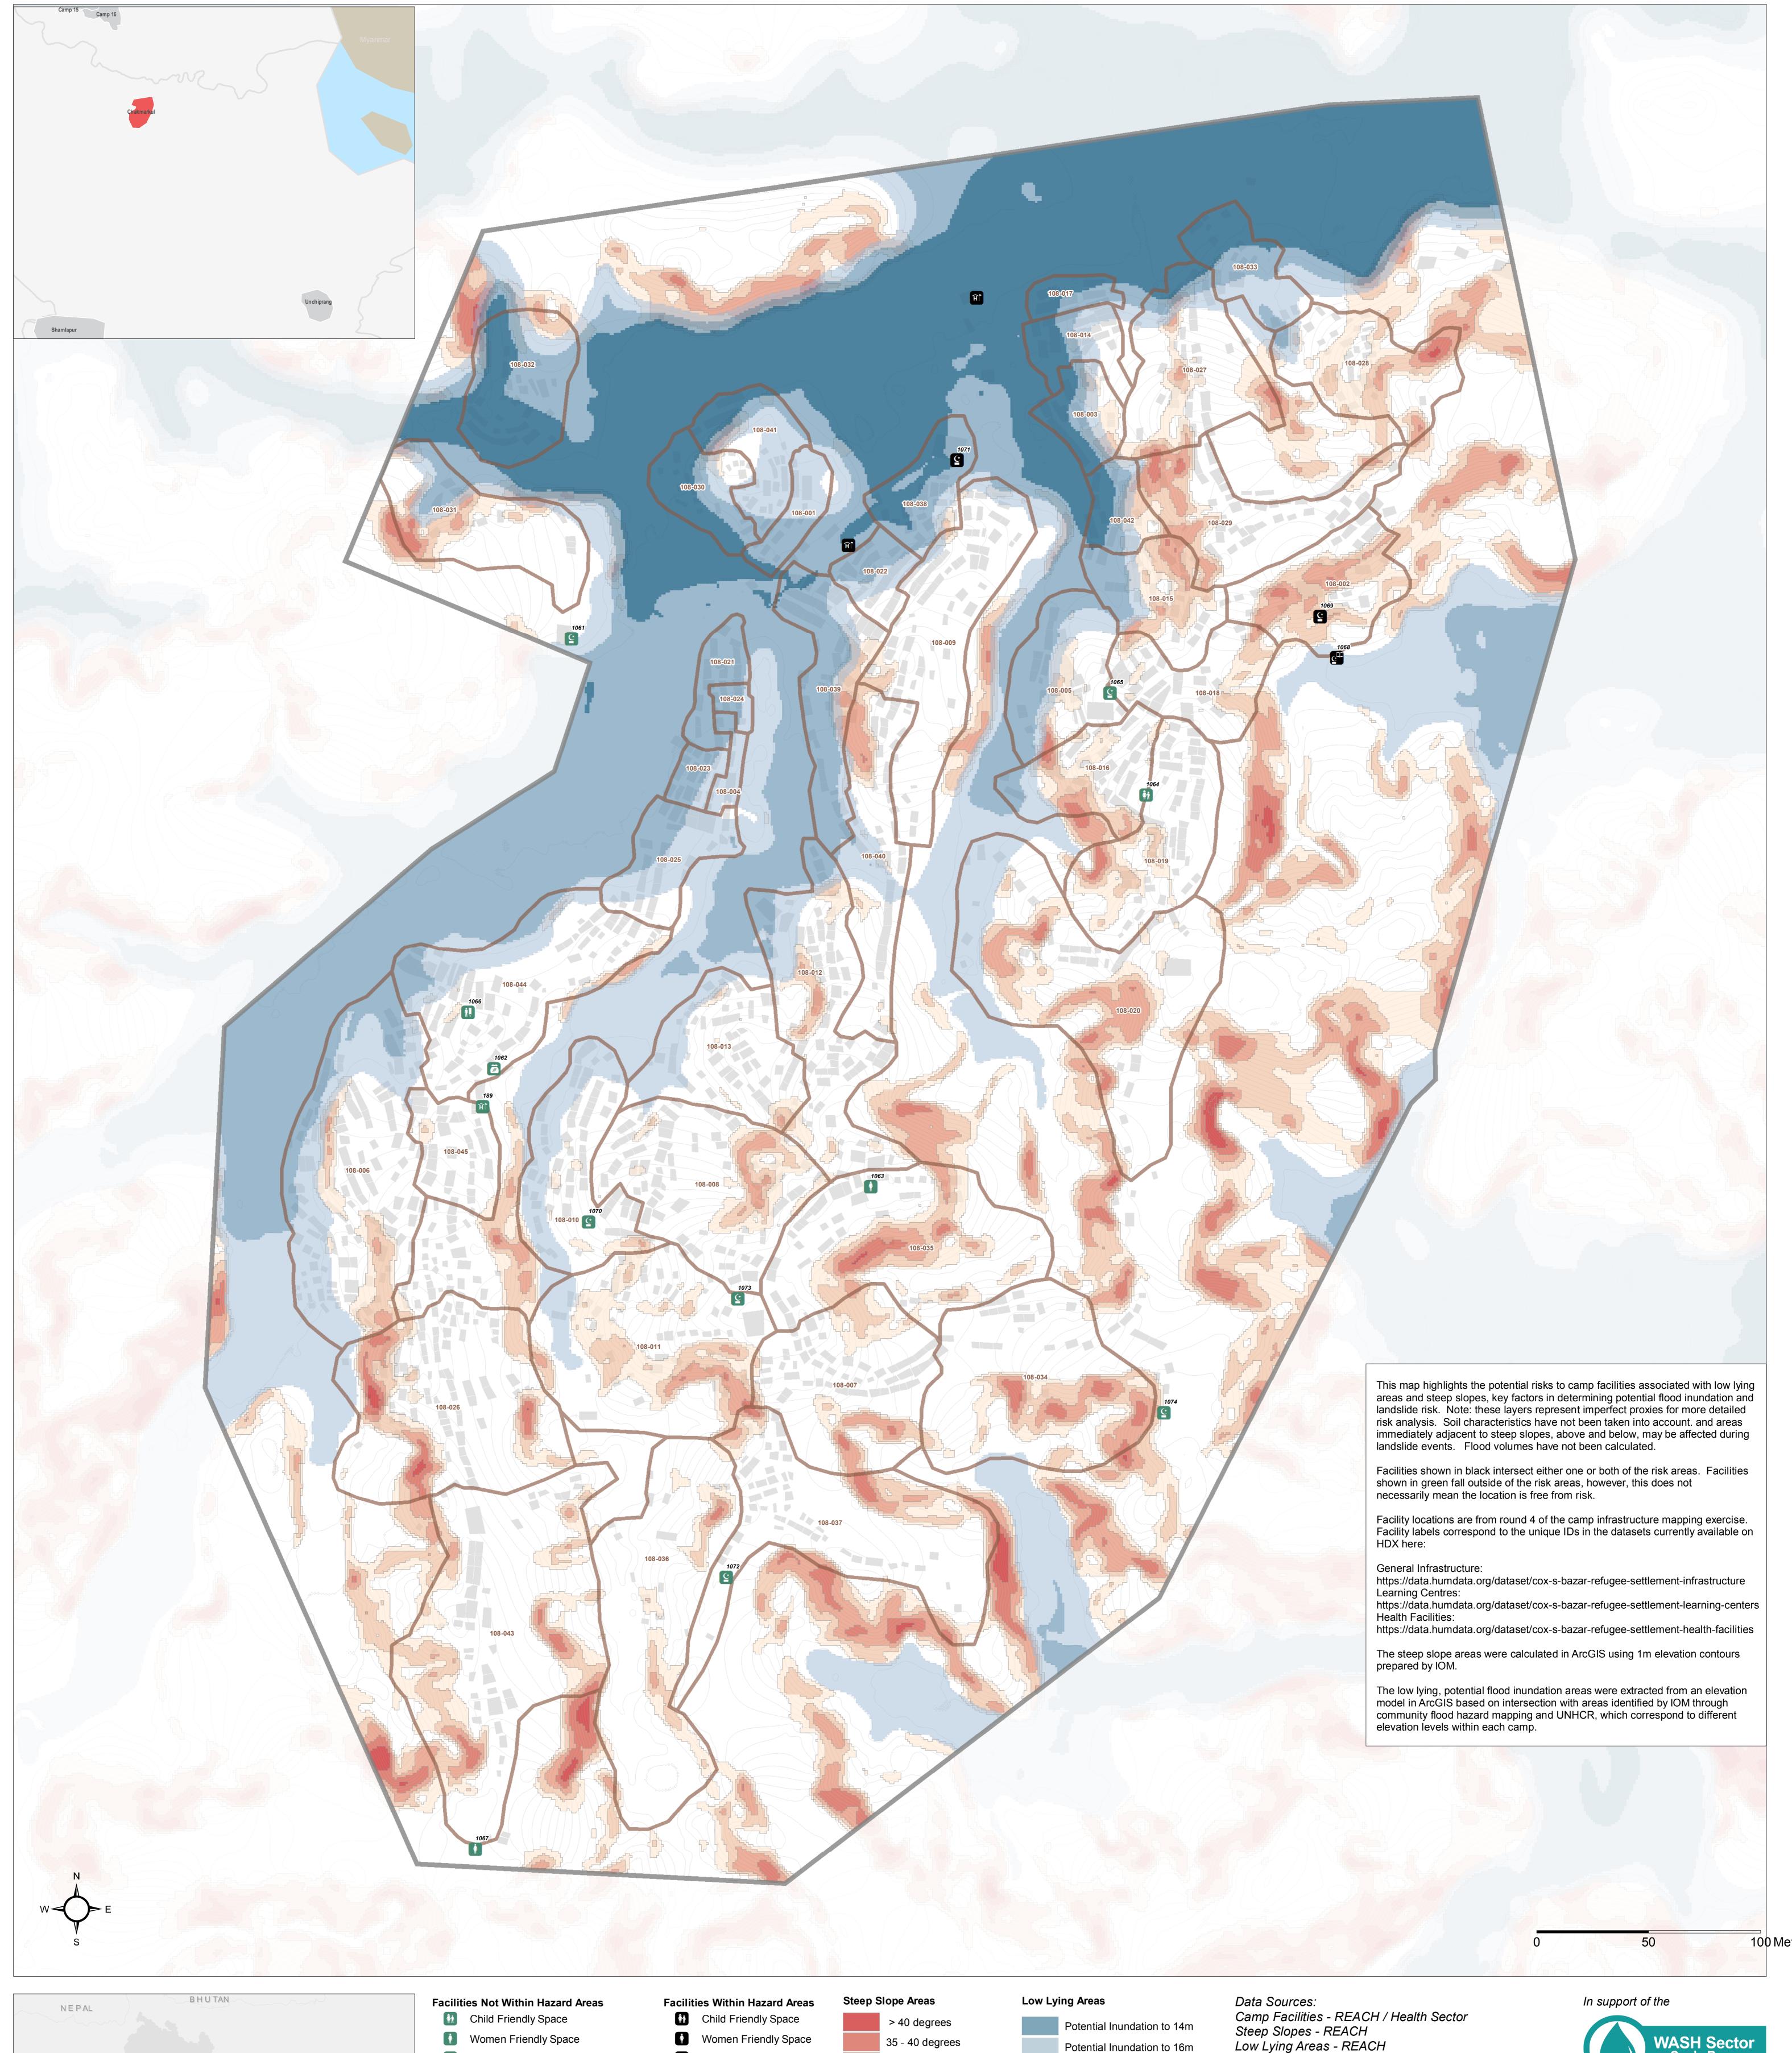
35 - 40 degrees 30 - 35 degrees 25 - 30 degrees

20 - 25 degrees Elevation Contours (1m)

Potential Inundation to 16m

Potential Inundation to 18m
