7,101 buildings total*

6,029 buildings damaged**

85% of neighbourhood damaged

Coordinate System: GCS WGS 1984
 File: MOZ_Map_CycloneIdai_Beira_DamageByType_Matadouro_30APR2019
 Contact: reach.mapping@impact-initiatives.org

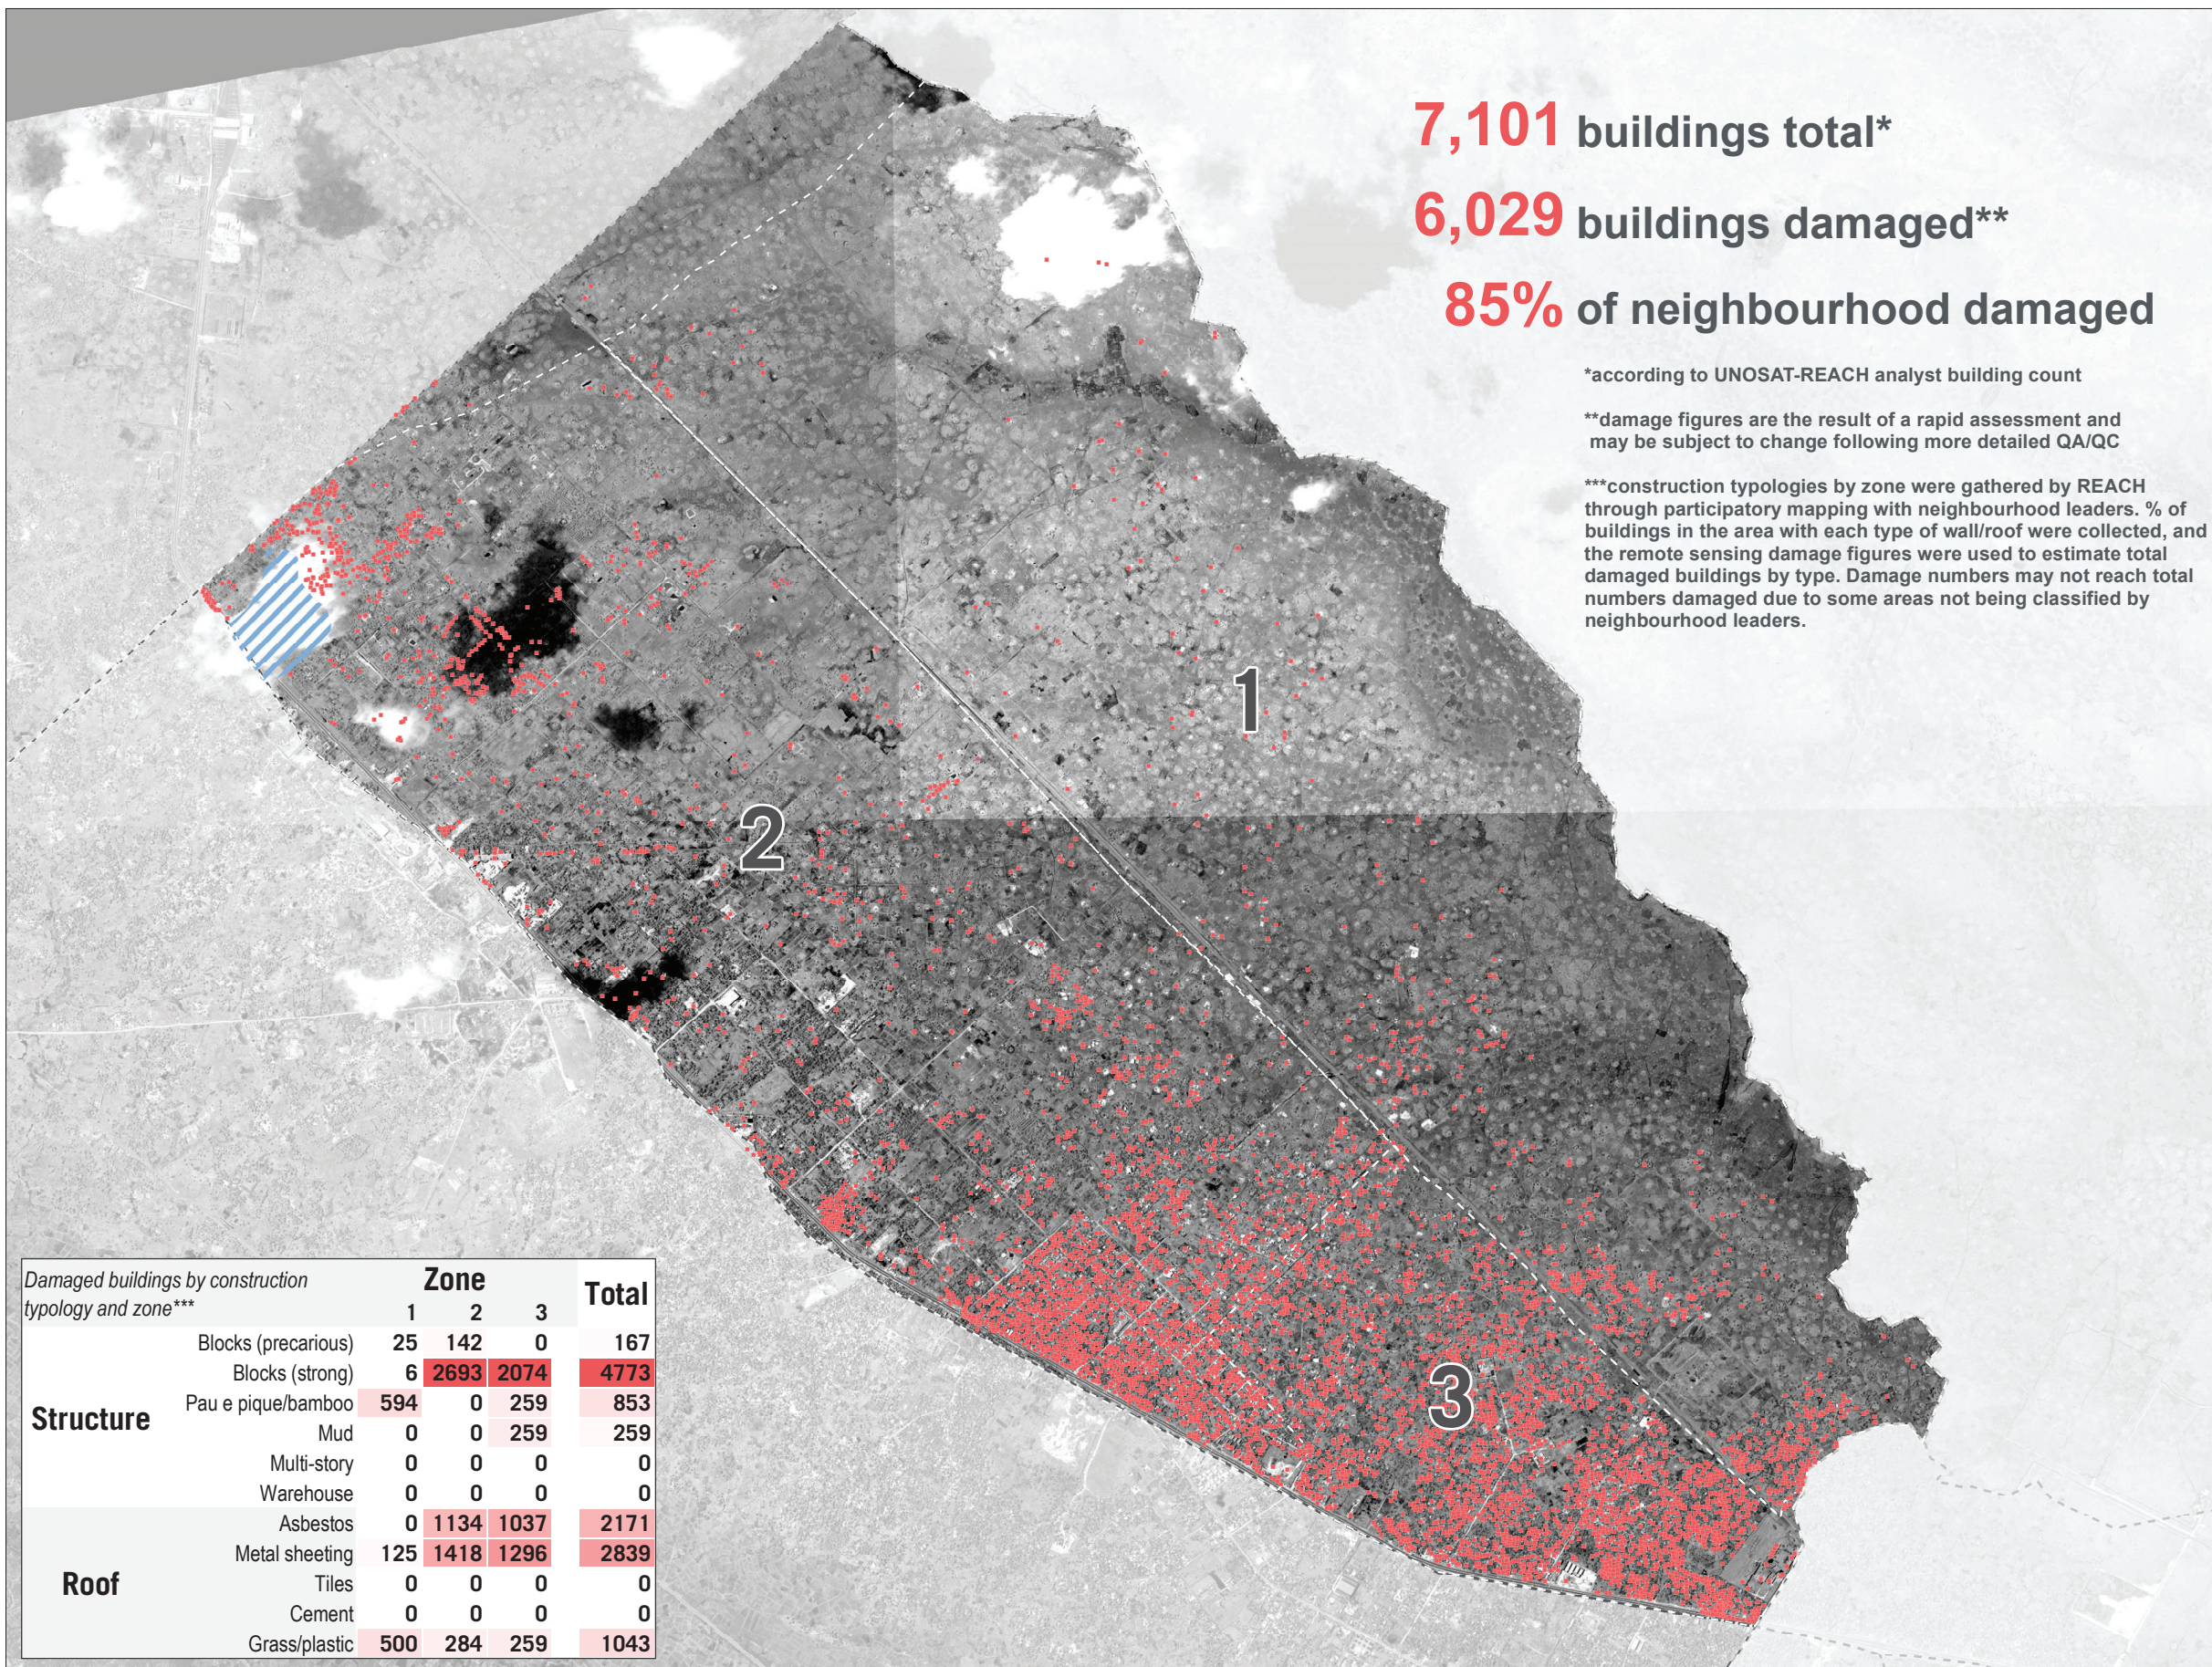
Structure	Roof	Zone			Total
		1	2	3	
Blocks (precarious)		25	142	0	167
Blocks (strong)		6	2693	2074	4773
Pau e pique/bamboo		594	0	259	853
Mud		0	0	259	259
Multi-story		0	0	0	0
Warehouse		0	0	0	0
Asbestos		0	1134	1037	2171
Metal sheeting		125	1418	1296	2839
Tiles		0	0	0	0
Cement		0	0	0	0
Grass/plastic		500	284	259	1043
