WASH Site Profile - Leda MS

Teknaf, Cox's Bazar, Bangladesh (May 2018) GPS Coordinates: 20.9741, 92.244

Summary

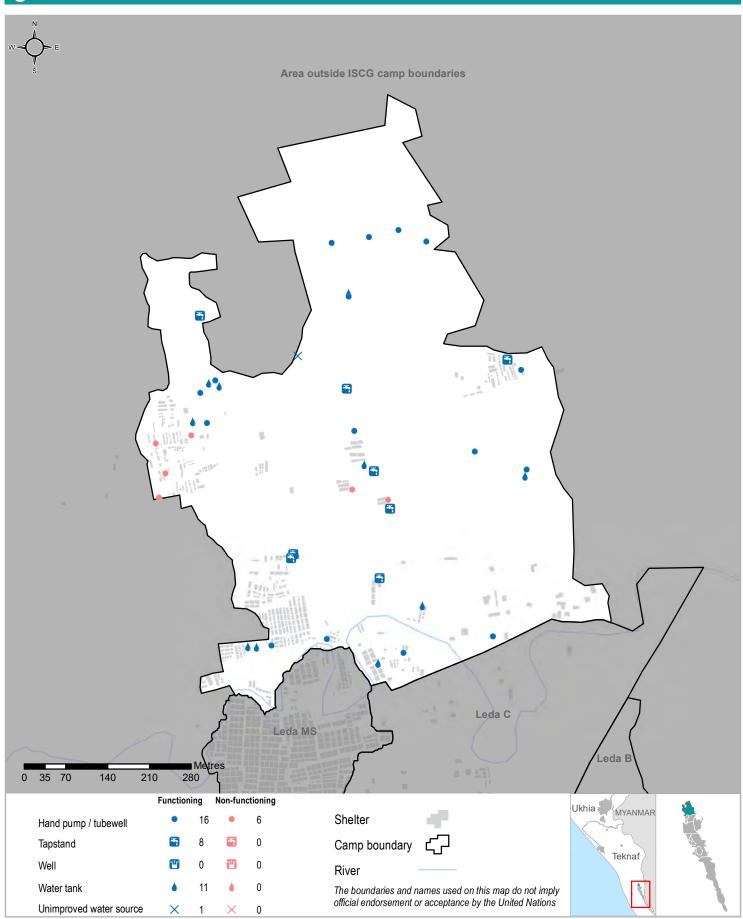
Water Access

Three most commonly identified types of water points, by functionality:

Key sectoral standards:	Target	Current Round	Achievement
# of people per functional improved water source ³	max. 250	444	
% of shelters with at least 1 functional improved water source ³ within 200m	100%	100%	
% of functional improved water source with no latrine within 10m	100%	N/A

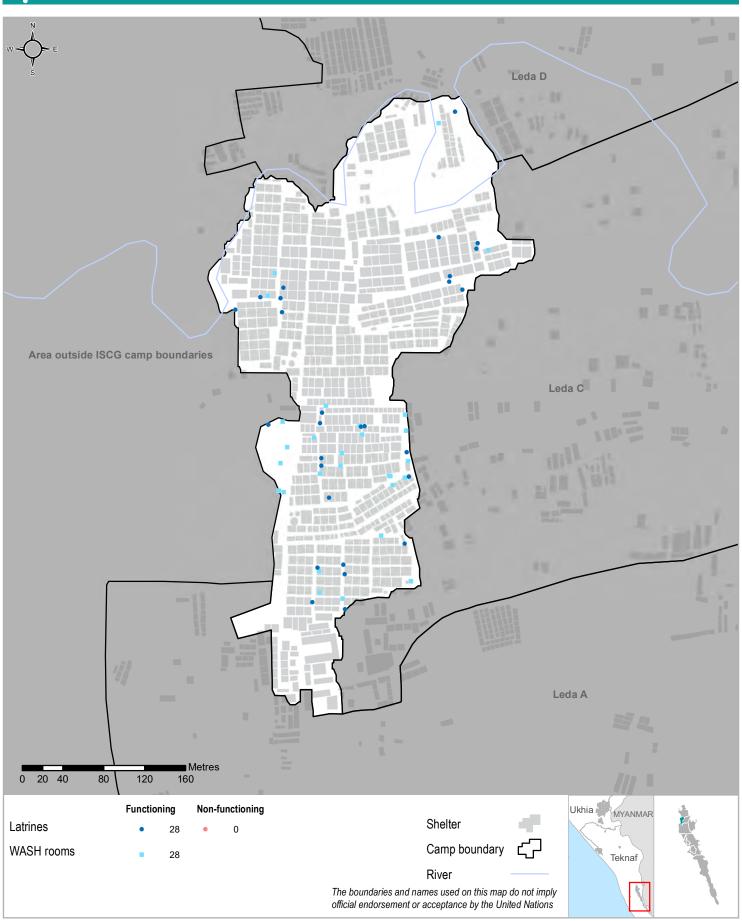
Sanitation

Latrine characteristics:

Key sectoral standards:	Target	Current Round	Achievement
# of people per functional (non-full) and safe latrine ²	max. 20	84	
# of people per functional (non-full) latrine	max. 20	76	
# of people per safe latrine ²	max. 20	84	
% of shelters with at least one functional and safe latrine ² block within 50m	100%	88%
