WASH Site Profile - Leda A

Teknaf, Cox's Bazar, Bangladesh (March 2018) GPS Coordinates: 92.24560256 20.96850835

Summary

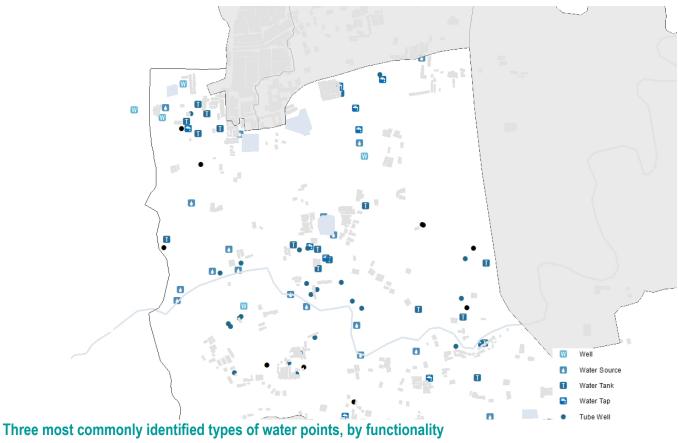
Access to Water

39%	Handpump/tube well	69%	31%	
26%	Water tank	89%	11%	Functional Non-functional
16%	Tapstand	100%	0%	Non-iunctional

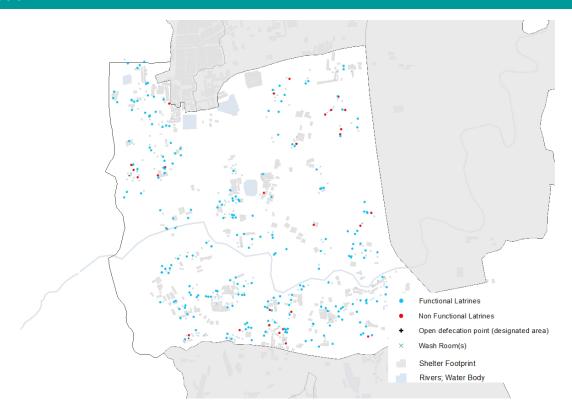
Sanitation

87% Functional (non-full) latrines13% Non-functional latrines

77% Safe (roof, door, wall) 23% Unsafe
