# **SHELTER AND WASH RAPID ASSESSMENT**

**TYPHOON HAIYAN, PHILIPPINES, 2013**

**FINAL Report**

**15 January 2014**

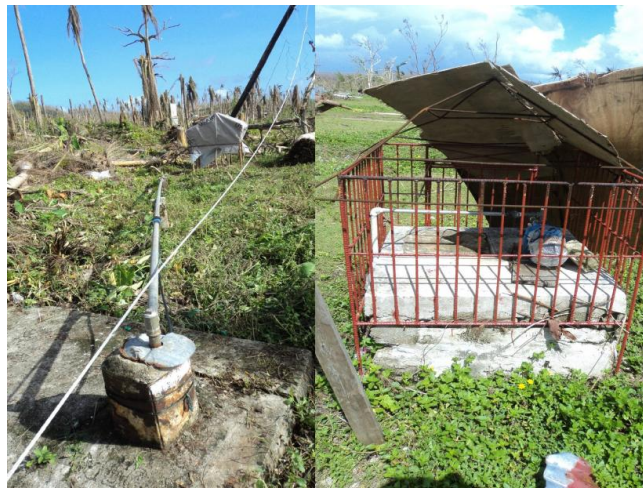
**Figure 12:** Level II WSS not working due to interrupted power supply

House connections were damaged by debris from collapsed buildings as well as water erosion. Where pipes are still present, loose joints and cracks on PVC pipes allow cross contamination by waste water. Despite this dramatic scenario, in urban areas access to drinking water and water supply for domestic purpose is improving day by day thanks to the coordinated rehabilitation efforts between humanitarian agencies, municipalities, water districts and DOH.

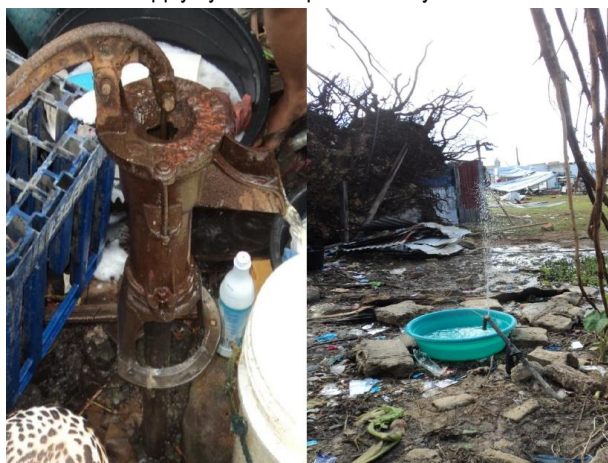
**Figure 13:** Level I and III water supply systems in poor sanitary conditions increase public health risk

Water supplies located in inland areas show transmission and distribution mains damaged by water erosion along river crossings and water storage facilities damaged by flying objects and collapsed trees. Cross contamination is still a serious concern due to loose pipe joints and cracks on PVC pipes. In general, for level III water supply systems fetching water from rivers, the regular provision of chlorine for water disinfection is a concern (Figure 13)

Level I water supply systems in coastal areas are heavily contaminated by sea water and waste water (protected/unprotected shallow well with hand pumps and protected/unprotected springs- direct observations). Inland level I water supply systems are not affected and the quality of water collected is similar to the one before the Haiyan emergency: spring water and shallow wells are widely utilised for drinking purposes. The water is not treated at the source and the population showed trust on its quality.

5. Level I WSS (spring catchments and shallow wells) should be rehabilitated or upgraded to minimize surface water contamination. Level III and II WSS should be investigated for leakages with dedicated instruments (manual and electronic listening sticks) to define a basic leakage control strategy aimed to decrease WSS contaminations.

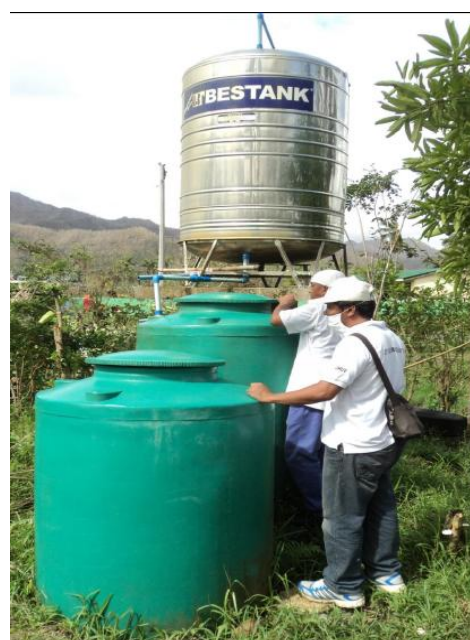
Few barangays in Leyte and Eastern Samar are still utilizing slow sand filters: shallow wells (protected and unprotected) are pumped to deliver raw water to an elevated water tower – usually 3,000 L capacity – which feeds water by gravity to slow sand filters; operations and maintenance are up to the community and the treated water is sold for about 2 PHP/5 gallon.

At present, these systems are not working due to damage to power lines providing electricity to centrifugal pumps. Moreover, some pumps and water towers have been irreparably damaged by the storm surge and flying objects during the cyclone (Figure 14).

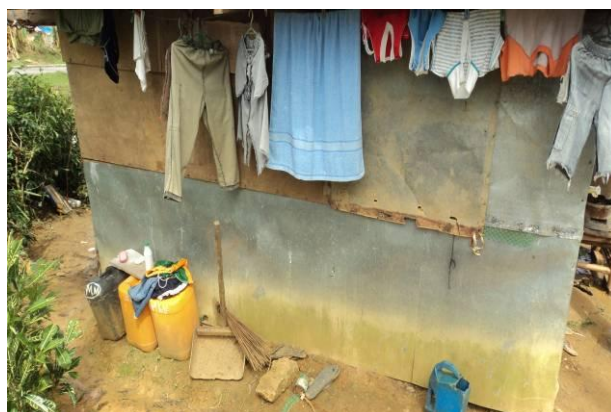
**Figure 15:** Jerry cans for water collection stored in unsanitary conditions

Household water treatment during previous emergencies was supported by DOH and Pilipino Red Cross (international and national donations) with the provision of chemical products for water disinfection under different commercial names: aqua drops, aqua chlorine tabs, waterine solution, Aqua tabs, PUR etc. This approach is limited in time and geographic distribution and the main household water treatment method recommended by DOH and Pilipino Medical Association remains boiling water before drinking. This recommendation doesn't consider constraints related to the local availability of firewood and charcoal and neither the additional cost a family should face on a daily basis. These are the main reasons boiling water as water treatment is not widely or regularly adopted.
