WASH Site Profile - Camp 18

Ukhia, Cox's Bazar, Bangladesh (May 2018) GPS Coordinates: 21.189, 92.1476

This profile provides an overview of water, sanitation and hygiene (WASH) infrastructure within Camp 18 in Ukhia, Cox's Bazar. Primary data for the sixth round was collected between 22 April -12 May 2018.¹ Findings should be considered indicative only. The full camp dataset is available on HDX.

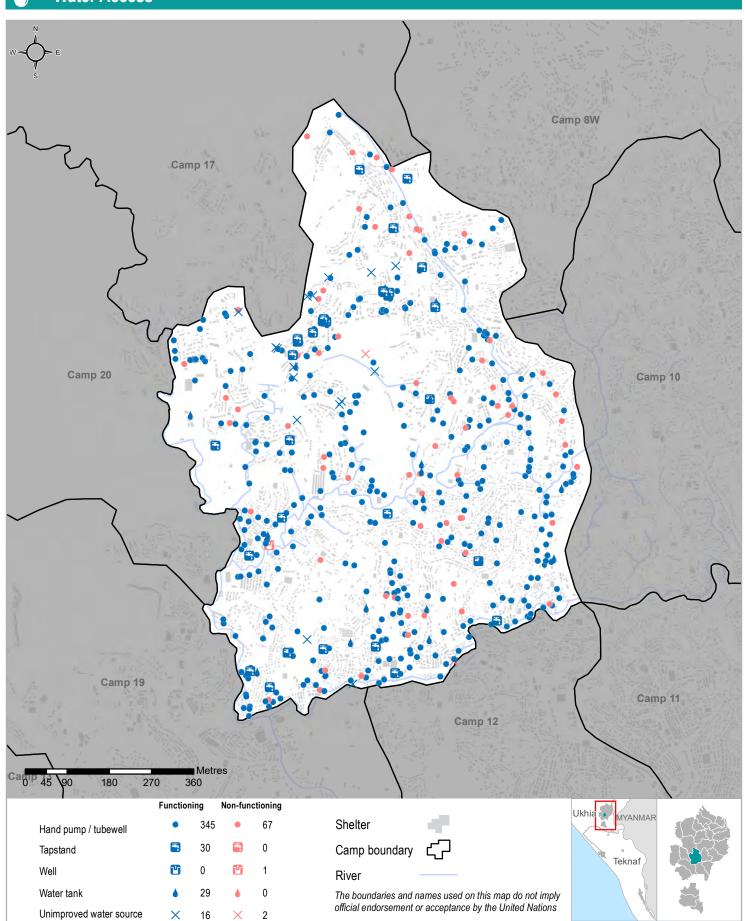
Water Access

Three most commonly identified types of water points, by functionality:

88%	Handpump / tube well	83%	17%	
6%	Water tank	100%	0%	Functional
6%	Tapstand	100%	0%	Non-functional

Key sectoral standards:	Target	Current Round	Achievement
# of people per functional improved water source ³	max. 250	67	
% of shelters with at least 1 functional improved water source³ within 200m	100%	100%	
% of functional improved water source with no latrine within 10m	100%	35%

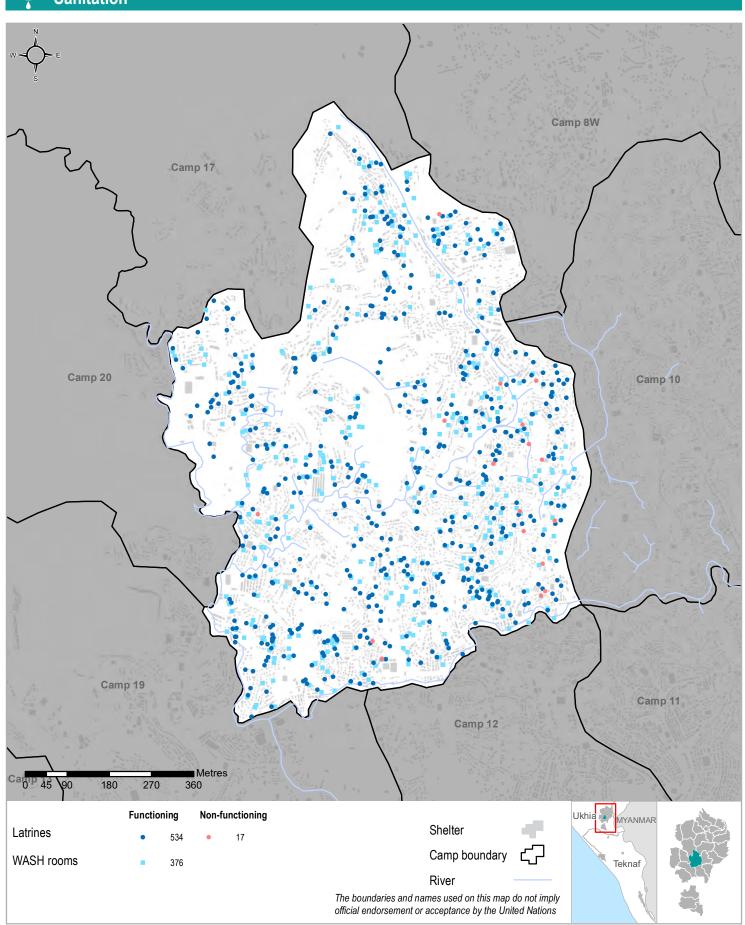
Sanitation

Latrine characteristics: Functionality and safety

Key sectoral standards:	Target	Current Round	Achievement
# of people per functional (non-full) and safe latrine ²	max. 20	27	
# of people per functional (non-full) latrine	max. 20	25	
# of people per safe latrine ²	max. 20	26	
% of shelters with at least one functional and safe latrine ² block within 50m	100%	99%
