Data collection period for this camp: 17 - 28/04/2019

File: Camp 11 Contact: reach.mapping@impact-initiatives.org Note: Data, designations and boundaries contained on this map are not warranted to be error-free and do not imply acceptance by the REACH partners, associated, donors mentioned on this map.

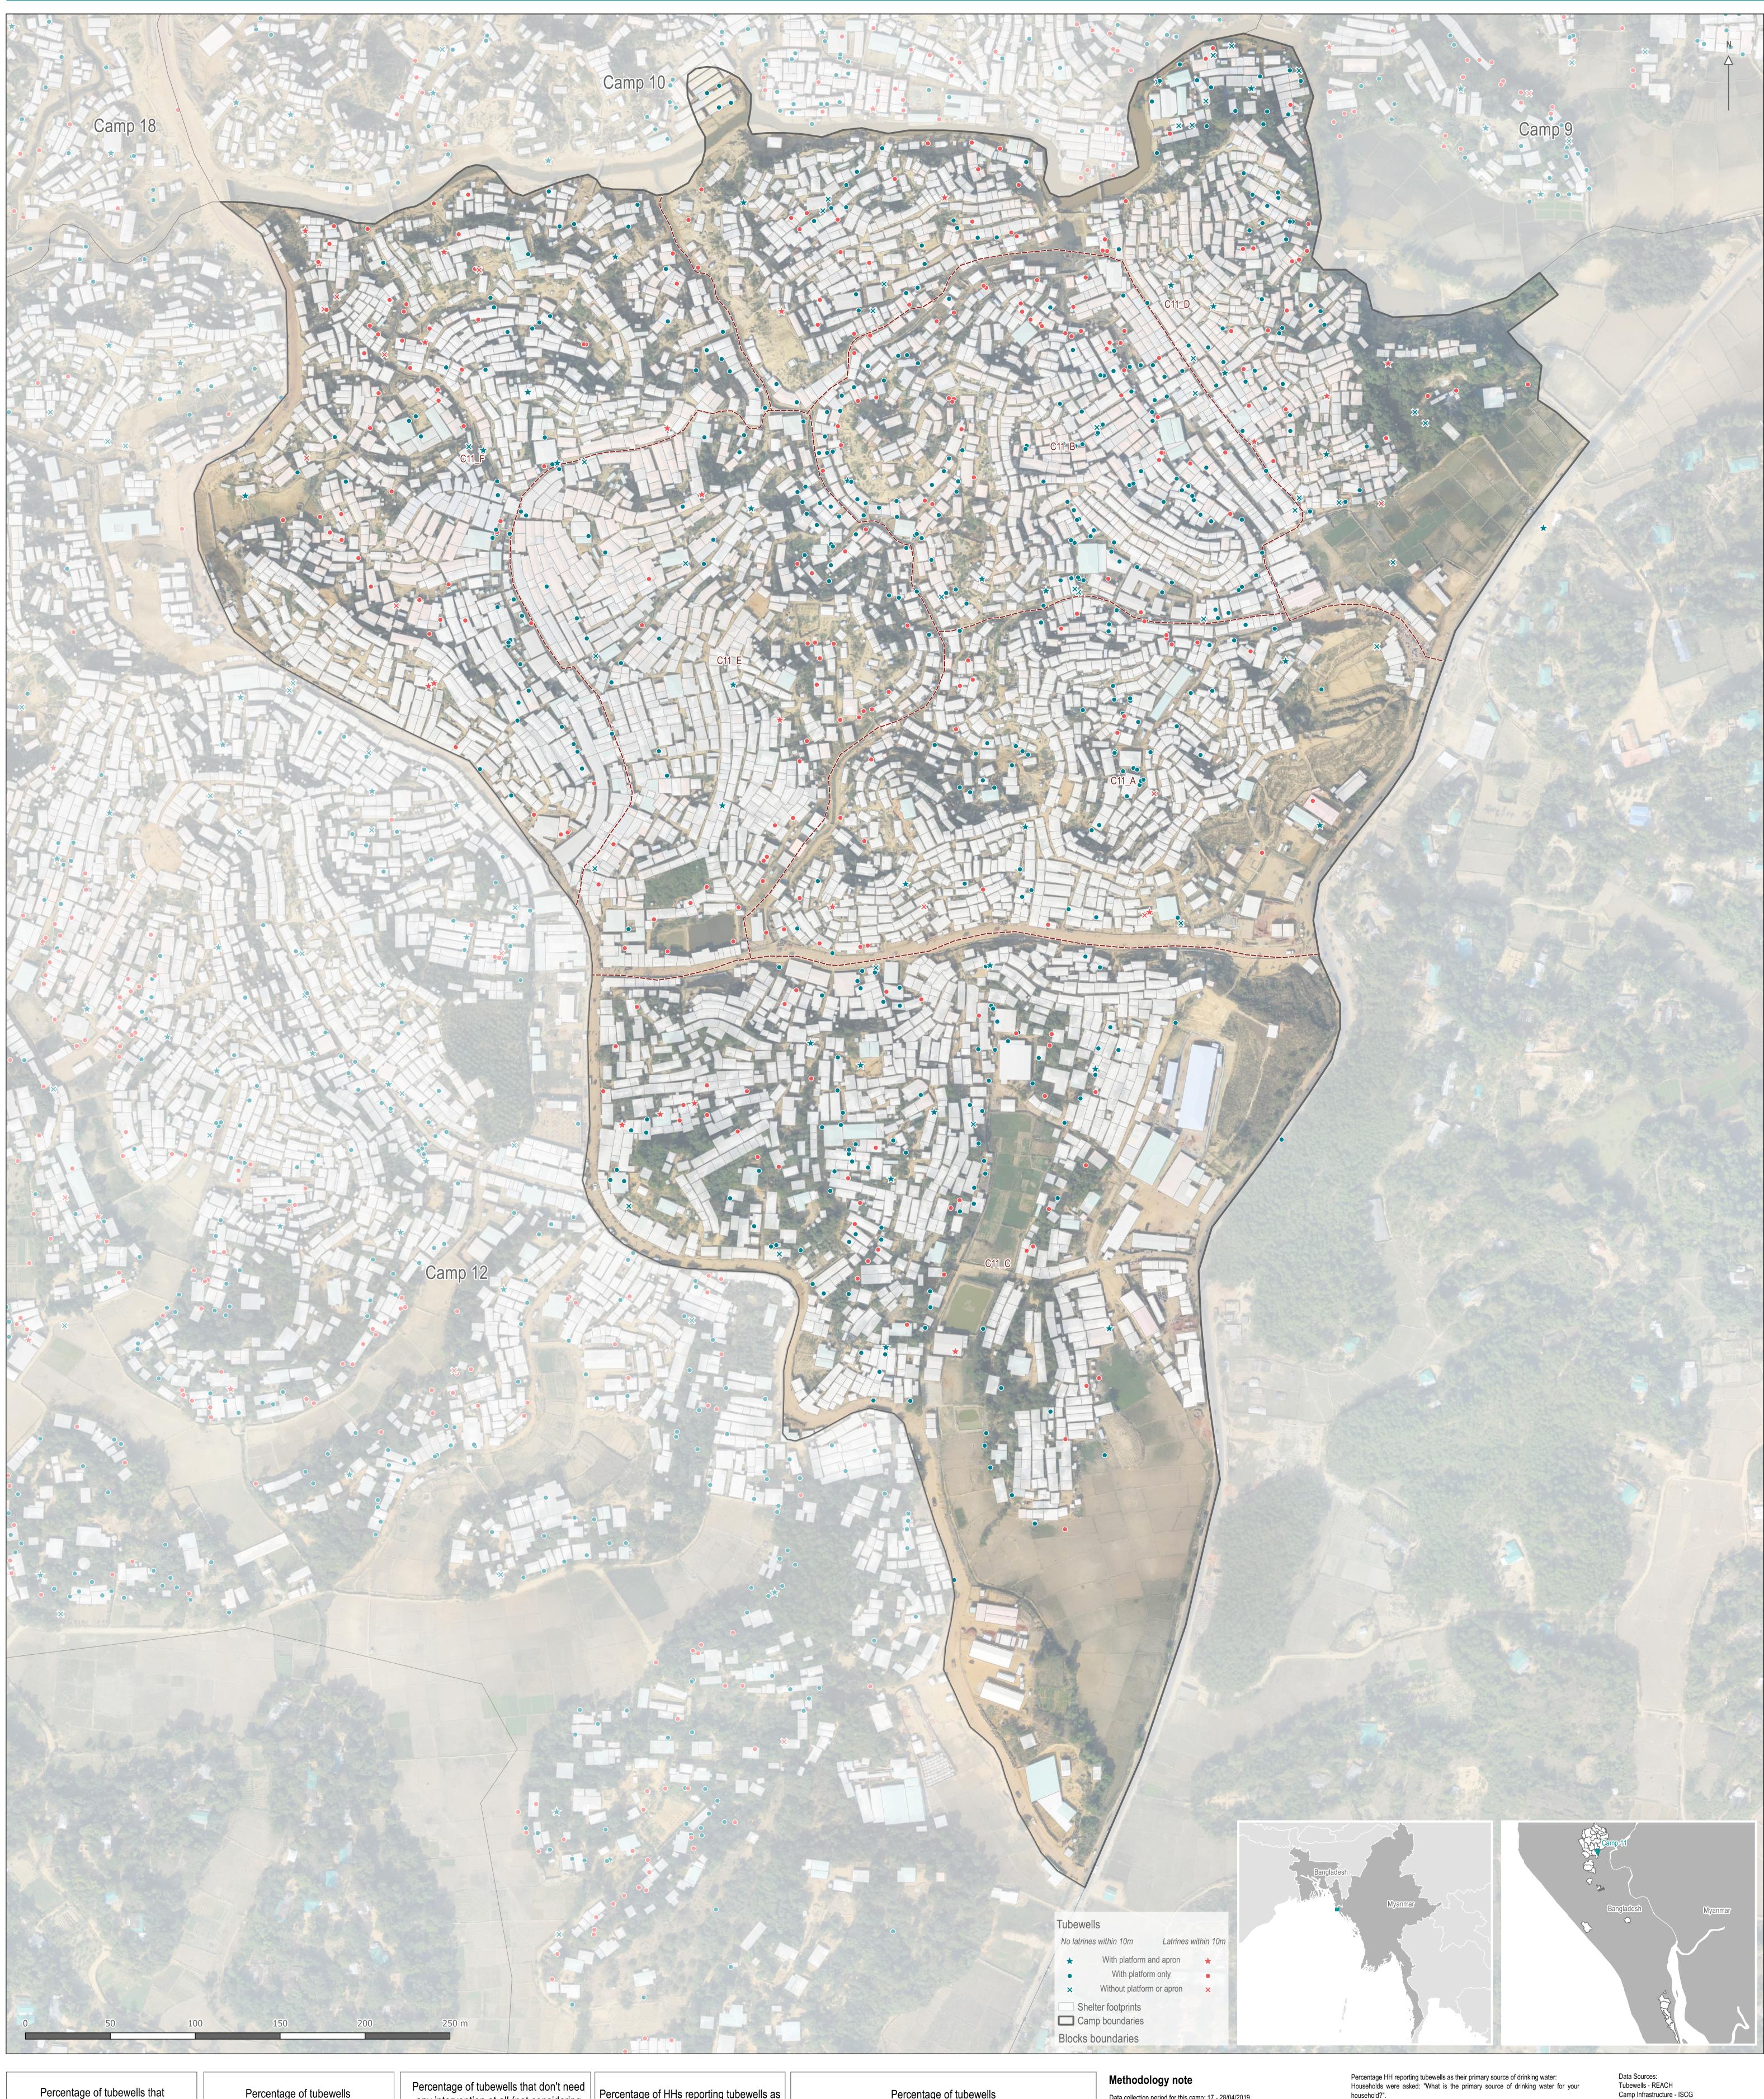
Percentage of tubewells that are functional:

Tubewell is considered functional when the enumerator could draw water from the tube at the moment of visit. Some areas have been visited closer to the end of the dry season, when more wells fell dry. This can affect the functionality rate.

Source: Tubewell Coding Percentage of tubewells with drainage problems: A tubewell has drainage problems when at least one of the following is true: - No drainage channel exists

- Drainage channel is broken/cracked - Drainage channel permits ponding - Drainage channel needs cleaning (e.g. it is blocked)

Percentage tubewells that don't need any intervention at all (not considering Tubewells are considered to not need any intervention at all if they have a platform that extends more than 1 meter on all sides, that is not cracked, with no stagnant water on it and if the tubewell is not loose at the bottom. This indicator does not include whether or not the tubewell has drainage problems. Source: Tubewell Coding

## Contamination risk index:

0-2 = low, 3-5 = intermediate, 6-8 = high, > 8 = very high.

classified in the following categories:

The contamination score was calculated as follows, based on the results of a SPHERE-standard recommended sanitary survey. For each of these aspects, the tubewell gets points for every answer that has a negative effect on contamination: - if there is a latrine within 10m of the tubewell (1 point)

- if this latrine is located uphill (1 point)
- if there are other sources of pollution within 10m of the tubewell (1 point) - if the tubewell has no platform (3 points) - if the tubewell has a platform but it's cracked (1 point)

- if the tubewell has a platform but it has drainage problems (1 point) - if the tubewell has a platform but the concrete extends less than 1m from the - if the tubewell has a platform but there is water on the platform (1 point) - if there is stagnant water within 2m of the tubewell (1 point)

- if there is no fencing around the tubewell (1 point)
The scores of all questions in the sanitary survey are added up together and this is

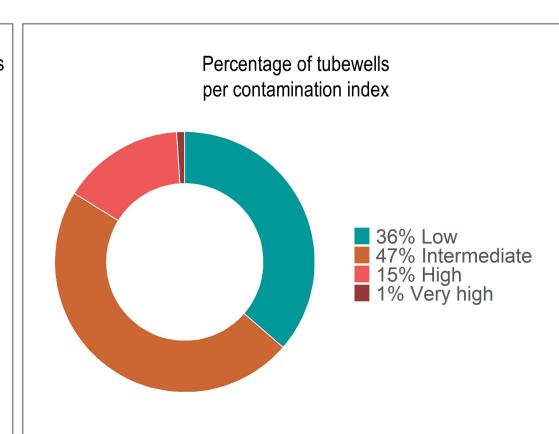
- if the handpump is loose at the bottom (1 point)
