WASH Site Profile - Camp 20

Ukhia, Cox's Bazar, Bangladesh (August 2018) GPS Coordinates: 92.1402, 21.1909

This profile provides an overview of water, sanitation and hygiene (WASH) infrastructure within Camp 20 in Úkhia, Cox's Bazar. Primary data for this round was collected from 29th July to 29th August 2018.1 Findings should be considered indicative only. Full camp dataset is available on HDX.

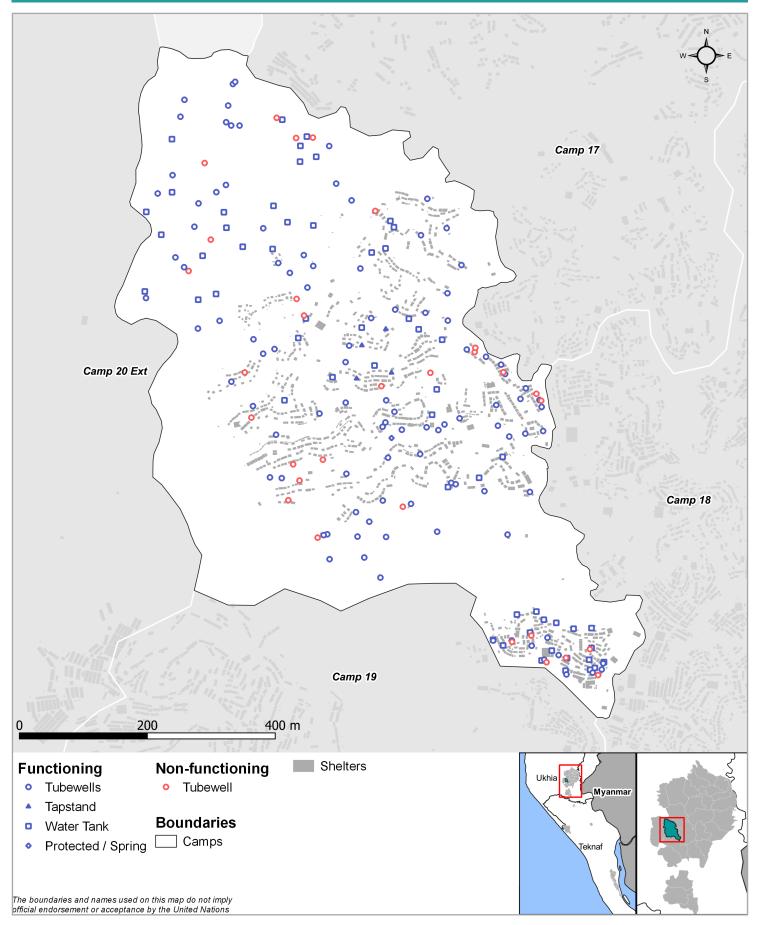
Water Access

Three most commonly identified types of water points, by functionality:

68%	Handpump / tube well	77%	23%	
29%	Water tank	100%	0%	Functional
2%	Tapstand	100%	0%	Non-functional

Key sectoral standards:	Target	Current Round	Achievement
# of people per functional improved water source	max. 250	42	
% of shelters with at least 1 functional improved water source³ within 200m	100%	100%	
% of functional improved water sources with no latrine within 10m	100%	44%

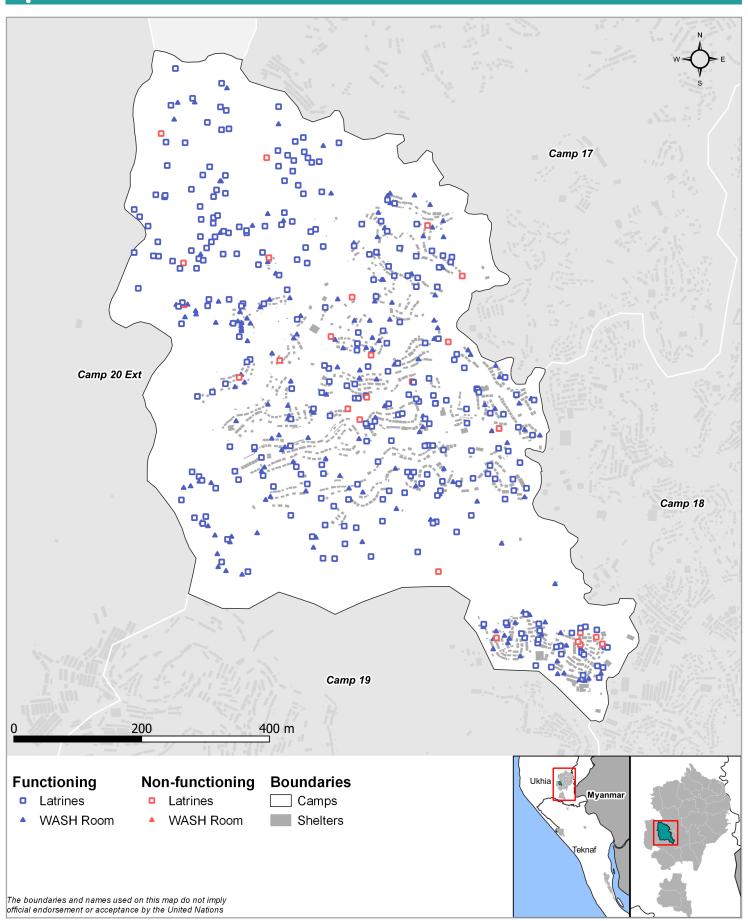
Sanitation

Latrine characteristics:

88% Functional (non-full) and safe² 12% Non-functional and / or unsafe

93% Functional (non-full) 7% Non-functional

93% Safe² Unsafe 1% With lights 99% Without lights

Key sectoral standards:	Target	Current Round	Achievement
# of people per functional (non-full) and safe latrine ²	max. 20	18	
# of people per functional (non-full) latrine	max. 20	17	
# of people per safe latrine ²	max. 20	17	
% of shelters with at least one functional and safe latrine² block within 50m	100%	99%
