# **WASH Site Profile - Camp 20 Ext**

Ukhia, Cox's Bazar, Bangladesh (October 2018) **GPS Coordinates: 92.134, 21.1902**

This profile provides an overview of water, sanitation and hygiene (WASH) infrastructure within Camp 20 Ext in Ukhia, Cox's Bazar. Primary data for this round was collected from 17 September to 22 October 2018.¹ Findings should be considered indicative only. Full camp dataset is available on HDX.

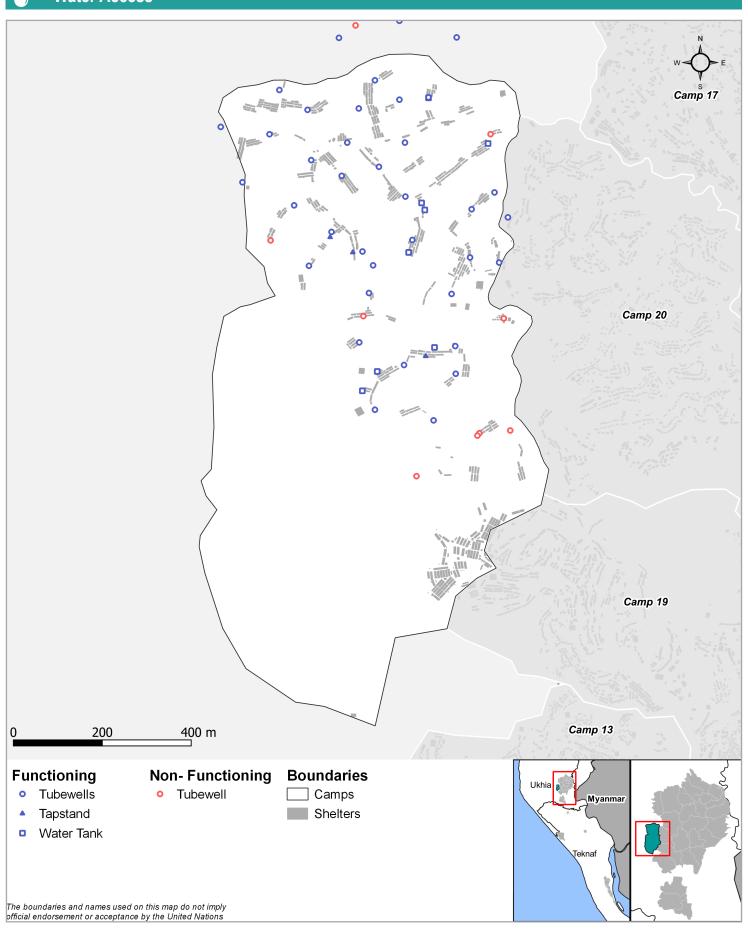
## **Water Access**

Three most commonly identified types of water points, by functionality:

81%	Handpump / tube well	80%		20%	
14%	Water tank	100%		0%	Functional
5%	Tapstand	100%	<b>♦</b>	0%	Non-functional

Key sectoral standards:	Target	<b>Current Round</b>	Achievement
# of people per functional improved water source	max. 250	83	
% of shelters with at least 1 functional improved water source³ within 200m	100%	100%	
% of functional improved water sources with no latrine within 10m	100%	79%

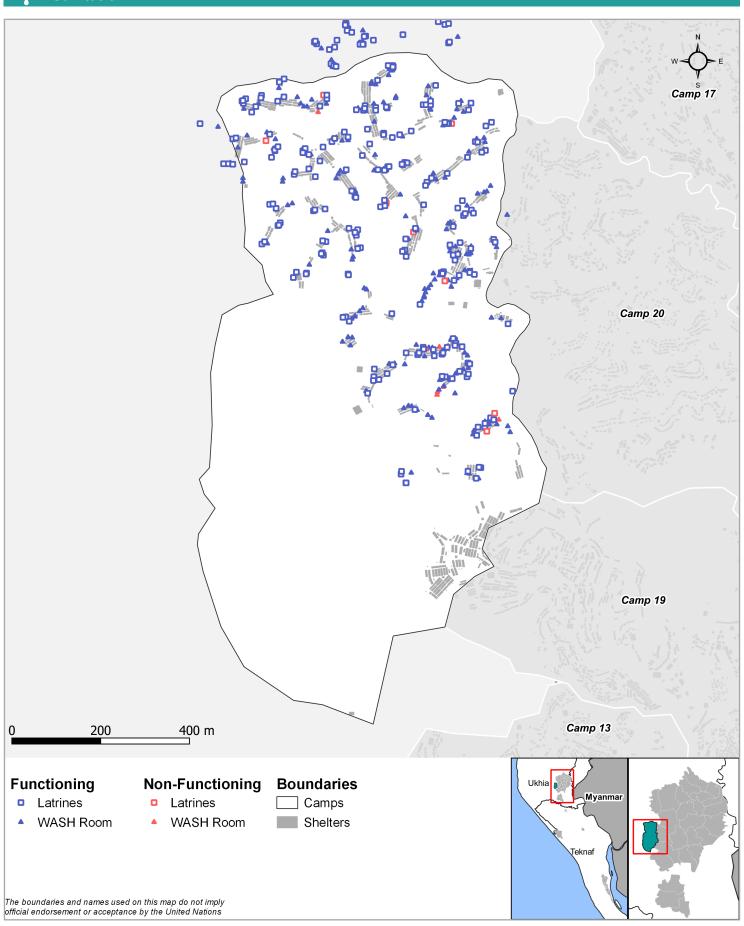
### **Sanitation**

97% Functional (non-full) and safe<sup>2</sup> 3% Non-functional and / or unsafe

99% Functional (non-full) 1% Non-functional

99% Safe<sup>2</sup> 1% Unsafe 7% 93%

Key sectoral standards:	Target	<b>Current Round</b>	Achievement
# of people per functional (non-full) and safe latrine <sup>2</sup>	max. 20	9	
# of people per functional (non-full) latrine	max. 20	9	
# of people per safe latrine <sup>2</sup>	max. 20	9	
% of shelters with at least one functional and safe latrine <sup>2</sup> block within 50m	100%	96%
