Ein Terma Summary

71% of Structures Damaged or Destroyed

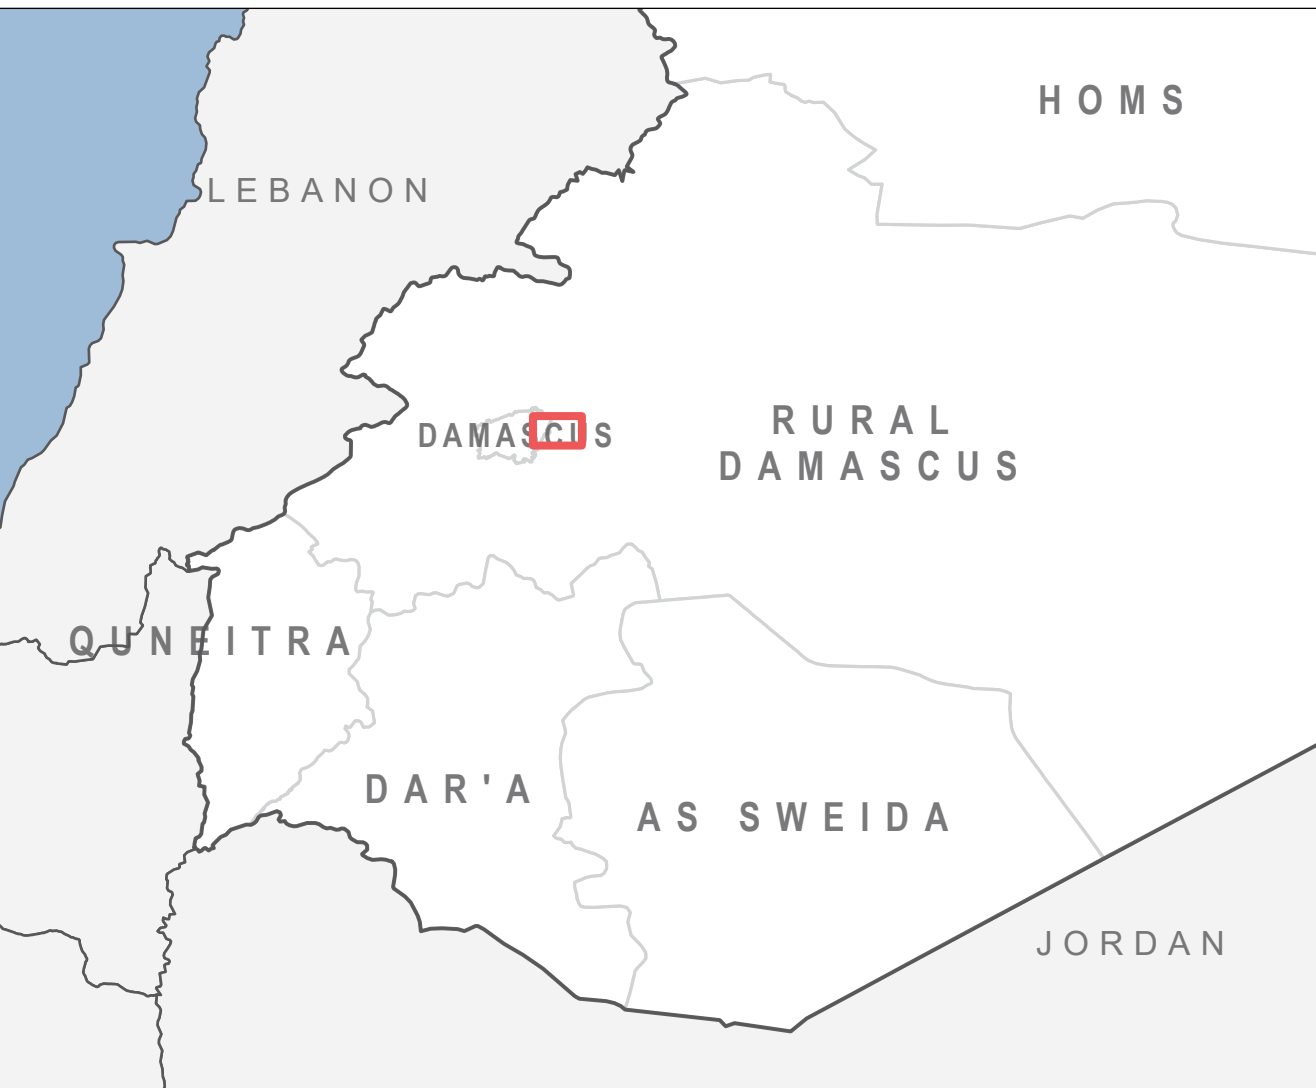
Damage Severity Density

* Severity calculated based on density of damaged infrastructure and weighted by scale of damaged based on; destroyed, severely damaged, or moderate damage.

Structure Damage Class

- Low
- Destroyed
- Severe Damage
- Moderate Damage
