Pulka Town WASH Infrastructure Mapping

Gwoza LGA, Borno State, Nigeria

February 2021

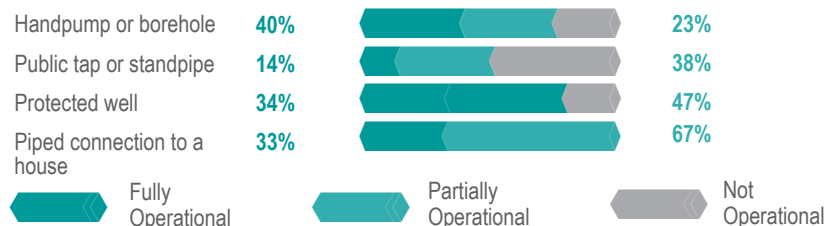
Improved waterpoints functionality by type

23% of assessed waterpoints were reported to be damaged or in need of repair.
