## Summary

This profile provides an overview of water, sanitation and hygiene (WASH) infrastructure within Camp 23 (Shamlapur) in Teknaf, Cox's Bazar. Primary data for this round was collected from 17 September to 22 October 2018.<sup>1</sup> Findings should be considered indicative only. Full camp dataset is available on [HDX](#).

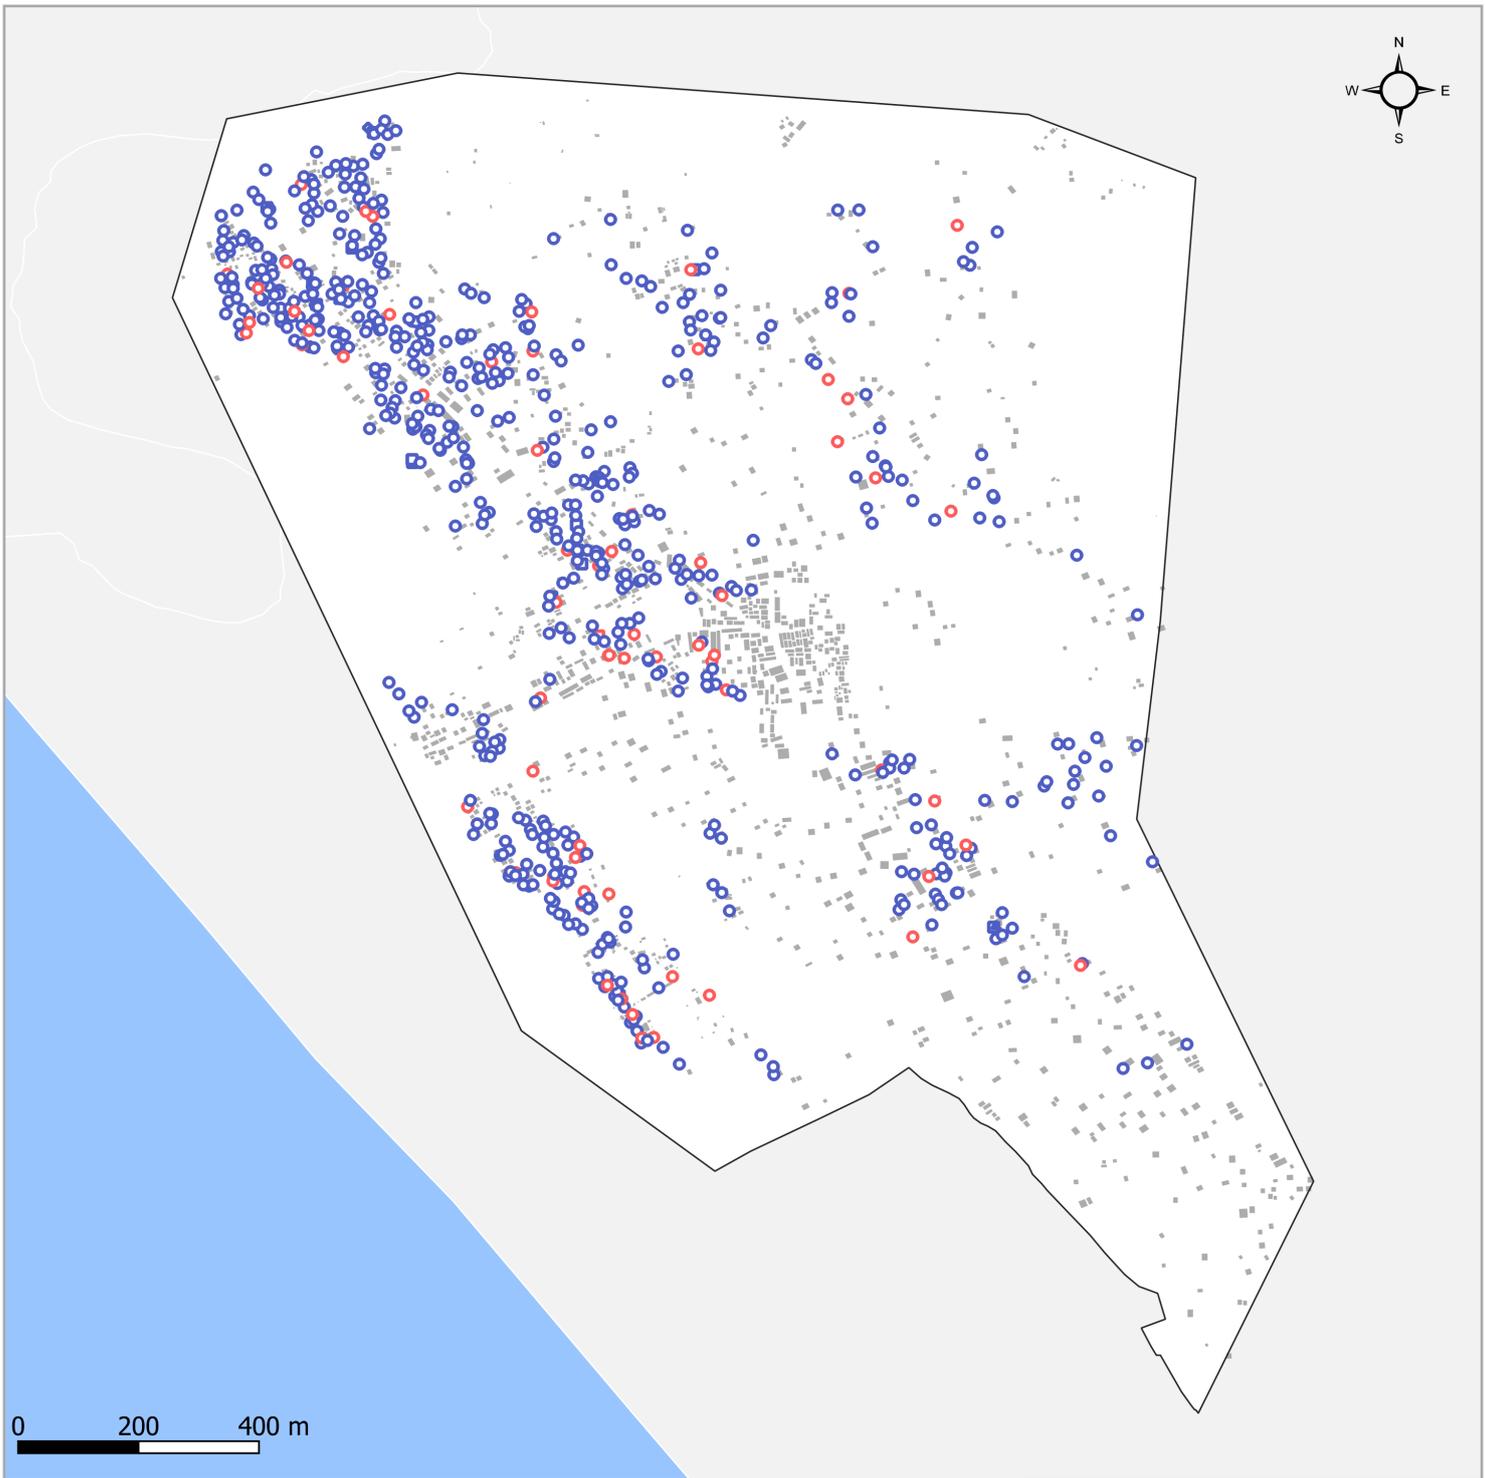
## Water Access

Functioning	Non-Functioning	Boundaries
○ Tubewells	○ Tubewell	□ Camps
▲ Tapstand	■ Water Tank	■ Shelters
■ Water Tank		
◆ Protected / Spring

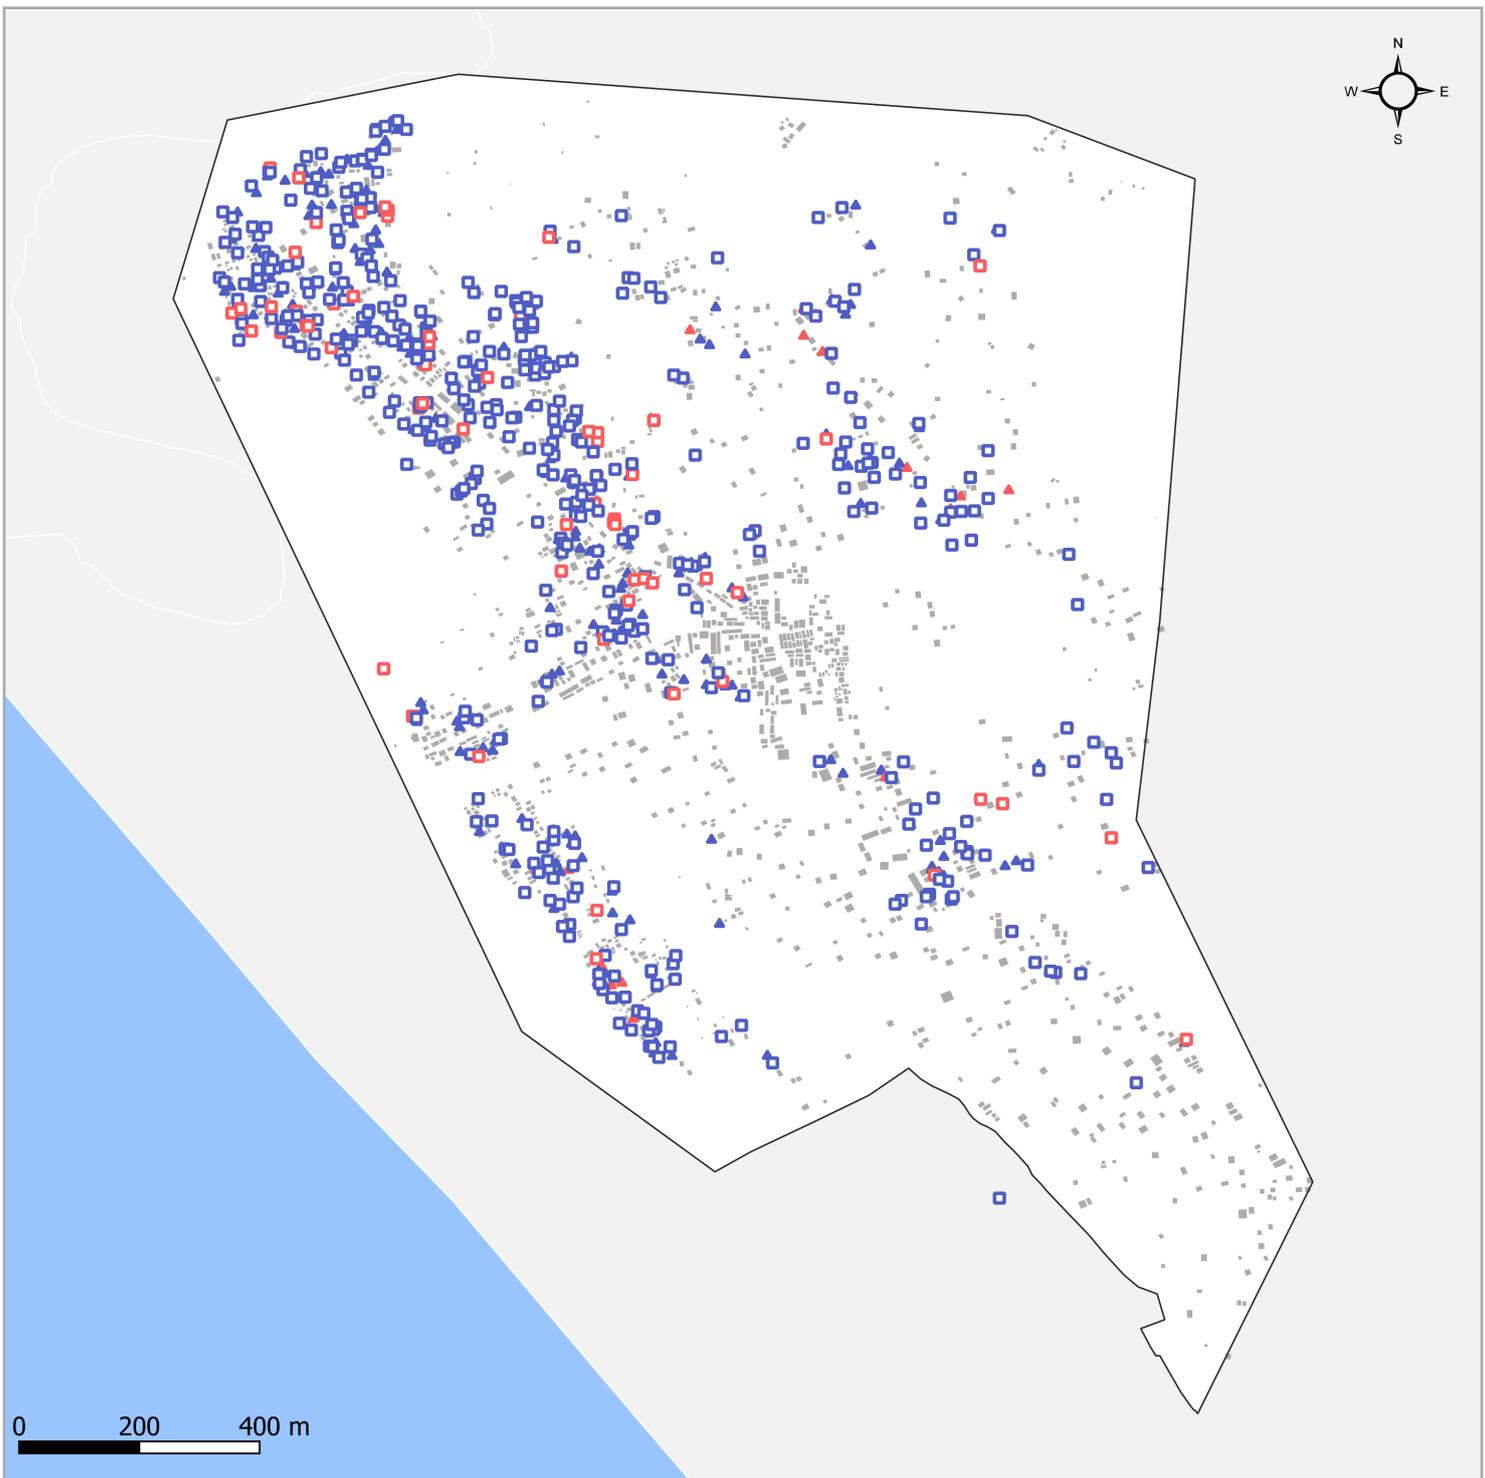
## Sanitation

Functioning	Non-Functioning	Boundaries
<ul style="list-style-type: none"> <li><span style="color: blue;">□</span> Latrines</li> <li><span style="color: blue;">▲</span> WASH Room</li> </ul>	<ul style="list-style-type: none"> <li><span style="color: red;">□</span> Latrines</li> <li><span style="color: red;">▲</span> WASH Room</li> </ul>	<ul style="list-style-type: none"> <li><span style="border: 1px solid black; display: inline-block; width: 15px; height: 10px;"></span> Camps</li> <li><span style="background-color: grey; display: inline-block; width: 15px; height: 10px;"></span> Shelters</li> </ul>
